## AHU screening (single-system, 2026-06)

### AHU\_1

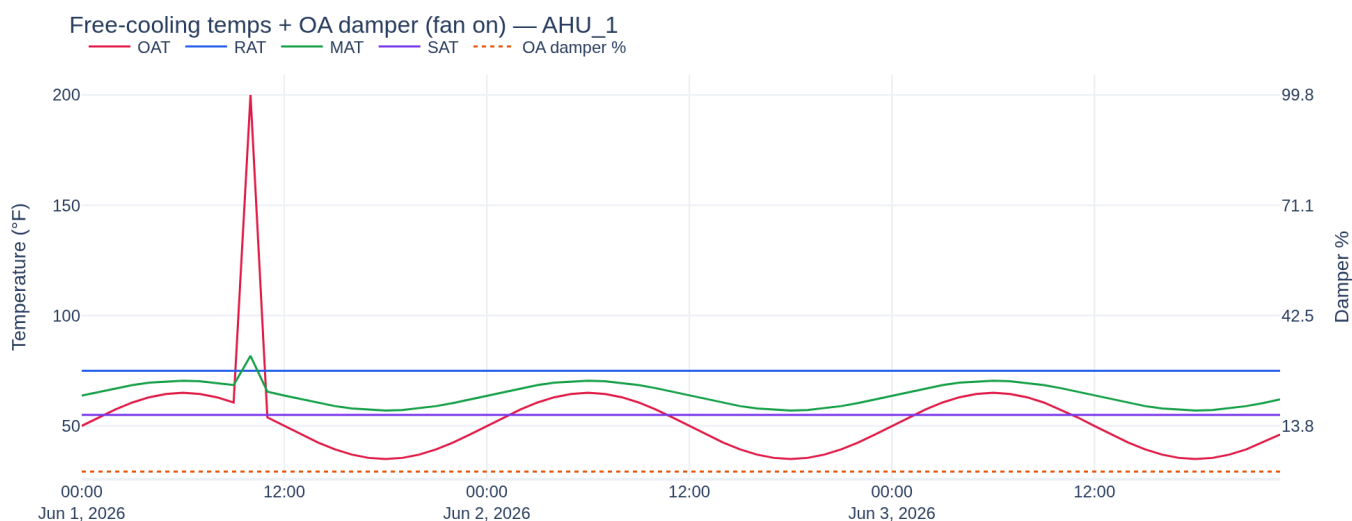
Free-cooling temperatures and outdoor-air damper

Outdoor air temperature read outside its physical range (low 35.0, high 200.0). Return air temperature and supply air temperature stayed stuck flat. Outdoor air temperature jumped suddenly and changed faster than expected.

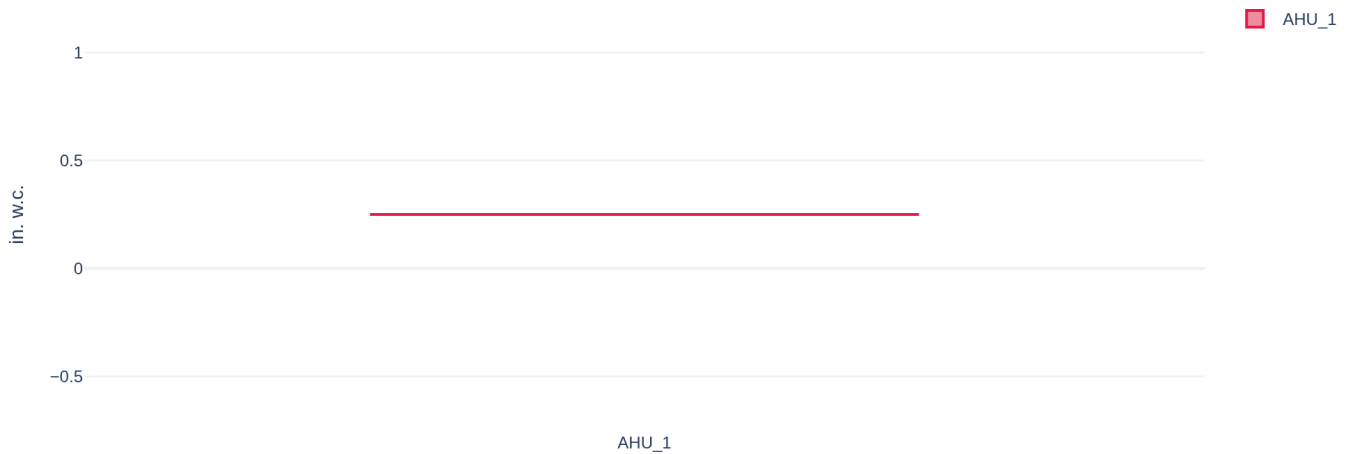
Duct static while the fan runs

Duct static pressure with the fan running.

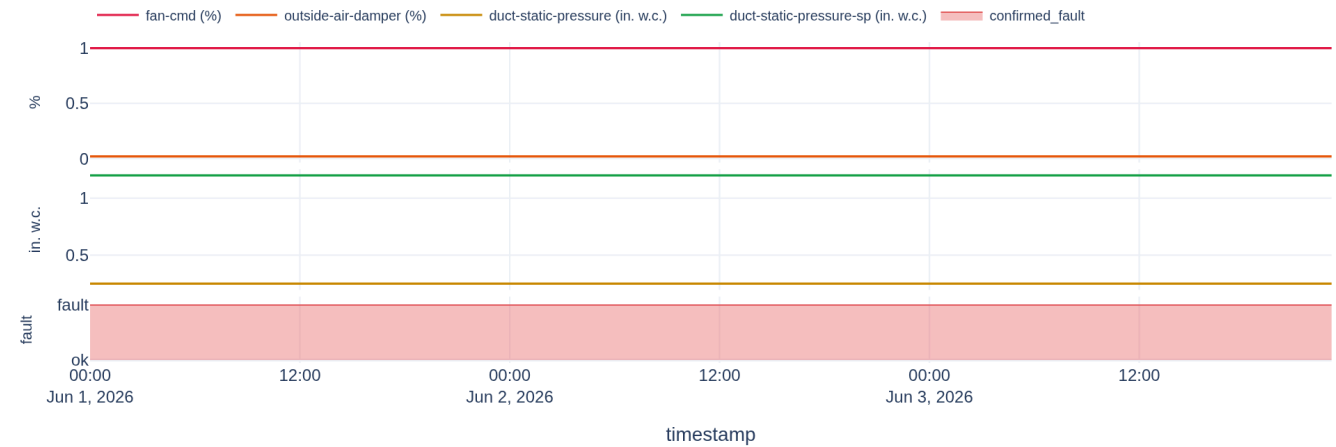
**FC1 – Duct static below SP at full fan (GL36 A)**

Troubleshoot: Flags duct static too low while the supply fan is near full speed. Check:  $DSP < DSPSP - \epsilon DSP$  AND  $VFDSPD \geq 100\% - \epsilon VFDSPD$ .

In the data: In June 2026 this holds for 72.0 hours, 2026-06-01 00:00 UTC through 2026-06-03 23:00 UTC. duct static pressure was on for 0.0 percent of those samples; duct static setpoint was on for 100.0 percent of those samples; fan speed command was on for 100.0 percent of those samples.

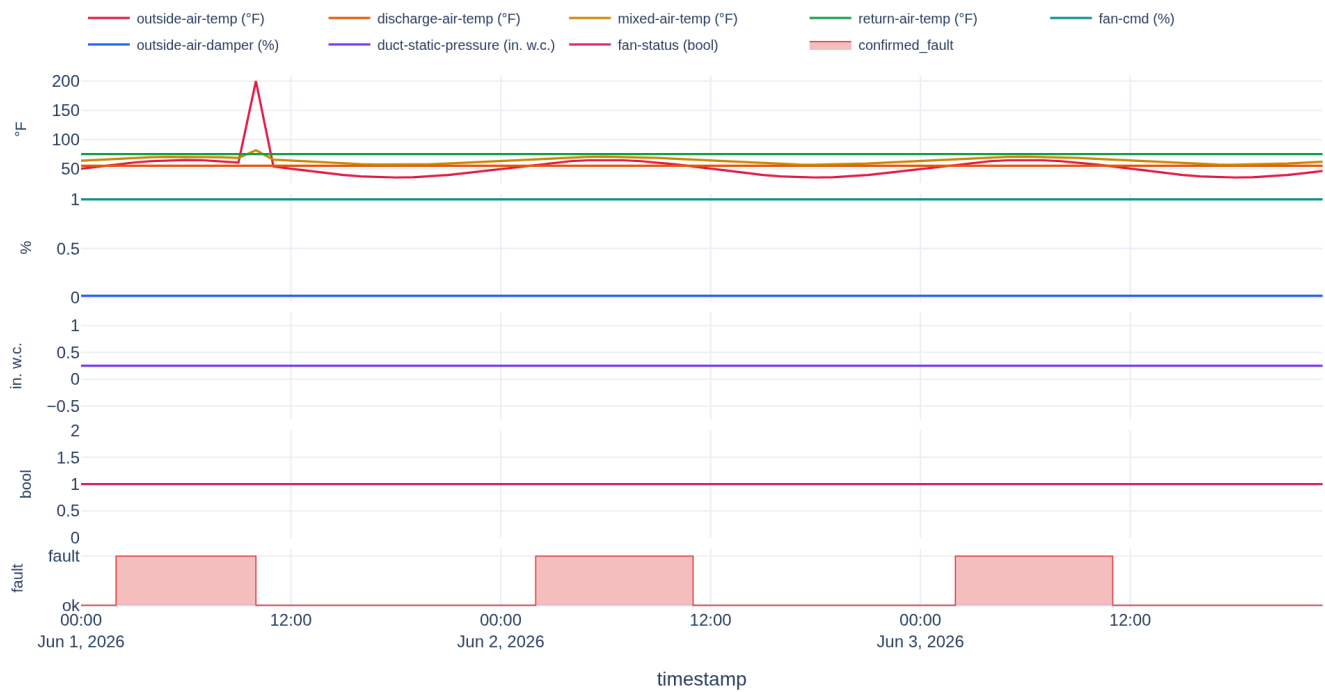
**ECON-1 – Economizer stuck closed**

Troubleshoot: Fan on, OA damper < 5%, OAT > 55°F (should be economizing). Check: Fan on, OA damper < 5%, OAT > 55°F (should be economizing).

In the data: In June 2026 this holds for 26.0 hours, 2026-06-01 02:00 UTC through 2026-06-03 10:00 UTC. fan speed command was on for 100.0 percent of those samples; outdoor air damper was on for 0.0 percent of those samples; outdoor air temperature was about 63.0.

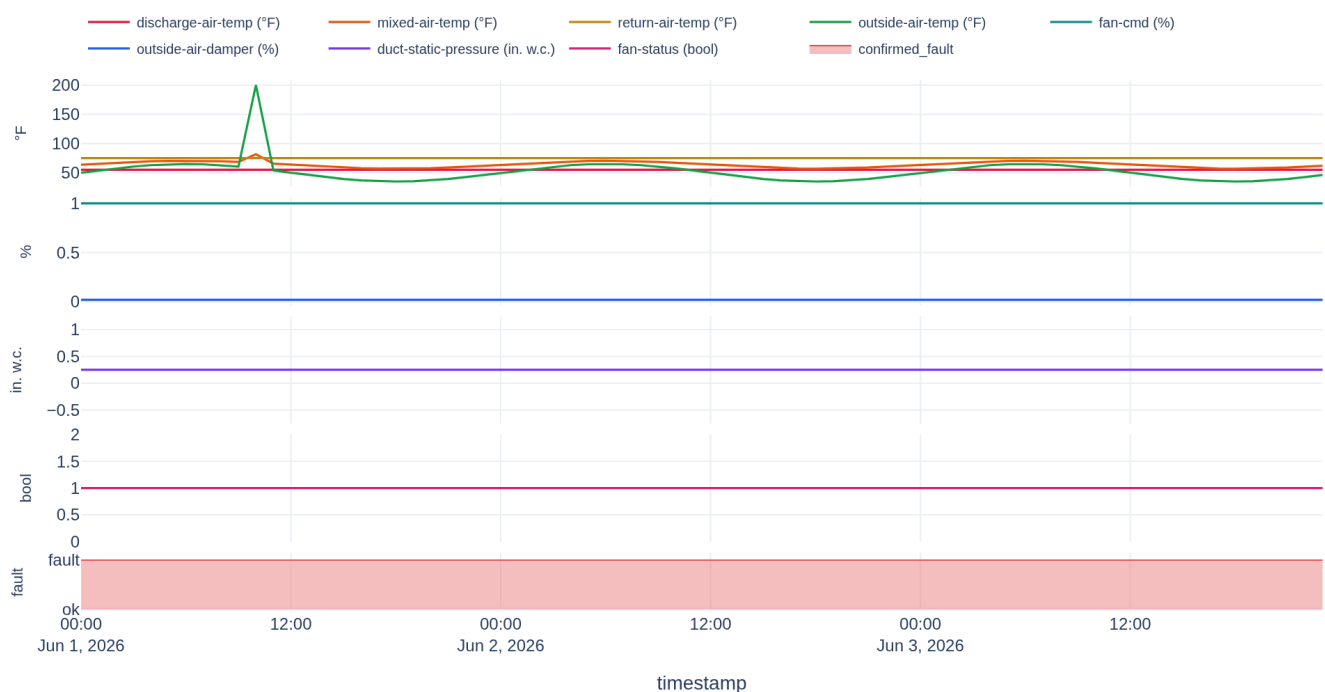
#### SCHED-247 – Always-on fan or pump runtime

Troubleshoot: Flags fans or pumps that stay on for nearly the entire analysis window (24/7 runtime). Check: Ranked proof (status/current > command) is on for  $\geq$  always\_on\_pct of the window. Pressure is inferred runtime only and does not trip this rule ID.

In the data: In June 2026 this holds for 72.0 hours, 2026-06-01 00:00 UTC through 2026-06-03 23:00 UTC. fan status was on for 100.0 percent of those samples; fan speed command was on for 100.0 percent of those samples; duct static pressure was on for 0.0 percent of those samples.
