NORTH AMERICAN ELECTRIC RELIABILITY COUNCIL

Technical Analysis of the August 14, 2003, Blackout: What Happened, Why, and What Did We Learn?

Report to the NERC Board of Trustees by the NERC Steering Group

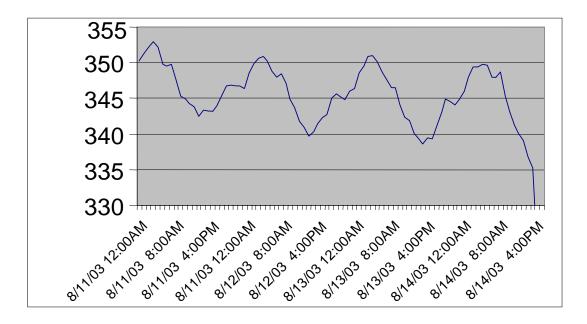
Figure II.6 — Representative Voltage Profile on FE System during Week of August 11

Unlike frequency, which is the same at any point in time across the interconnection, voltage varies by location and operators must monitor voltages continuously at key locations across their systems. During the days and hours leading up to the blackout, voltages were routinely depressed in a variety of locations in northern Ohio because of power transfers across the region, high air-conditioning demand, and other loads. During an interview, one FE operator stated, "some [voltage] sagging would be expected on a hot day, but on August 14 the voltages did seem unusually low." However, as shown below in figures II.6 and II.7, actual measured voltage levels at key points on the FE transmission system on the morning of August 14 and up to 15:05 were within the range previously specified by FE as acceptable. Note, however, that most control areas in the Eastern Interconnection have set their low voltage limits at levels higher than those used by FE.

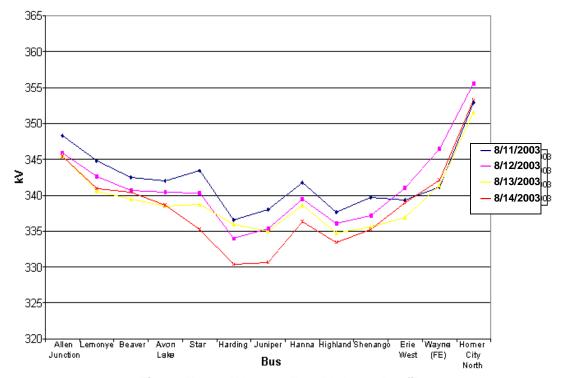
Figure II.8 — West-to-East Voltage Profile

• The bus voltages in the Cleveland-Akron area show a greater decline as the week progressed compared to buses outside this area.

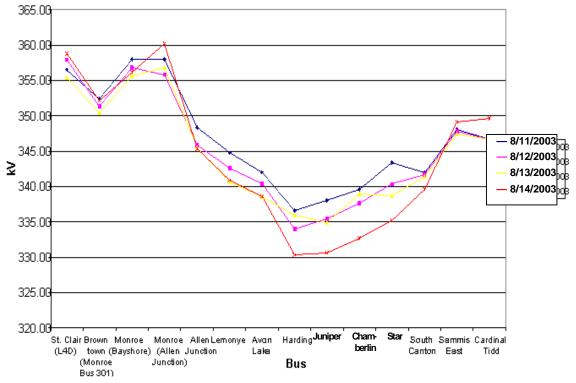
Figure II.9 — North-to-South Voltage Profile

Analysis showed that the declining voltages in the Cleveland-Akron area were strongly influenced by the increasing temperatures and loads in that area and minimally affected by transfers through FE to other systems. FE did not have sufficient reactive supply in the Cleveland-Akron area on August 14 to meet reactive power demands and maintain a safe margin from voltage collapse.

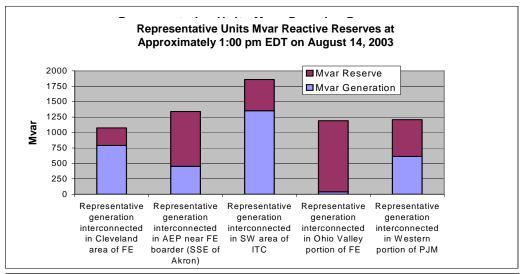
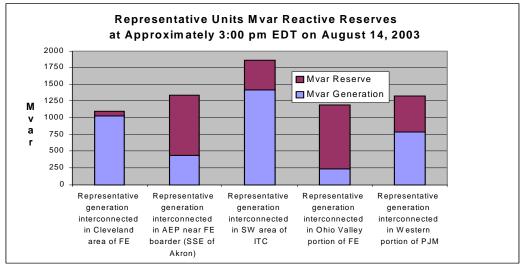
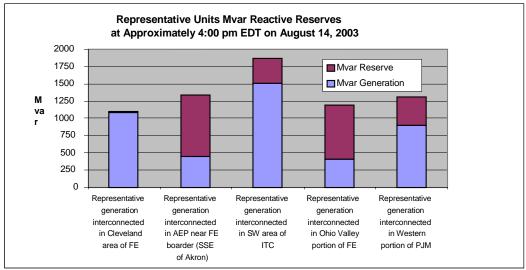
Figure II.10 — Reactive Reserves of Representative Groups of Generators on August 14, 2003

Figure II.10 shows the actual reactive power reserves from representative generators along the Lake Erie shore and in the Cleveland-Akron area for three time periods on August 14. It also shows the reactive power reserves from representative generators in AEP, MECS, and PJM that are located in the proximity of their interconnections with FE.

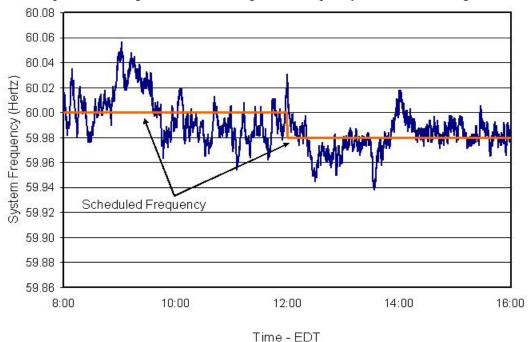
Figure II.11 — Eastern Interconnection Frequency Plot for August 14, 2003

Figure II.11 shows a plot of the frequency for the Eastern Interconnection on August 14. As is typical, frequency is highly random within a narrow band of several one hundredths of a hertz. Prior to the blackout, frequency was within the statistical bounds of a typical day. Scheduled frequency was lowered to 59.98 at noon to conduct a time error correction. This is a routine operation. After the blackout, the frequency was high and highly variable following the loss of exports to the Northeast. Also, there appears to be a pattern relating to the times during which frequency deviations are larger.

System frequency anomalies earlier in the day on August 14 are explained by previously known interchange scheduling issues and were not a precursor to the blackout. Although frequency was

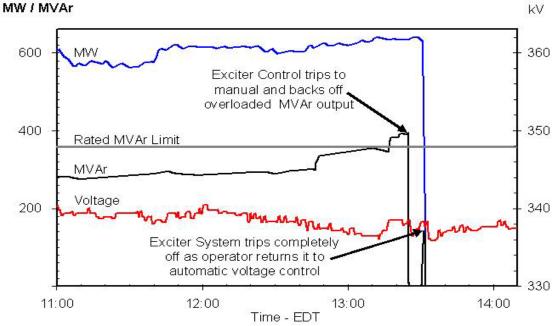
Figure III.1 — Eastlake 5 Output Prior to Trip at 13:31 EDT

About four or five minutes after the Mvar output decreased to zero, the operator was increasing the terminal voltage and attempting to place the exciter back on AVR control when the excitation system tripped altogether (see Figure III.1). The unit then tripped off at 13:31:34 when the loss of excitation relay operated. Later phone transcripts indicate subsequent trouble with a pump valve at the plant that would not re-seat after the trip. As a result, the unit could not be quickly returned to service.

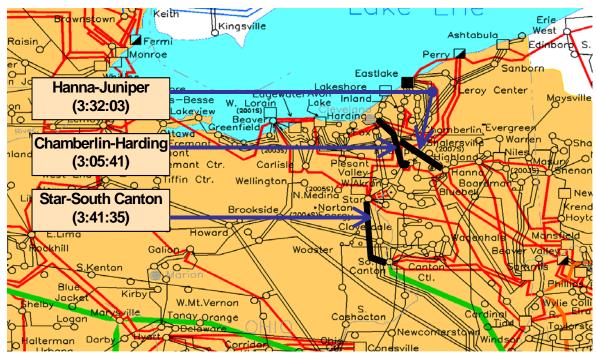
Figure III.3 — Location of Three Line Trips

Figure III.3 shows the location of the Chamberlin-Harding line and the two subsequent critical line trips.

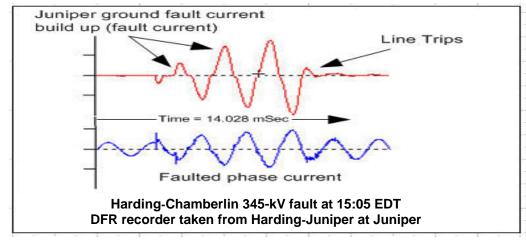
Figure III.4 — Juniper DFR Indication of Tree Contact for Loss of the Chamberlin-Harding Line

At 15:05:41, The FE Chamberlin-Harding 345-kV line tripped and locked out while loaded at 500 MVA or 43.5 percent of its normal and emergency ratings of 1,195 MVA (which are the same values). At 43.5 percent loading, the conductor temperature did not exceed its design temperature and the line could not have sagged sufficiently to allow investigators to conclude that the line sagged into the tree due to overload. Instead, investigators determined that FE had allowed trees in the Chamberlin-Harding right-of-way to grow too tall and encroach into the minimum safe clearance from a 345-kV energized conductor. The investigation team examined the relay data for this trip, which indicated high impedance Phase C fault-to-ground, and identified the geographic location of the fault. They determined that the relay data match the classic signature pattern for a tree-to-line fault (Figure III.4). Chamberlin-Harding tripped on directional ground relay — part of a directional comparison relay scheme protecting the line.

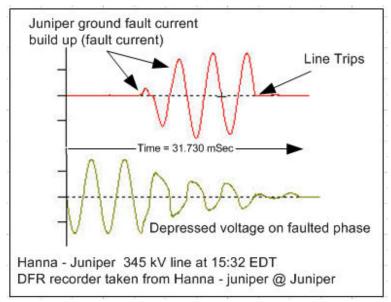
Figure III.5 — Juniper DFR Indication of Tree Contact for Loss of Hanna-Juniper

Incremental line current and temperature increases, escalated by the loss of Chamberlin-Harding, caused enough sag on the Hanna-Juniper line that it experienced a fault current due to tree contact, tripped and locked out at 15:32:03, with current flow at 2,050 amperes or 87.5 percent of its normal and emergency line rating of 2,344 amperes. Figure III.5 shows the Juniper digital fault recorder indicating the tree signature of a high-impedance ground fault. Analysis showed high arc resistance limiting the actual fault current well below the calculated fault current assuming a "bolted" (no arc resistance) fault.

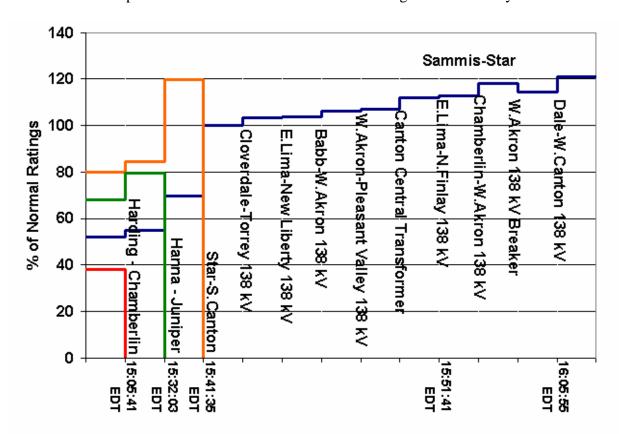
Figure III.6 — Line Loadings as the Northeast Ohio 345-kV Lines Trip

Figure III.6 shows the line loadings calculated by the investigation team as the 345-kV lines in northeast Ohio began to trip. Showing line loadings on the 345-kV lines as a percent of normal rating, the graph tracks how the loading on each line increased as each subsequent 345-kV and 138-kV line tripped out of service between 15:05 (Chamberlin-Harding) and 16:06 (Dale-West Canton). As the graph shows, none of the 345- or 138-kV lines exceeded their normal ratings on an actual basis (although contingency overloads existed) until after the combined trips of Chamberlin-Harding and Hanna-Juniper. But immediately after Hanna-Juniper was lost, Star-South Canton's loading jumped from an estimated 82 percent of normal to 120 percent of normal (still below its emergency rating) and remained at that level for ten minutes before tripping out. To the right, the graph shows the effects of the 138-kV line failures (discussed next) on the remaining 345-kV line, i.e., Sammis-Star's loading increased steadily above 100 percent with each succeeding 138-kV line lost.

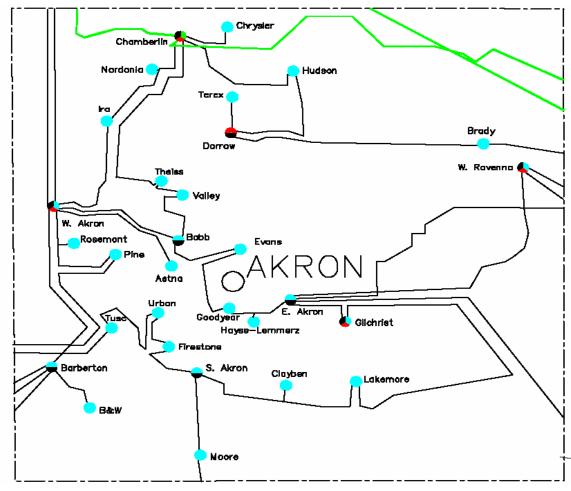
Figure III.7 — Akron Area Substations Participating in Localized 138-kV Cascade

Approximately 600 MW of customer loads were shut down in Akron and areas to the west and south of the city during the cascade because they were being served by transformers connected to those lines. As the lines failed, severe voltage drops caused a number of large industrial customers with voltage-sensitive equipment to go off-line automatically to protect their operations.

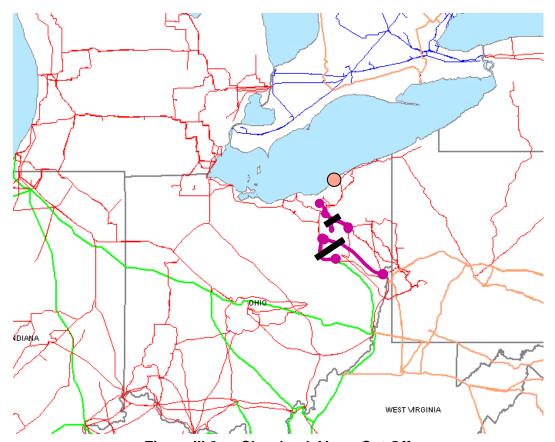
Figure III.8 — Cleveland-Akron Cut Off

As shown in Figure III.8, the Sammis-Star line trip completely severed the 345-kV path into northern Ohio from southeast Ohio, triggering a new, fast-paced sequence of 345-kV transmission line trips in which each line trip placed a greater flow burden on those lines remaining in service. After Sammis-Star tripped, there were only three paths left for power to flow into northern Ohio: (1) from northwestern Pennsylvania to northern Ohio around the south shore of Lake Erie, (2) from southern Ohio, and (3) from eastern Michigan and Ontario. Northeastern Ohio had been substantially weakened as a source of power to eastern Michigan, making the Detroit area more reliant on 345-kV lines west and northwest of Detroit, and from northwestern Ohio to eastern Michigan.

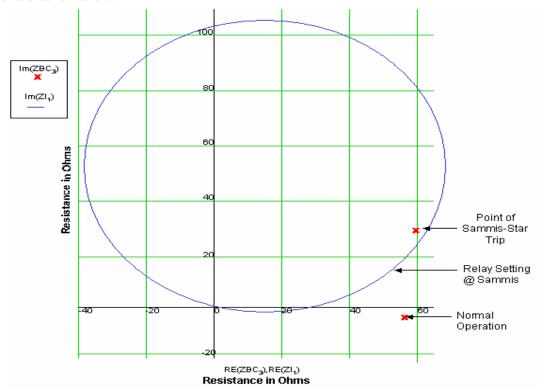
Figure III.9 — Load Encroachment of Sammis-Star Zone 3 Impedance Relay

A zone 3 relay can be defined as an impedance relay that is set to detect system faults on the protected transmission line and beyond.⁵ It sometimes serves a dual purpose. It can act through a timer to see faults beyond the next bus up to and including the furthest remote element attached to the bus. It is used for equipment protection beyond the line and it is an alternative to equipment failure communication systems sometimes referred to as breaker failure transfer trip. Zone 3 relays can also be used in the high-speed relaying system for the line. In this application, the relay needs directional intelligence from the other end of the line that it receives via a highly reliable communication system. In the Sammis-Star trip, the zone 3 relay operated because it was set to detect a remote fault on the 138-kV side of a Star substation transformer in the event of a breaker failure.

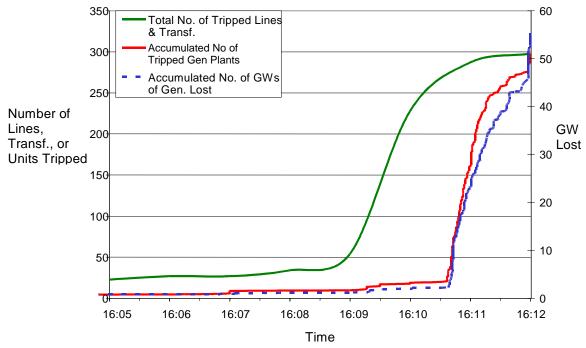
Figure IV.1 — Accumulated Line and Generator Trips During the Cascade

The events in the cascade started slowly, but spread quickly. Figure IV.1 illustrates how the number of lines and generators lost stayed relatively low during the Ohio phase of the blackout, but then picked up speed after 16:08:59. The cascade was complete only two-and-one-half minutes later.

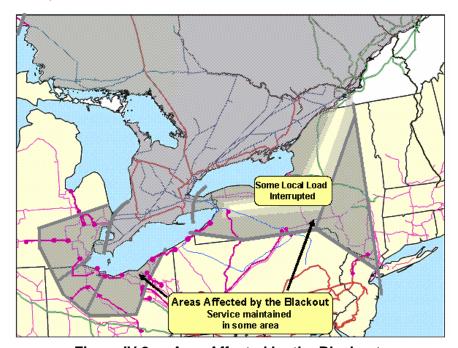
Figure IV.2 — Area Affected by the Blackout

In the final phase, after 16:10:46, the large electrical island in the northeast had less generation than load, and was unstable with large power surges and swings in frequency and voltage. As a result, many lines and generators across the disturbance area tripped, breaking the area into several electrical islands. Generation and load within most of the smaller islands were unbalanced, leading to further tripping of lines and generating units until equilibrium was established in each island. Although much of the disturbance area was fully blacked out in this process, some islands were able to reach equilibrium between generation and load without a total loss of service. For example, the island consisting of most of New England and the Maritime provinces stabilized, and generation and load returned to balance. Another island consisted of load in western New York and a small portion of Ontario, supported by some New York generation, the large Beck and Saunders plants in Ontario, and the 765-kV interconnection to Québec. These two large islands survived but other areas with large load centers collapsed into a blackout condition (Figure IV.2).

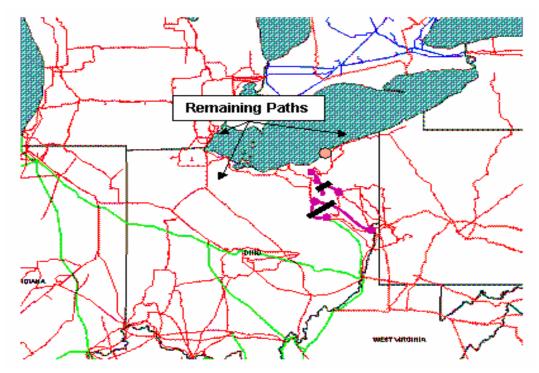
Figure IV.3 — Sammis-Star 345-kV Line Trip 16:05:57

After the loss of Sammis-Star and the underlying 138-kV system, there were no large capacity transmission lines left from the south to support the significant amount of load in northern Ohio (Figure IV.3). This overloaded the transmission paths west and northwest into Michigan, causing a sequential loss of lines and power plants.

The Sammis-Star trip completely severed the 345-kV path into northern Ohio from southeastern Ohio, triggering a new, fast-paced sequence of 345-kV transmission line trips in which each line trip placed a greater flow burden on those lines remaining in service. These line outages left only three paths for power to flow into western Ohio: (1) from northwestern Pennsylvania to northern Ohio around the south shore of Lake Erie, (2) from southwestern Ohio toward northeastern Ohio, and (3) from eastern Michigan and Ontario. The line interruptions substantially weakened northeast Ohio as a source of power to eastern

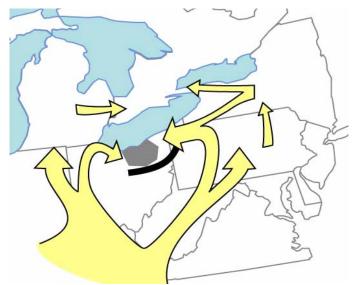
Figure IV.5 — Power Flows at 16:05:58, After the Sammis-Star Trip

Soon after the Sammis-Star trip, four of the five 48 MW Handsome Lake combustion turbines in western Pennsylvania tripped off-line. These units are connected to the 345-kV system by the Homer City-Wayne 345-kV line, and were operating that day as synchronous condensers to participate in PJM's spinning reserve market (not to provide voltage support). When Sammis-Star tripped and increased loadings on the local transmission system, the Handsome Lake units were close enough electrically to sense the impact and tripped off-line at 16:07:00 on under-voltage relay protection.

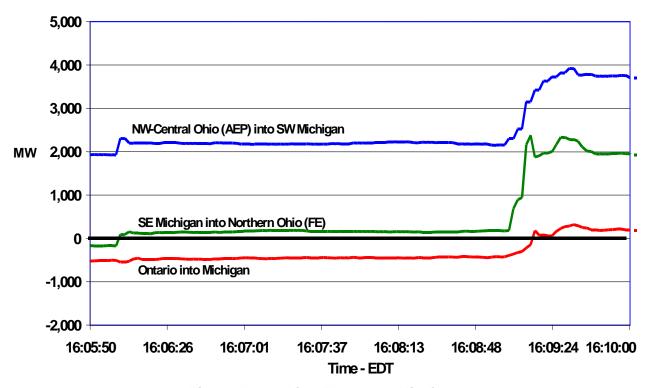
Figure IV.6 — Line Flows Into Michigan

During the period between the Sammis-Star trip and the trip of East Lima-Fostoria 345-kV line at 16:09:06.3, the system was still in a steady-state condition. Although one line after another was overloading and tripping within Ohio, this was happening slowly enough under relatively stable conditions that the system could readjust; after each line loss, power flows would redistribute across the remaining lines. This is illustrated in Figure IV.6, which shows the megawatt flows on the MECS interfaces with AEP (Ohio), FE (Ohio), and Ontario. The graph shows a shift from 150 MW of imports to 200 MW of exports from the MECS system into FE at 16:05:57 after the loss of Sammis-Star, after which this held steady until 16:08:59, when the loss of East Lima-Fostoria Central cut the main energy path from the south and west into Cleveland and Toledo. Loss of this path was significant, causing flow from MECS into FE to jump from 200 MW up to 2,300 MW, where it swung dynamically before stabilizing.

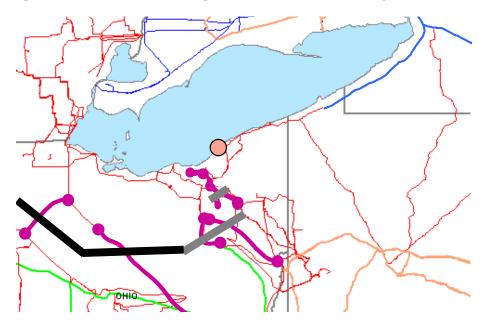
Figure IV.7 — Ohio 345-kV Lines Trip, 16:08:59 to 16:09:07

numerous 138-kV line trips in central Ohio, the East Lima-Fostoria Central line tripped at 16:09:06 on zone 3 relay operation due to high current and low voltage (80 percent). Modeling indicates that if automatic under-voltage load-shedding had been in place in northeastern and central Ohio, it might have been triggered at or before this point and dropped enough load to reduce or eliminate the subsequent line overloads that spread the cascade. The line trips across Ohio are shown in figure IV.7.

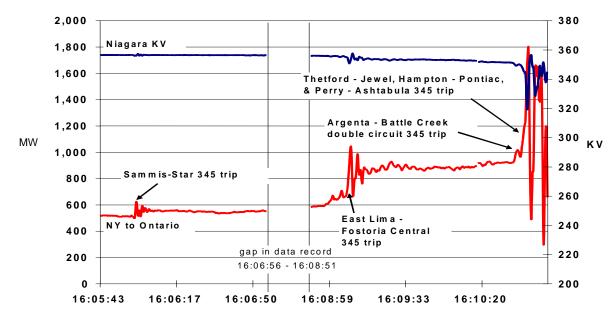
Figure IV.9 — New York-Ontario Line Flows at Niagara

Figure IV.9 shows voltage levels recorded in the Niagara area. It shows that voltage levels remained stable until about 16:10:30, despite significant power fluctuations. In the cascade that followed, the voltage instability was a companion to, not a driver of, the angular instability that tripped generators and lines. A high-speed recording of 345-kV flows at Niagara Falls taken by the Hydro One recorders (shown as the lower plot in Figure IV.9), shows the impact of the East Lima-Fostoria Central and the New York-to-Ontario power swing, which continued to oscillate for more than ten seconds. Looking at the MW flow plot, it is clear that when Sammis-Star tripped, the system experienced oscillations that quickly damped out and rebalanced. But East Lima-Fostoria triggered significantly greater oscillations that worsened in magnitude for several cycles, and then dampened more slowly but continued to oscillate until the Argenta-Battle Creek trip 90 seconds later. Voltages also began to decline at that time.

The far right side of Figure IV.9 shows the fluctuations in flows and voltages at the New York-Ontario Niagara border triggered by the trips of the Argenta-Battle Creek, Argenta-Tompkins, Hampton-Pontiac, and Thetford-Jewell 345-kV lines in Michigan, and the Erie West-Ashtabula-Perry 345-kV line linking the Cleveland area to Pennsylvania. Farther south, the very low voltages on the northern Ohio transmission system made it difficult for the generation in the Cleveland and Lake Erie area to remain synchronous with southeast Michigan. Over the next two minutes, generators in this area shut down after reaching a point of no recovery as the stress level across the remaining ties became excessive.

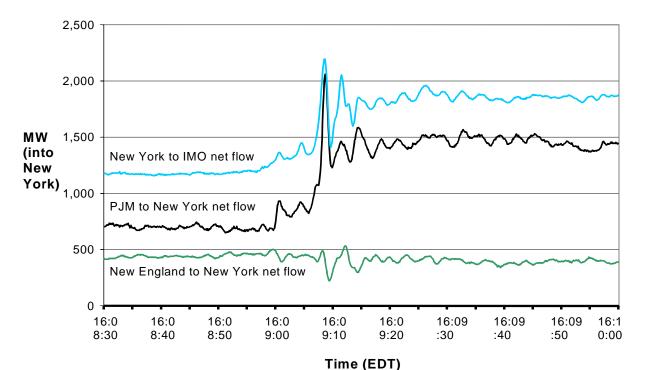
Figure IV.10 — First Power Swing has Varying Impacts on New York Interfaces

Figure IV.10, showing metered power flows along the New York interfaces, documents how the flows heading north and west toward Detroit and Cleveland varied at three different New York interfaces. Beginning at 16:09:05, power flows jumped simultaneously across all three interfaces; but when the first power surge peaked at 16:09:09, the change in flow was highest on the PJM interface and lowest on the New England interface. Power flows increased significantly on the PJM-New York and New York-Ontario interfaces because of the redistribution of flow around Lake Erie to serve the loads in northern Ohio and eastern Michigan. The New England and Maritimes systems maintained the same generation-to-load balance and did not carry the redistributed flows because they were not in the direct path of the flows. Therefore, the New England-New York interface flows showed little response.

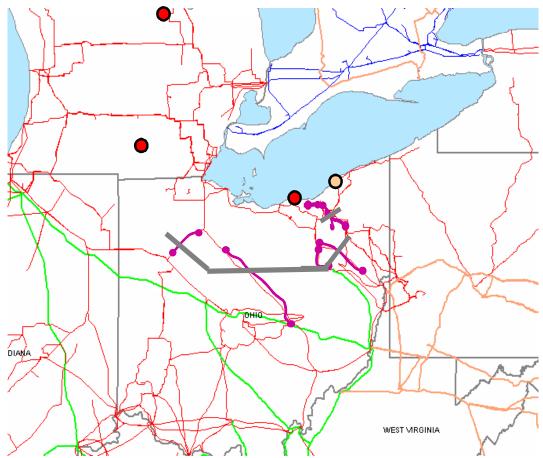
Figure IV.11 — Michigan and Ohio Power Plants Trip or Run Back

The MCV plant in central Michigan experienced a 300 MW run-back. The Avon Lake 7 unit tripped due to the loss of the voltage regulator. The Burger units tripped after the 138-kV lines from the Burger 138-kV generating substation bus to substations in Ohio tripped from high reactive power flow due to the low voltages in the Cleveland area. Three units at the Kinder Morgan generating station in south-central Michigan tripped due to a transformer fault and over-excitation.

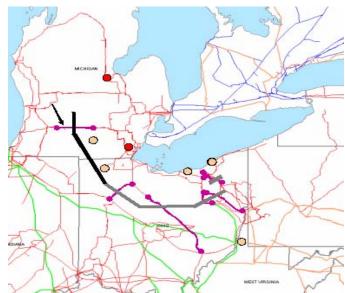
Figure IV.12 — Transmission and Generation Trips in Eastern Michigan, 16:10:36 to 16:10:37

Together, the above line outages interrupted the west-to-east transmission paths into the Detroit area from south-central Michigan. The Sumpter generating units tripped in response to under-voltage on the system. Michigan lines west of Detroit then began to trip, as shown in Figure IV.12.

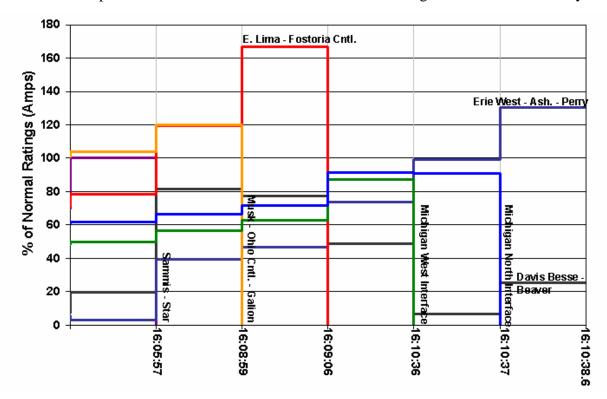
Figure IV.15a — Simulated 345-kV Line Loadings From 16:05:57 Through 16:10:38.6

Figure IV.15a shows the results of modeling of line loadings on the Ohio, Michigan, and other regional interfaces for the period between 16:05:57 until the Thetford-Jewell trip; this helps to illustrate how power flows shifted during this period. Evolving system conditions were modeled for August 14, based on the 16:05:50 power flow case developed by the MAAC-ECAR-NPCC Operations Studies Working Group. Each horizontal line in the graph indicates a single or set of 345-kV lines and their loading as a function of normal ratings over time as first one, then another, set of circuits tripped out of service. In general, each subsequent line trip causes the remaining line loadings to rise. Note that Muskingum and East Lima-Fostoria Central were overloaded before they tripped, but the Michigan west and north interfaces were not overloaded before they tripped. Erie West-Ashtabula-Perry was loaded to 130 percent after the Hampton-Pontiac and Thetford-Jewell trips.

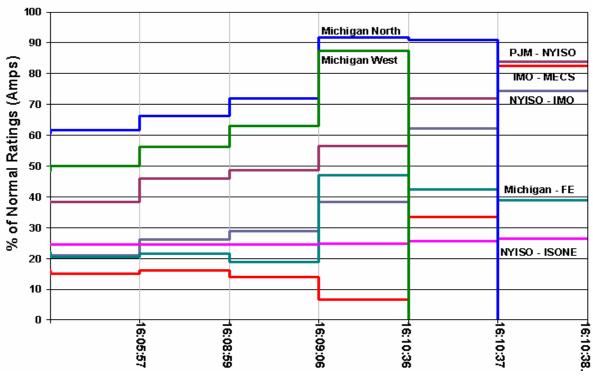
Figure IV.15b — Simulated Regional Interface Loadings From 16:05:57 Through 16:10:38.4

The regional interface loadings graph (Figure VI.15b) shows that loadings at the interfaces between PJM-New York, New York-Ontario, and New York-New England were well within normal ratings before the east-west Michigan separation.

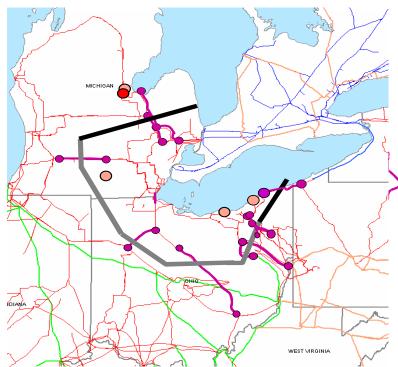
Figure IV.16 — Michigan Lines Trip and Ohio Separates From Pennsylvania, 16:10:36 to 16:10:38.6

Perry-Ashtabula was the last 345-kV line connecting northern Ohio to the east along the southern shore of Lake Erie. This line tripped at the Perry substation on a zone 3 relay operation and separated the northern Ohio 345-kV transmission system from Pennsylvania and all 345-kV connections. After this trip, the load centers in eastern Michigan and northern Ohio (Detroit, Cleveland, and Akron) remained connected to the rest of the Eastern Interconnection only to the north of Lake Erie at the interface between the Michigan and Ontario systems (Figure IV.16). Eastern Michigan and northern Ohio now had little internal generation left and voltage was declining. The frequency in the Cleveland area dropped rapidly, and between 16:10:39 and 16:10:50, underfrequency load shedding in the Cleveland area interrupted about 1,750 MW of load. However, the load shedding was not enough to reach a balance with local generation and arrest the frequency decline. The still-heavy loads in Detroit and Cleveland drew power over the only major transmission path remaining: the lines from eastern Michigan east into Ontario.

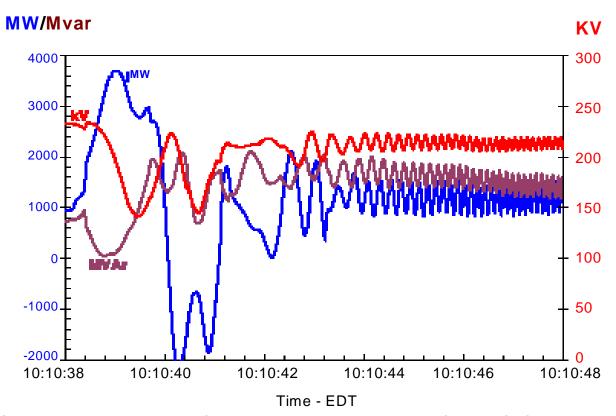
Figure IV.17 — Real and Reactive Power and Voltage From Ontario Into Michigan

At 16:10:38.6, after the 345-kV transmission paths in Michigan and Ohio tripped, the power that had been flowing at modest levels into Michigan from Ontario suddenly jumped in magnitude. While flows from Ontario into Michigan had been in the 250 to 350 MW range since 16:10:09.06, with this new surge the

flows peaked at 3,700 MW at 16:10:39 (Figure IV.17). Electricity moved along a giant loop from the rest of the Eastern Interconnection through Pennsylvania and into New York and Ontario, and then into Michigan via the remaining transmission path to serve the combined loads of Cleveland, Toledo, and Detroit (Figure IV.18). This sudden large change in power flows lowered voltages and increased current levels on the transmission lines along the Pennsylvania-New York transmission interface.

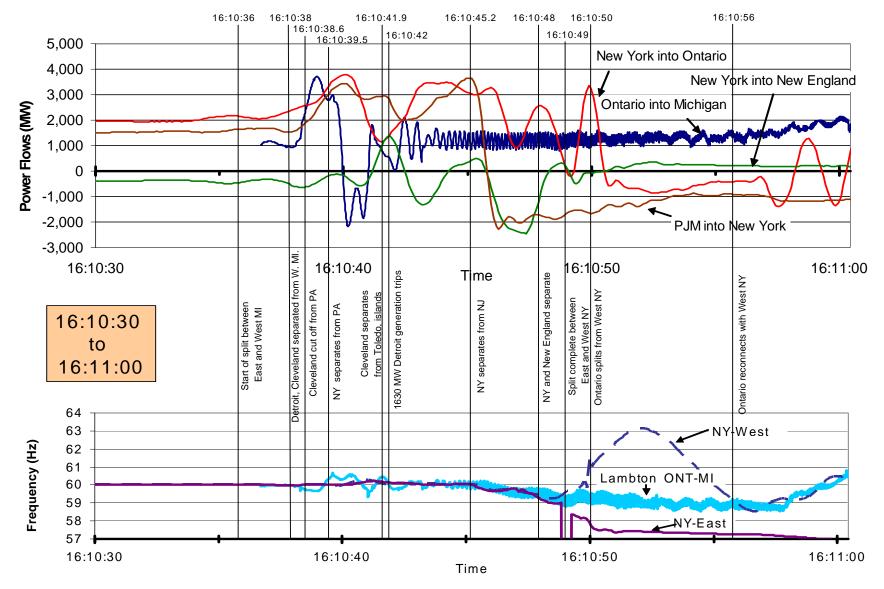
Figure IV.19 — Measured Power Flows and Frequency Across Regional Interfaces, 16:10:30 to 16:11:00, With Key Events in the Cascade

Because the demand for power in Michigan, Ohio, and Ontario was drawing on lines through New York and Pennsylvania, heavy power flows were moving northward from New Jersey over the New York tie lines to meet those power demands, exacerbating the power swing. Figure IV.19 shows actual net line flows summed across the interfaces between the main regions affected by these swings: Ontario into Michigan, New York into Ontario, New York into New England, and PJM into New York. This shows that the power swings did not move in unison across every interface at every moment, but varied in magnitude and direction. This occurred for two reasons. First, the availability of lines across each interface varied over time, as did the amount of load that drew upon each interface, so net flows across each interface were not facing consistent demand with consistent capability as the cascade progressed. Second, the speed and magnitude of the swing was moderated by the inertia, reactive power capabilities, loading conditions, and locations of the generators across the entire region.

After Cleveland was cut off from Pennsylvania and eastern power sources, Figure IV.19 also shows the start of the dynamic power swing at 16:10:38.6. Because the loads of Cleveland, Toledo, and Detroit (less the load already blacked out) were now served through Michigan and Ontario, this forced a large shift in power flows to meet that demand. As noted above, flows from Ontario into Michigan increased from 1,000 MW to a peak of 3,700 MW shortly after the start of the swing, while flows from PJM into New York were close behind (Figure IV.20). But within one second after the peak of the swing, at 16:10:40, flows reversed and flowed back from Michigan into Ontario at the same time that frequency at the interface dropped (Figure IV.21). The large load and imports into northern Ohio were losing synchronism with southeastern Michigan. Flows that had been westbound across the Ontario-Michigan interface by more than 3,700 MW at 16:10:38.8 reversed to 2,100 MW eastbound by 16:10:40, and then returned westbound starting at 16:10:40.5.

Re-examination of Figure IV.19 shows the power swing from the northeast through Ontario into Michigan and northern Ohio that began at 16:10:37, and how it reverses and swings back around Lake Erie at 16:10:39. That return was caused by the combination of natural oscillation accelerated by major load losses, as the northern Ohio system disconnected from Michigan. It caused a power flow change of 5,800 MW, from 3,700 MW westbound to 2,100 eastbound across the Ontario-to-Michigan border between 16:10:39.5 and 16:10:40. Since the system was now fully dynamic, this large oscillation eastbound would lead naturally to a rebound, which began at 16:10:40 with an inflection point reflecting generation shifts between Michigan and Ontario and additional line losses in Michigan.

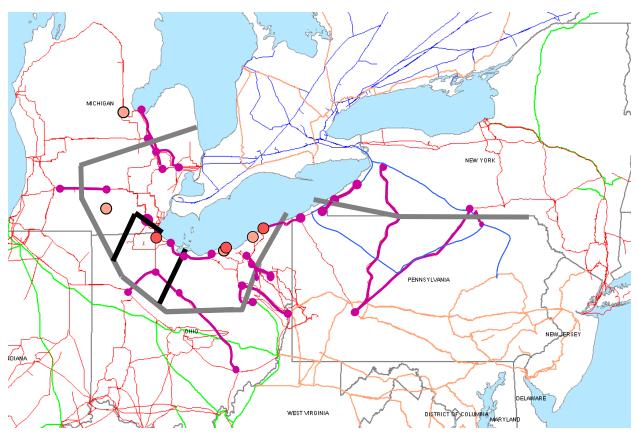
Figure IV.22 — Cleveland and Toledo Islanded, 16:10:39 to 16:10:46

In northern Ohio, the trips of the Bay Shore-Monroe, Majestic-Lemoyne, Allen Junction-Majestic-Monroe 345-kV lines, and the Ashtabula 345/138-kV transformer cut off Toledo and Cleveland from the north, turning that area into an electrical island (Figure IV.22). After these 345-kV line trips, the high power imports from southeastern Michigan into Ohio suddenly stopped at 16:10:40. Frequency in this island began to fall rapidly. This caused a series of power plants in the area to trip off-line due to the operation of underfrequency relays, including the Bay Shore units. Cleveland area load was disconnected by automatic underfrequency load shedding (approximately 1,300 MW), and another 434 MW of load

was interrupted after the generation remaining within this transmission island was tripped by underfrequency relays. This sudden load drop would contribute to the reverse power swing described previously. In its own island, portions of Toledo blacked out from automatic underfrequency load shedding but most of the Toledo load was restored by automatic reclosing of lines such as the East Lima-Fostoria Central 345-kV line and several lines at the Majestic 345-kV substation.

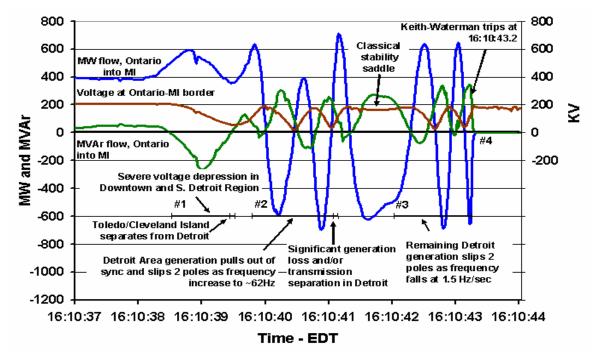
Figure IV.23 — Generators Under Stress in Detroit, as Seen From Keith PSDR

The large power surge into Michigan, beginning at 16:10:38, occurred when Toledo and Cleveland were still connected to the grid through Detroit. After the Bayshore-Monroe line tripped at 16:10:39, Toledo and Cleveland separated into their own island, dropping a large amount of load off of the Detroit system. This suddenly left Detroit with excess generation, much of which greatly accelerated in angle as the depressed voltage in Detroit (caused by the high demand in Cleveland) caused the Detroit units to begin to pull out of step with the rest of the grid. When voltage in Detroit returned to near-normal, the generators could not sufficiently decelerate to remain synchronous. This out-of-step condition is evident in Figure IV.23, which shows at least two sets of generator "pole slips" by plants in the Detroit area

between 16:10:40 and 16:10:42. Several large units around Detroit: Belle River, St. Clair, Greenwood, Monroe, and Fermi Nuclear all tripped in response. After the Cleveland-Toledo island formed at 16:10:40, Detroit frequency spiked to almost 61.7 Hz before dropping, momentarily equalized between the Detroit and Ontario systems. But Detroit frequency then began to decay at 2 Hz/sec and the generators experienced under-speed conditions.

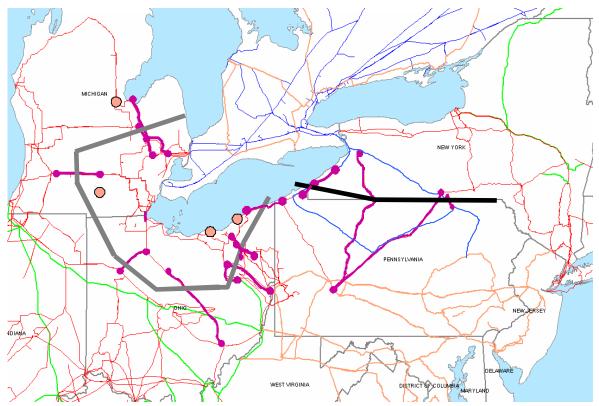
Figure IV.24 — Western Pennsylvania Separates From New York, 16:10:39 to 16:10:44

Watercure (177 miles) and Homer City-Stolle Road (207 miles) are relatively long lines with high impedances. Zone 1 relays do not have timers, and therefore operate nearly instantly when a power swing enters the relay target circle. For normal length lines, zone 1 relays have smaller target circles because the relay is measuring less than the full length of the line, but for a long line the greater impedance enlarges the relay target circle and makes it more likely to be hit by the power swing. The Homer City-Watercure and Homer City-Stolle Road lines do not have zone 3 relays.

Given the length and impedance of these lines, it was highly likely that they would trip and separate in the face of such large power swings. Most of the other interfaces between regions have shorter ties. For instance, the ties between New York and Ontario and Ontario to Michigan are only about two miles long, so they are electrically very short and thus have much lower impedance and trip less easily than these long lines. A zone 1 relay target on a short line covers a small distance so a power swing is less likely to enter the relay target circle at all, averting a zone 1 trip.

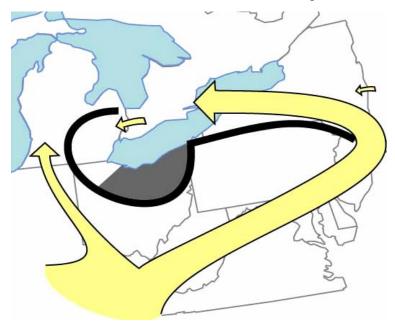
Figure IV.25 — Power Flows at 16:10:44

At 16:10:44, (see Figure IV.25) the northern part of the Eastern Interconnection (including eastern Michigan) was connected to the rest of the Interconnection at only two locations: (1) in the east through the 500-kV and 230-kV ties between New York and northeastern New Jersey, and (2) in the west through the long and electrically fragile 230-kV transmission path connecting Ontario to Manitoba and Minnesota. The separation of New York from Pennsylvania (leaving only the lines from New Jersey into New York connecting PJM to the northeast) helped to buffer PJM in part from these swings. Frequency was high in Ontario at that point, indicating that there was more generation than load, so much of this flow reversal never got past Ontario into New York.

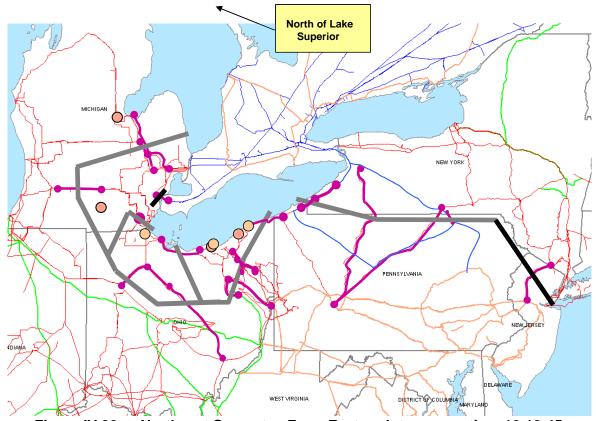
Figure IV.26 — Northeast Separates From Eastern Interconnection, 16:10:45

At 16:10:45, northwest Ontario separated from the rest of Ontario when the Wawa-Marathon 230-kV lines (168 km long) disconnected along the northern shore of Lake Superior, tripped by zone 1 distance relays at both ends. This separation left the loads in the far northwest portion of Ontario connected to the Manitoba and Minnesota systems, and protected them from the blackout (Figure IV.26).

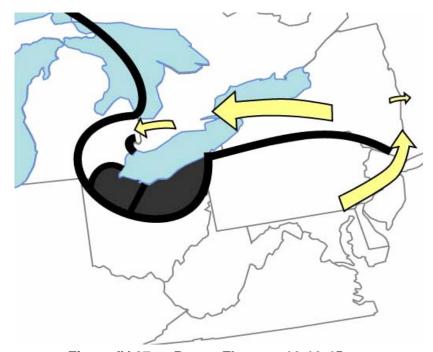
Figure IV.27 — Power Flows at 16:10:45

As shown in Figure IV.27, the 69-mile long Branchburg-Ramapo line and Ramapo transformer between New Jersey and New York was the last major transmission path remaining between the Eastern Interconnection and the area ultimately affected by the blackout. Figure IV.28 shows how that line disconnected at 16:10:45, along with other underlying 230 and 138-kV lines in northeastern New Jersey. Branchburg-Ramapo was carrying over 3,000 MVA and 4,500 amps with voltage at 79 percent before it tripped, either on a high-speed swing into zone 1 or on a direct transfer trip. The investigation team is still examining why the higher impedance 230-kV overhead lines tripped while the underground Hudson-Farragut 230-kV cables did not; the available data suggest that the lower impedance of underground cables made these less vulnerable to the electrical strain placed on the system.

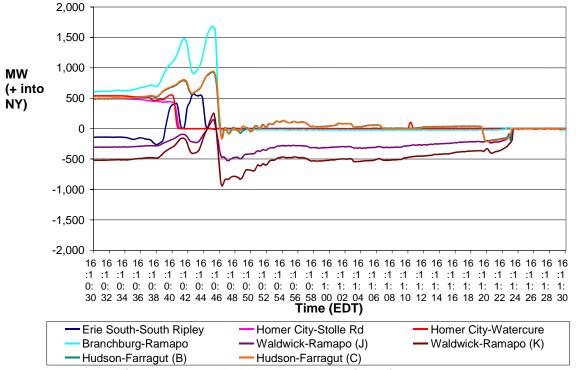
Figure IV.28 — PJM to New York Ties Disconnect

This left the northeast portion of New Jersey connected to New York, while Pennsylvania and the rest of New Jersey remained connected to the rest of the Eastern Interconnection. Within northeastern New Jersey, the separation occurred along the 230-kV corridors, which are the main supply feeds into the northern New Jersey area (the two Roseland-Athenia circuits and the Linden-Bayway circuit). These circuits supply the large customer load in northern New Jersey and are a primary route for power transfers into New York City, so they are usually more highly loaded than other interfaces. These lines tripped west and south of the large customer loads in northeast New Jersey.

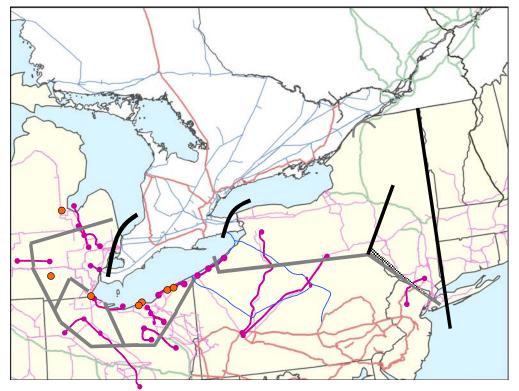
Figure IV.29 — New York and New England Separate, Multiple Islands Form

- New York-New England upstate transmission lines disconnected: 16:10:46 to 16:10:47
- New York transmission system split along Total East interface: 16:10:49
- The Ontario system just west of Niagara Falls and west of St. Lawrence separated from the western New York island: 16:10:50

Figure VI.29 illustrates the events of this phase.

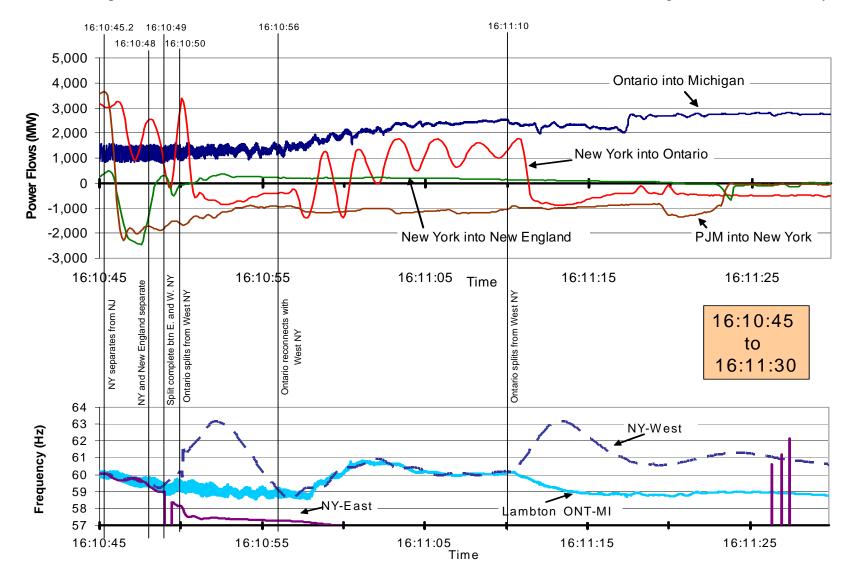
Figure IV.30 — Measured Power Flows and Frequency Across Regional Interfaces, 16:10:45 to 16:11:30, With Key Events in the Cascade

The entire northeastern system was experiencing large scale, dynamic oscillations during this period. Even if the UFLS and generation had been perfectly balanced at any moment in time, these oscillations would have made stabilization difficult and unlikely. Figure IV.30 gives an overview of the power flows and frequencies during the period 16:10:45 through 16:11:00, capturing most of the key events in the final phase of the cascade.

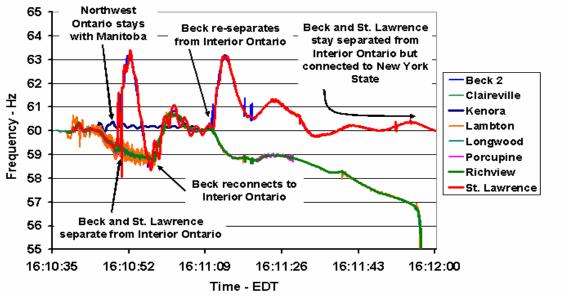
Figure IV.31 — Separation of Ontario and Western New York

The Ontario system separated from the western New York island just west of Niagara Falls and west of St. Lawrence at 16:10:50. This separation was due to relay operations that disconnected nine 230-kV lines within Ontario. These left most of Ontario isolated. Ontario's large Beck and Saunders hydro stations, along with some Ontario load, the NYPA Niagara and St. Lawrence hydro stations, and NYPA's 765-kV AC interconnection to their HVDC tie with Québec, remained connected to the western New York system, supporting the demand in upstate New York. From 16:10:49 to 16:10:50, frequency in Ontario declined below 59.3 Hz, initiating automatic UFLS (3,000 MW). This load shedding dropped about 12 percent of Ontario's remaining load. Between 16:10:50 and 16:10:56, the isolation of Ontario's 2,300 MW Beck and Saunders hydro units onto the western New York island, coupled with UFLS, caused the frequency in this island to rise to 63.4 Hz due to excess generation relative to the load remaining within the island. This is shown in Figure VI.31. The high frequency caused trips of five of the U.S. nuclear units within the island, and the last one tripped on the second frequency rise.

Three of the 230-kV transmission circuits reclosed near Niagara automatically to reconnect Ontario to New York at 16:10:56. Even with these lines reconnected, the main Ontario island (still attached to New York and eastern Michigan) was extremely deficient in generation, so its frequency declined towards 58.8 Hz, the threshold for the second stage of UFLS. Over the next two seconds, another 19 percent of Ontario demand (4,800 MW) automatically disconnected by UFLS. At 16:11:10, these same three lines tripped a second time west of Niagara, and New York and most of Ontario separated for a final time. Following this separation, the frequency in Ontario declined to 56 Hz by 16:11:57. With Ontario still supplying 2,500 MW to the Michigan-Ohio load pocket, the remaining ties with Michigan tripped at 16:11:57. Ontario system frequency declined, leading to a widespread shutdown at 16:11:58 and a loss of 22,500 MW of load in Ontario, including the cities of Toronto, Hamilton, and Ottawa.

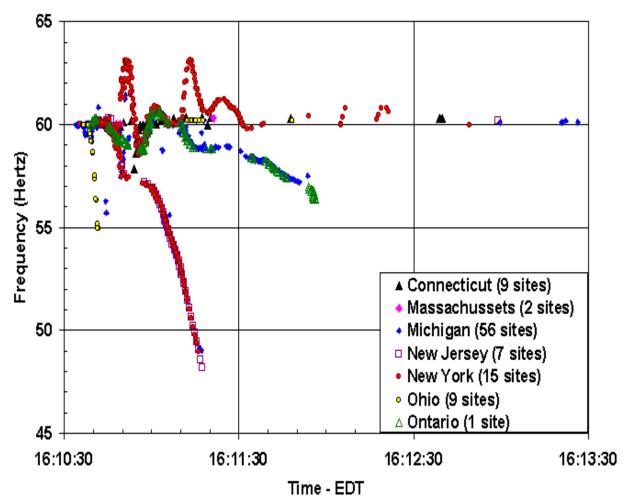
Figure IV.32 — Electric Islands Reflected in Frequency Plot

Figure IV.32 shows frequency data collected by the distribution-level monitors of Softswitching Technologies, Inc. (a commercial power quality company serving industrial customers) for the area affected by the blackout. The data reveal at least five separate electrical islands in the Northeast as the cascade progressed. The two paths of red circles on the frequency scale reflect the Albany area island (upper path) versus the New York City island, which declined and blacked out much earlier.

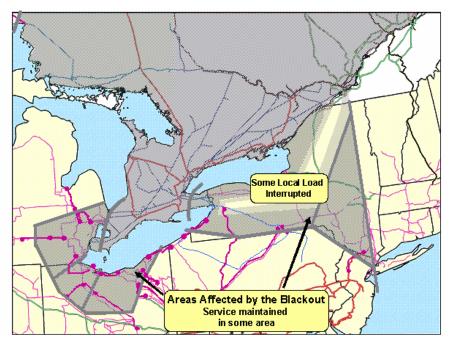
Figure IV.33 — Areas Affected by the Blackout

Most of the Northeast (the area shown in gray in Figure VI.33) had now blacked out. Some isolated areas of generation and load remained on-line for several minutes. Some of those areas in which a close generation-demand balance could be maintained remained operational.

One relatively large island remained in operation, serving about 5,700 MW of demand, mostly in western New York. Ontario's large Beck and Saunders hydro stations, along with some Ontario load, the NYPA Niagara and St. Lawrence hydro stations, and NYPA's 765-kV AC interconnection with Québec, remained connected to the western New York system, supporting demand in upstate New York. This island formed the basis for restoration in both New York and Ontario.

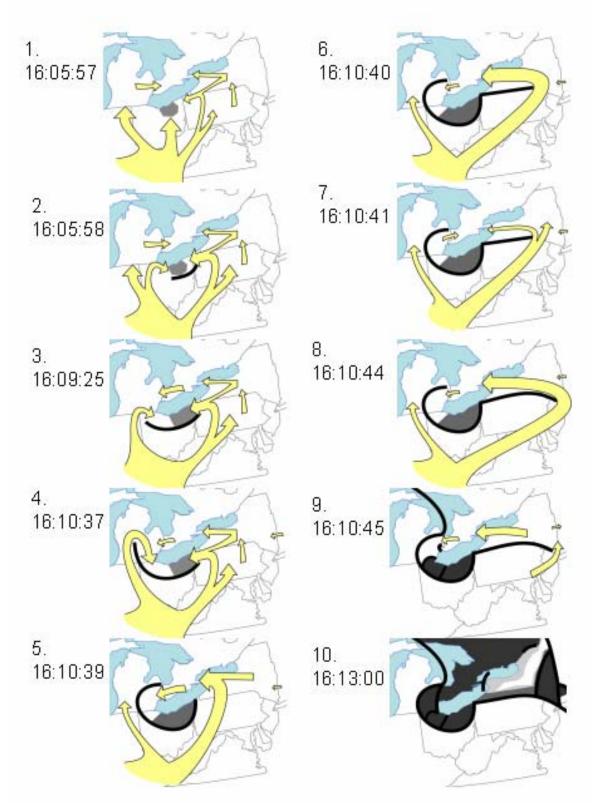
Figure IV.34 — Cascade Sequence Summary

The entire cascade sequence is summarized graphically in figure VI.34.
