RESERVE STUDY - MARCH 9, 2023

Commercial Owners Association (Sample Only)

3525 Main Street  
Los Angeles, California

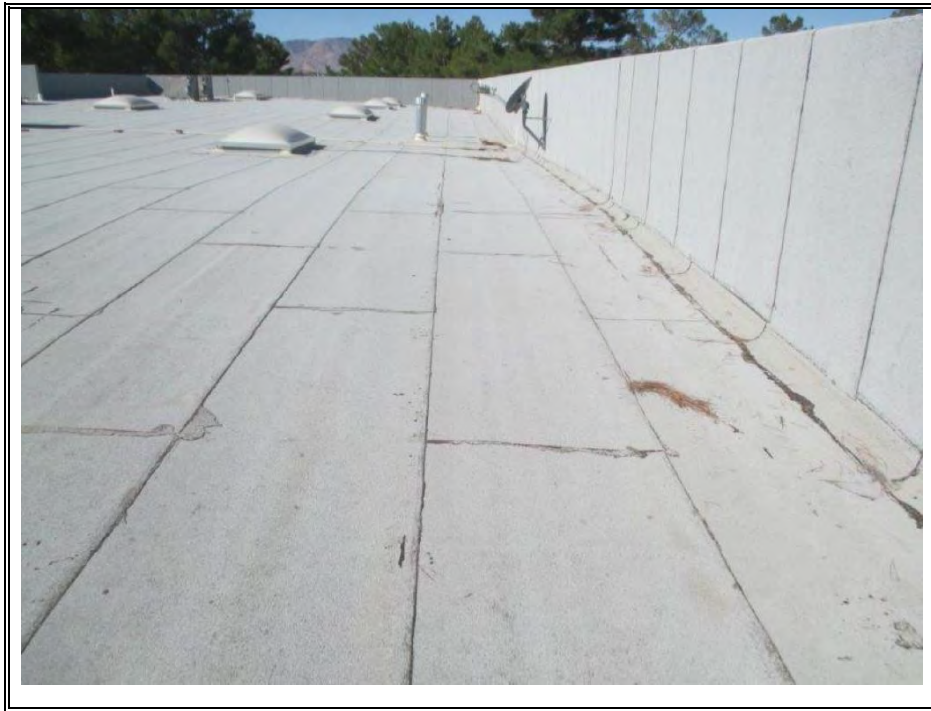
**CAP SHEET ROOF (TYPICAL)**

**OBSERVATIONS:** *This component includes the cap-sheet roofing (flat) on each building. Conditions varied and for reporting purposes the remaining lives have been averaged. On this type of structure, 2 layers are generally permitted. However, if the association should decide to re-roof over the existing roofing, experience dictates that the typical useful life of the new materials would be reduced by approximately one third (33%). The average component cost and typical useful life reflects removal of the existing roofing prior to the installation of the new roofing.*

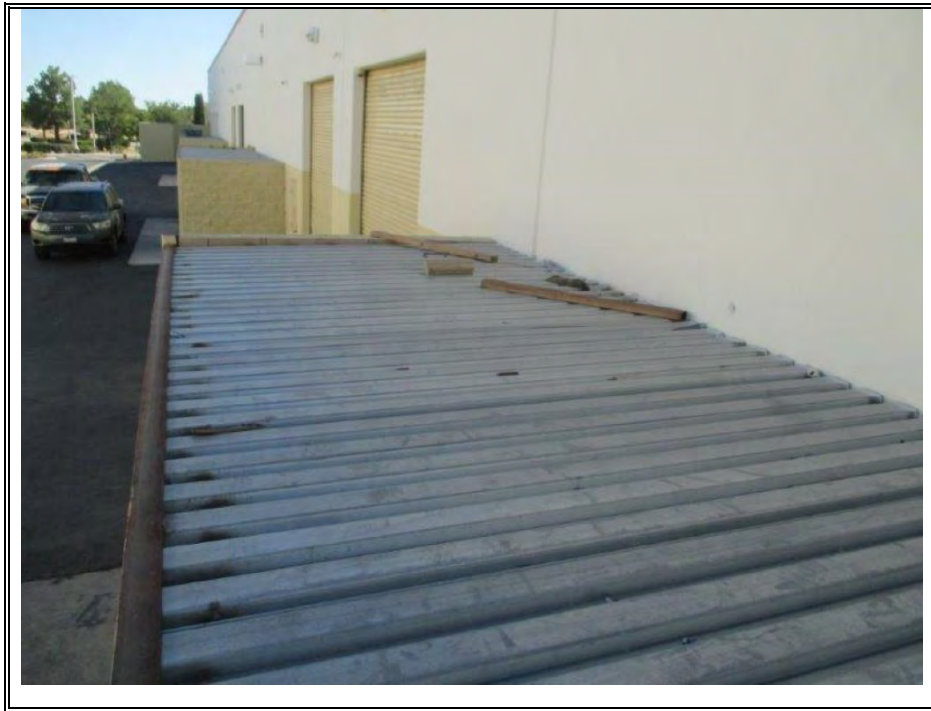
**STANDING SEAM ROOF (TYPICAL)**

**OBSERVATIONS:** *This component includes the standing seam galvanized roofing (sloped/metal) over the trash enclosures. It would typically have a life expectancy in excess of 30 years and therefore no amount has been budgeted for its replacement at this time.*

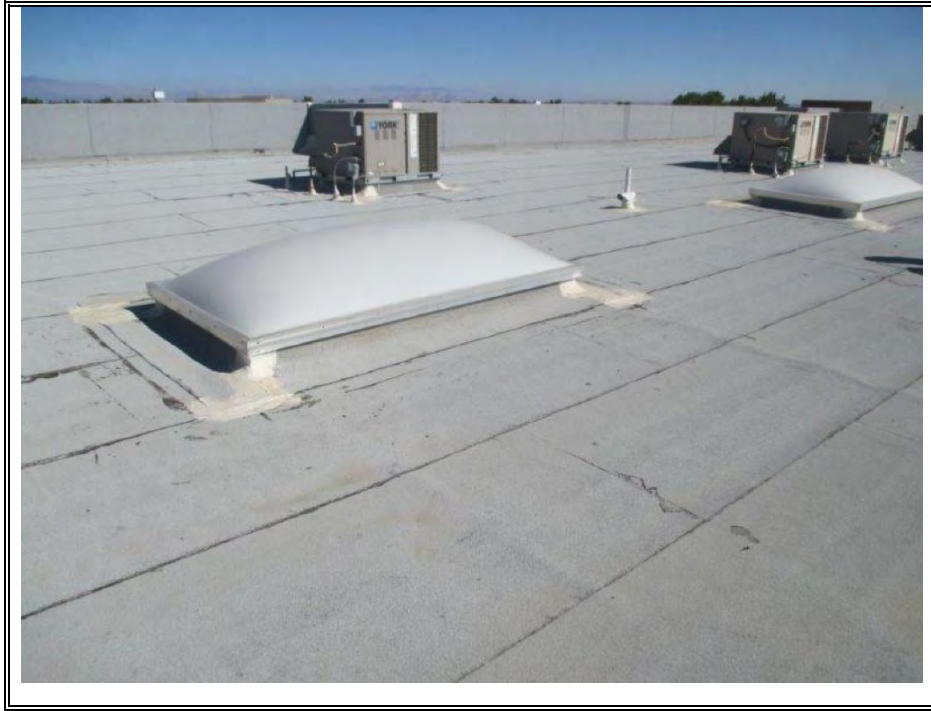
**SKYLIGHTS (TYPICAL)**

**OBSERVATIONS:** *This component includes the Plexiglas skylights. They appeared to be in average condition.*

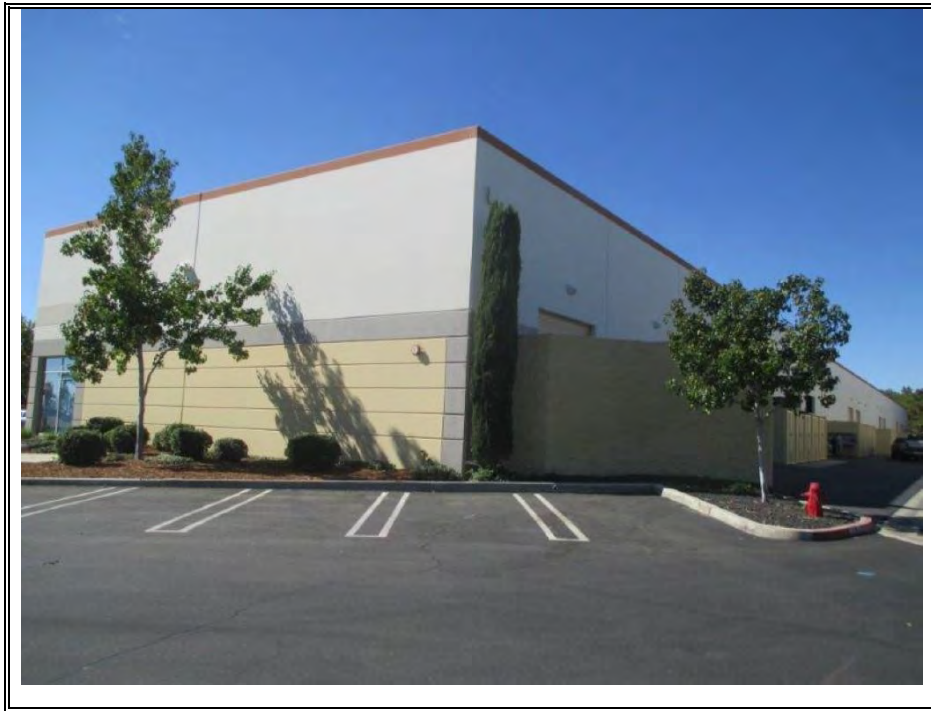
**FOUNDATIONS/STRUCTURAL FRAME (TYPICAL)**

**OBSERVATIONS:** *This component includes the foundations and structural frame, along with the exterior surfaces. We were informed of repairs to wall cracks in 2016. Provided there are no major catastrophes, the proper drainage principles are maintained and that structural pest control procedures are adhered to (see component ID #0202), this would normally be considered to be a lifetime component for which no reserve budget would be called for.*

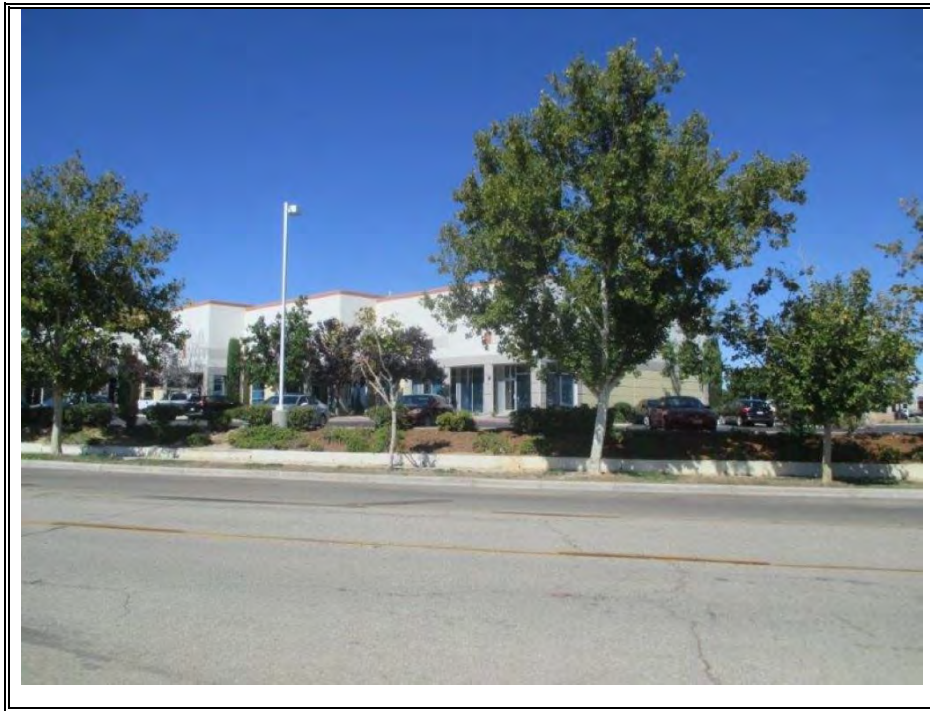
#### STRUCTURAL PEST CONTROL (TYPICAL)

**OBSERVATIONS:** *This component addresses the need for fumigation of each building. When and where an infestation of wood destroying pests or organisms occurs, and how severe the infestation will be, is difficult to predict. The California Department of Real Estate (DRE) suggests that annual inspections be performed to discover any infestation in its early stages before it becomes a serious problem. As these buildings have been primarily constructed of concrete and steel, no funding for complete fumigation has been provided. It is recommended that any necessary treatments be funded on an as-needed basis from the operating account. It is also suggested that the association seek the services of a licensed pest control operator for further evaluation and recommendations.*

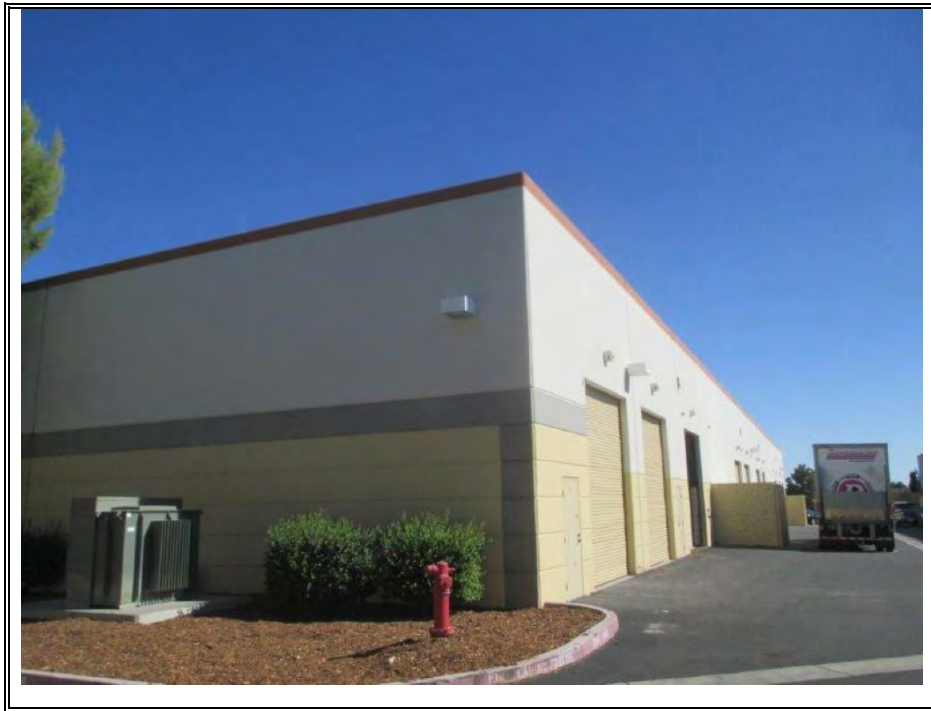
**EXTERIOR FLATWORK (TYPICAL)**

**OBSERVATIONS:** *This component includes the painted concrete surfaces on the buildings and the block walls. We were informed they were painted in 2014 and they appeared to be in average condition.*

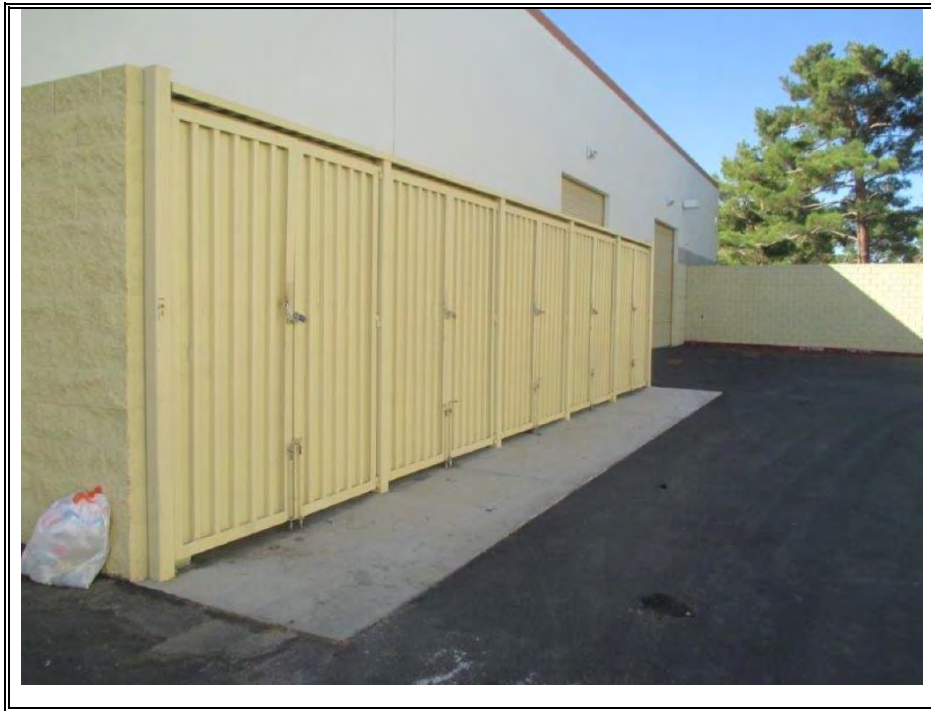
**METAL (TYPICAL)**

**OBSERVATIONS:** *This component includes the painted surfaces of the exterior metal trash bins and roll-up doors. We were informed they were painted in 2014 and they appeared to be in varied conditions. For reporting purposes, the remaining lives have been averaged.*

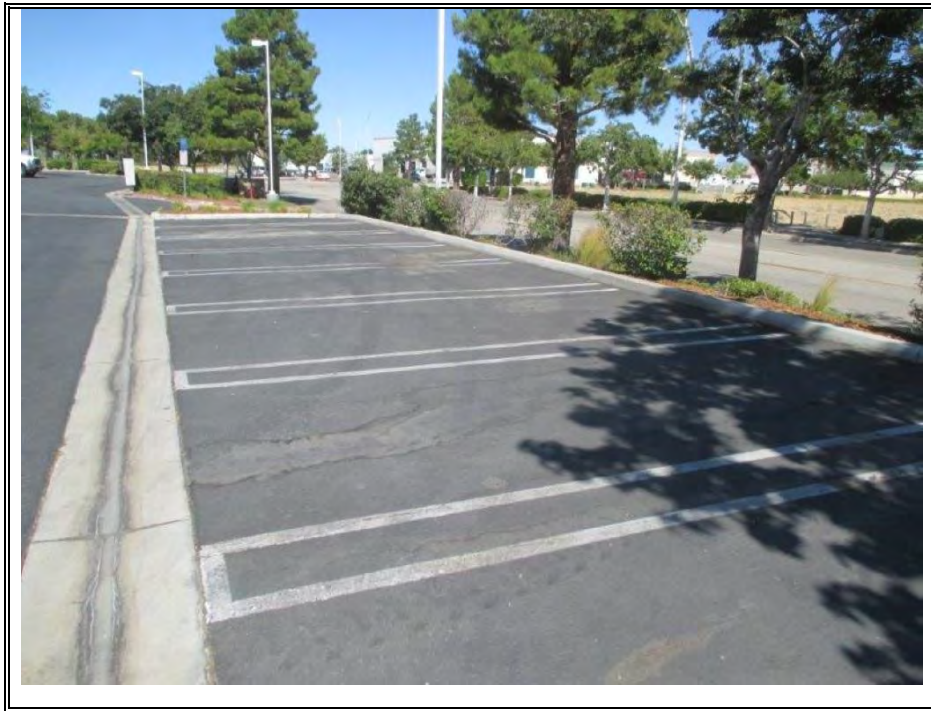
**PARKING STRIPES (TYPICAL)**

**OBSERVATIONS:** *This component includes the painted parking stripes that delineate the individual parking spaces at the parking lot. We were informed they were painted in 2014 and they appeared to be in varied conditions. For reporting purposes, the remaining lives have been averaged.*

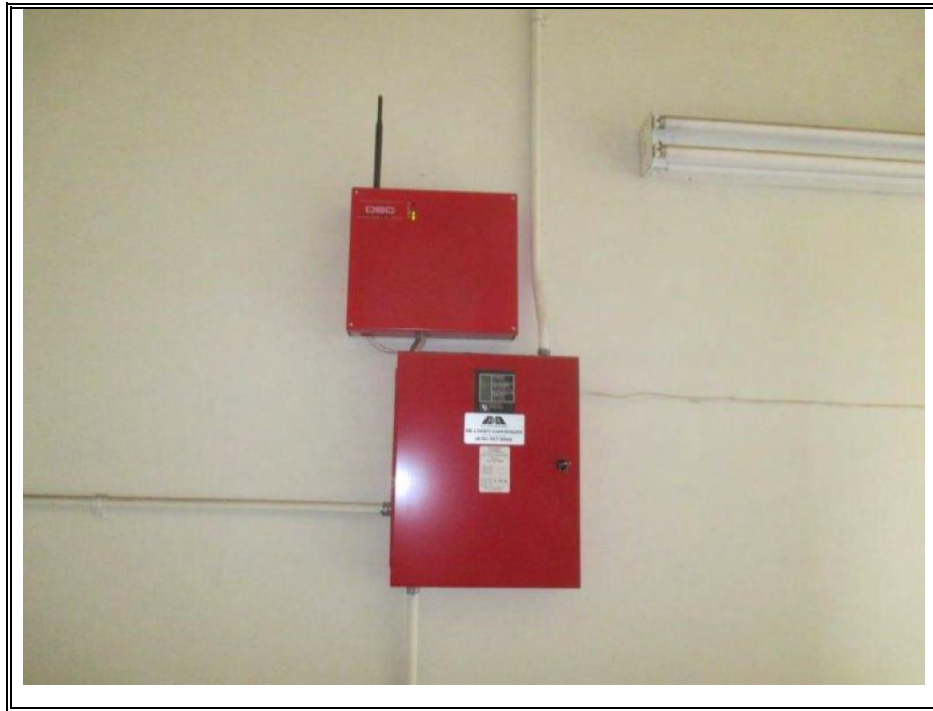
**FIRE ALARM SYSTEM (TYPICAL)**

**OBSERVATIONS:** *This component includes the fire alarm systems in the utility room of each building. We were informed one was replaced in 2018 and, as conditions varied, for reporting purposes their remaining lives have been averaged.*

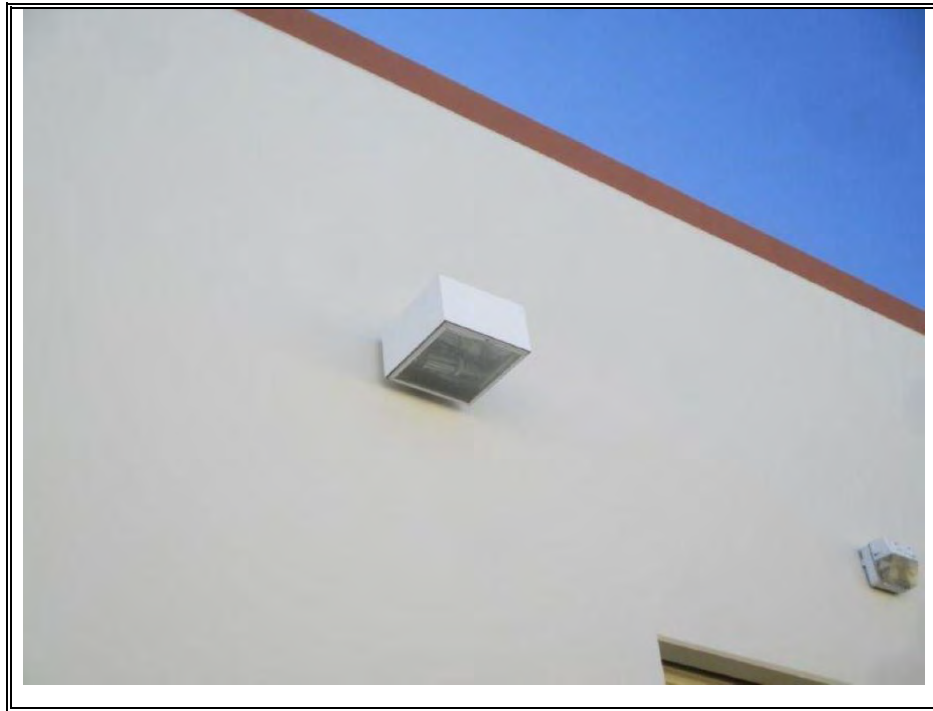
**LIGHTING-EXTERIOR (TYPICAL)**

**OBSERVATIONS:** *This component includes the various sized light fixtures at the exterior of each building. Inspection was limited (viewed from a distance) however, we were informed they were converted to LED in 2018 and they appeared to be in good condition. The external location of these fixtures usually makes them subject to a greater rate of deterioration due to exposure to the elements. Also, it is often desirable to replace these fixtures as they eventually become dated and/or more energy efficient options become available.*

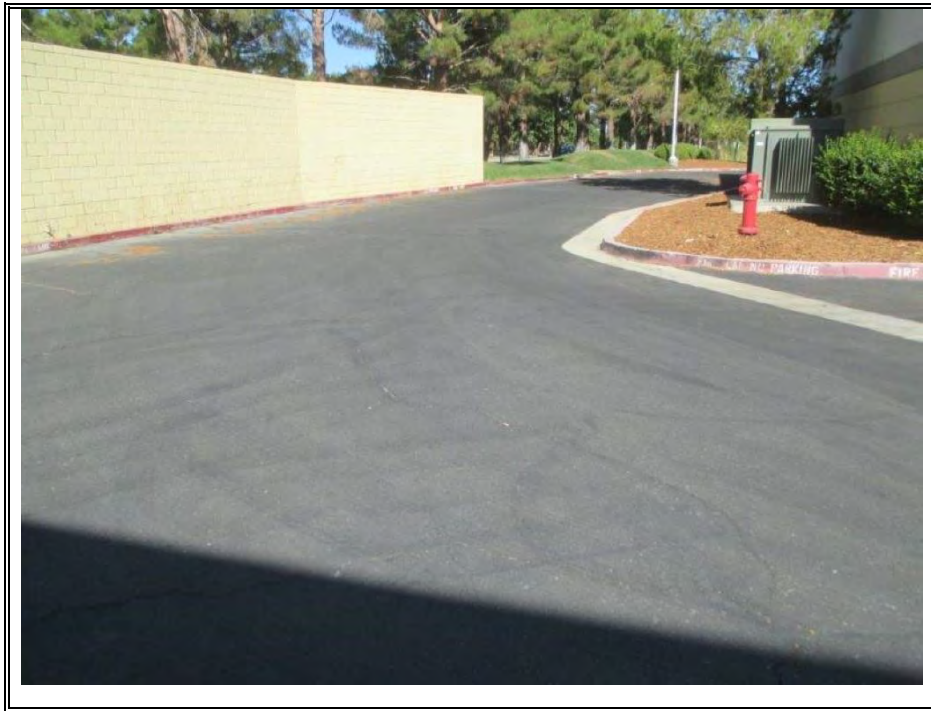
**ASPHALT SEAL COAT (TYPICAL)**

**OBSERVATIONS:** *This component includes the seal coat for the parking lot. We were informed it was applied in 2014 and it appeared to be in an average condition for its age. While a relatively inexpensive procedure, the seal coat serves to enhance the longevity of the underlying asphalt as well as its appearance by replenishing the oil and fine aggregates of the underlying asphalt. It is important that this procedure always be undertaken within 6 months of any overlay or resurfacing and performed thereafter on a 3 – 5 year cycle (typically a warranty requirement). See component ID #0502 for further comments.*

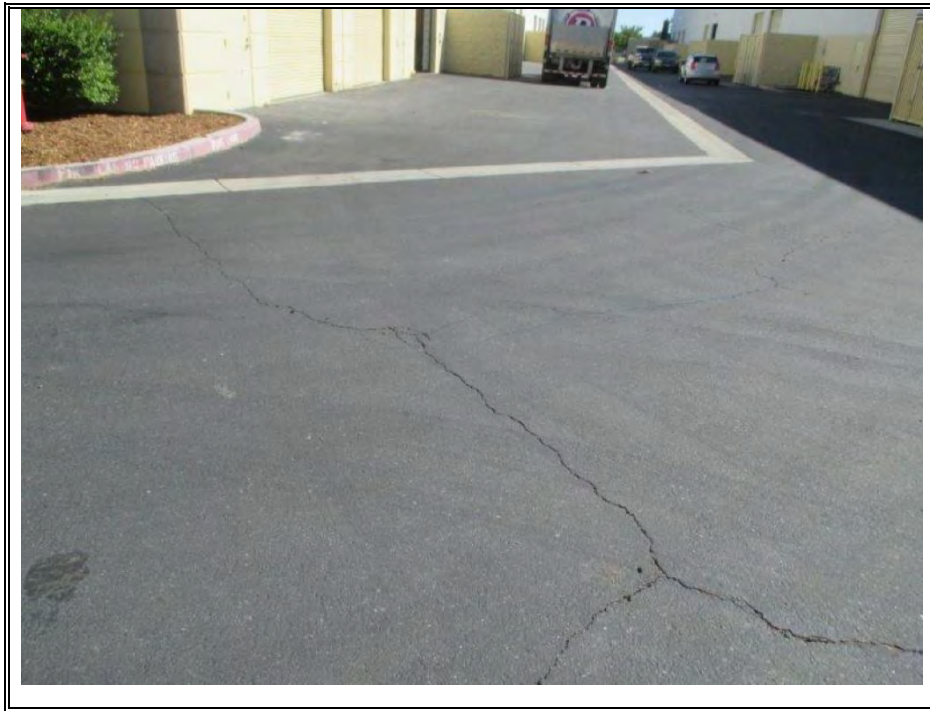
**ASPHALT REPLACEMENT (TYPICAL)**

**OBSERVATIONS:** *This component provides for replacement of the asphalt surfaces described in component ID #0501. The surfaces appeared to be in an aging condition. Aging, oxidation, and vehicle traffic eventually cause cracking, ponding and uneven pavement. Such surface irregularities may result in improper drainage and compromised driving surfaces. Asphalt replacement entails removal of the existing pavement, grading and compaction of the existing aggregate base material, and the installation of hot asphalt pavement. It is recommended that pavement engineering be obtained prior to replacement in order to guarantee that new pavement specifications will meet or exceed the needs of the common area pavement. In conjunction with replacement, seal coat should be performed within 6 months and then at 3 – 5 year intervals thereafter (see component ID #0501). It is recommended that prior to replacement, further evaluation be obtained from a soils/geotechnical engineer.*

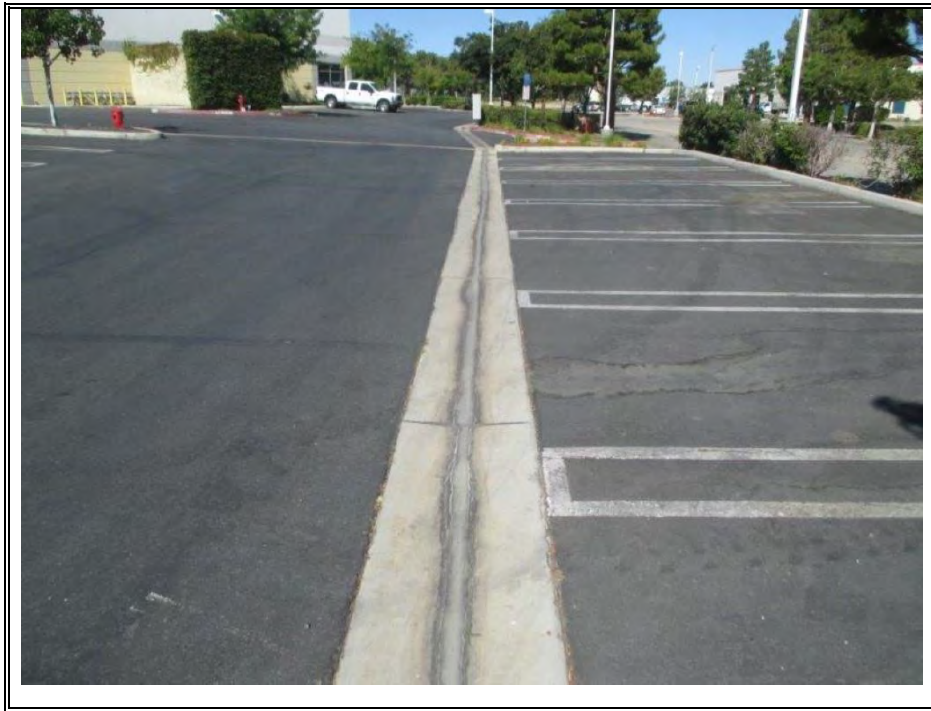
**SWALES (TYPICAL)**

**OBSERVATIONS:** *This component includes the concrete "V" drains (swales) in the asphalt parking area. They appeared to be in average condition. However, cracks and poor drainage can result in water undermining both the swales and asphalt with associated failures. It is recommended that replacement be coordinated with replacement of the asphalt.*

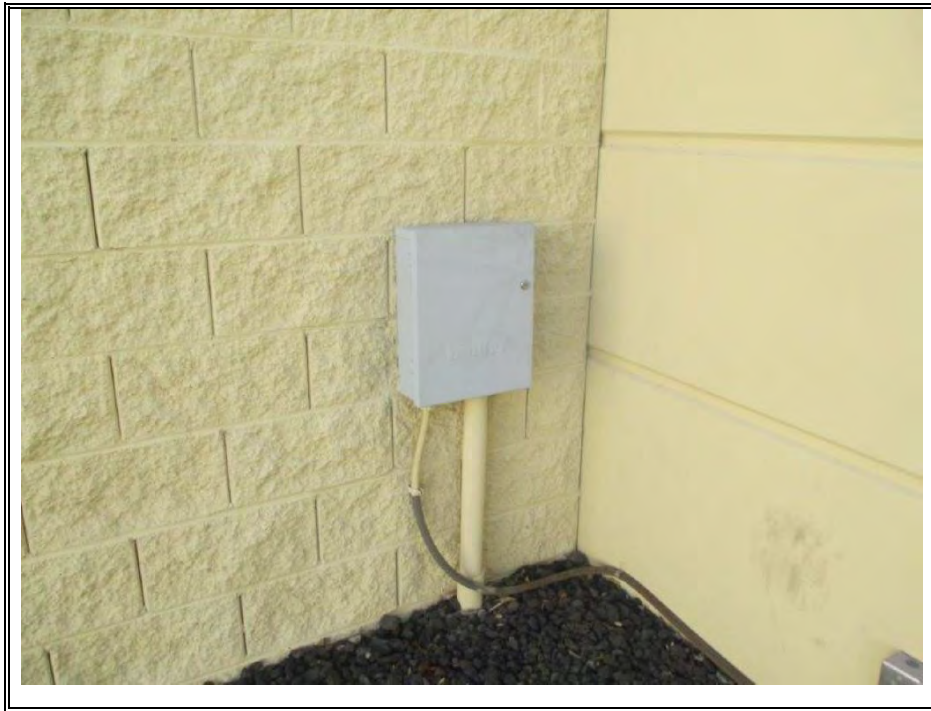
**IRRIGATION CONTROLLER (TYPICAL)**

**OBSERVATIONS:** *This component includes an irrigation controller. It was inaccessible for inspection (locked), and for purposes of reporting the condition, number of stations and remaining life has been estimated. It tends to have a more predictable life expectancy, and the average component cost provides for its replacement. However, average life expectancies cannot be predicted for the other sprinkler components or automatic valve actuation systems. Repairs/replacements of such systems usually occur on an ongoing basis and should be covered under the operating account.*

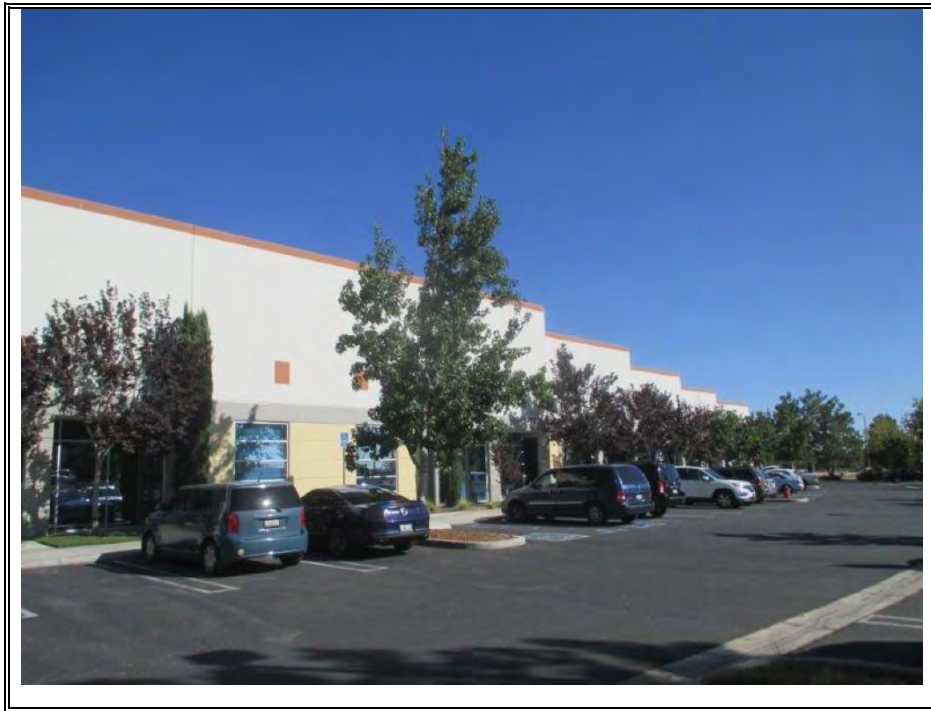
**MAJOR TREE TRIMMING/REMOVAL (TYPICAL)**

**OBSERVATIONS:** *This component addresses major tree trimming / removal. We were informed of trimming being done in 2017. There were no major problems observed (or reported to us) with respect to structural damage from any trees. However, we recommend that the situation be monitored, and removal of trees should be anticipated in the future if necessary. Close proximity of trees to the structures can become destructive to foundations and walkways. It is recommended that trimming / removal be performed on an as-needed basis and funded from the operating account. Any necessary adjustments can be included in future Reserve Study Updates. Study Updates.*

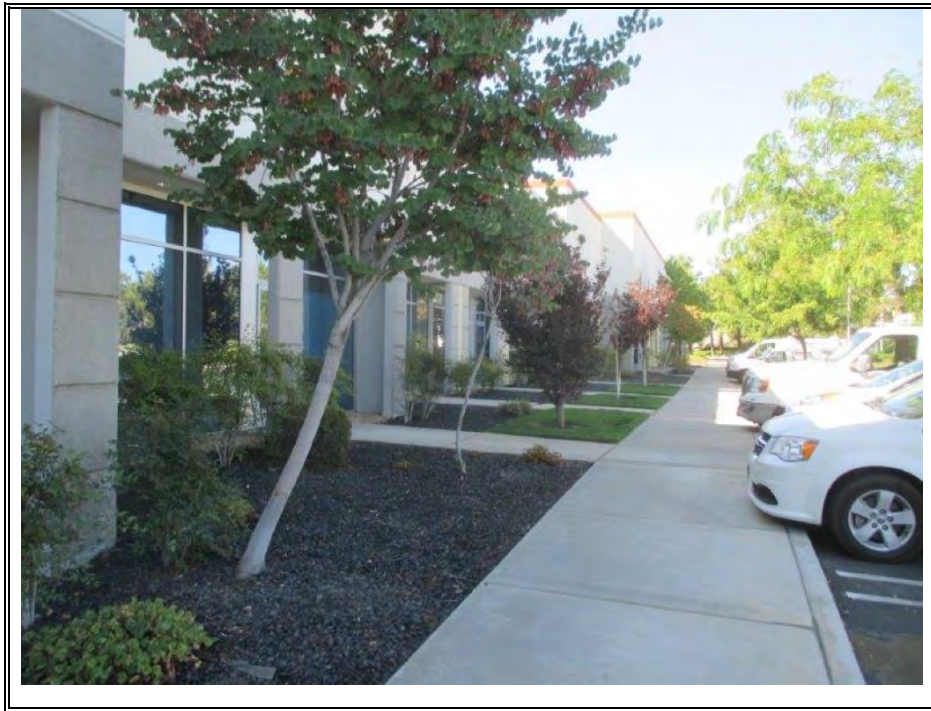
**LANDSCAPE REMODEL (TYPICAL)**

**OBSERVATIONS:** *This component addresses the landscaping throughout the development. We were informed of landscape / irrigation modifications being done in 2017/2018. It is recommended that landscape modifications be performed on an as-needed basis and funded from the operating account.*

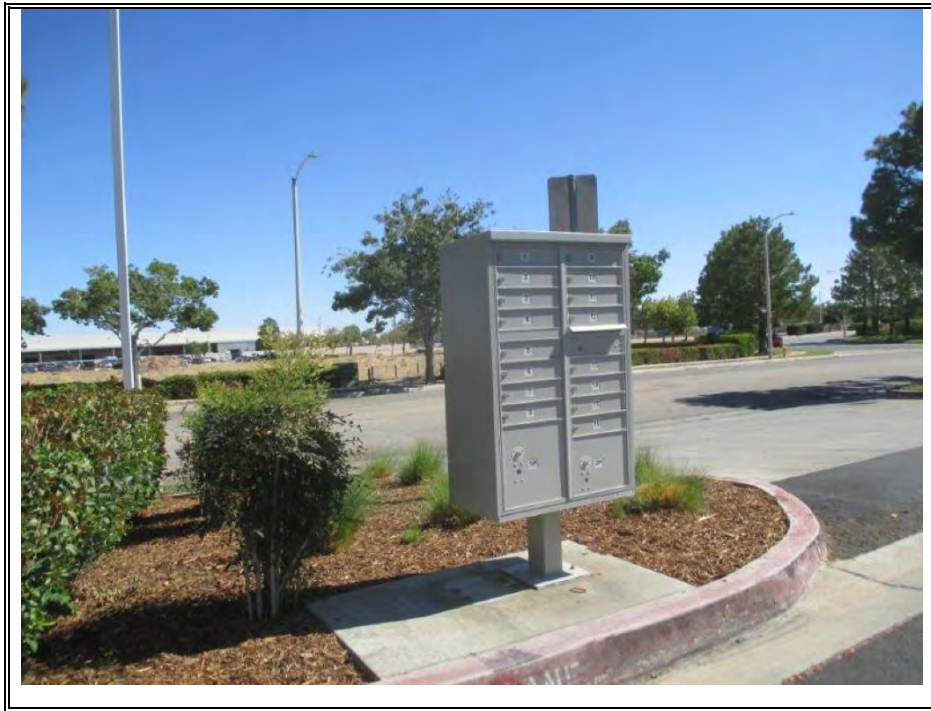
**MAILBOXES (TYPICAL)**

**OBSERVATIONS:** *This component addresses the pedestals of aluminum mailboxes. We were informed they are the responsibility of the U.S.P.S.*

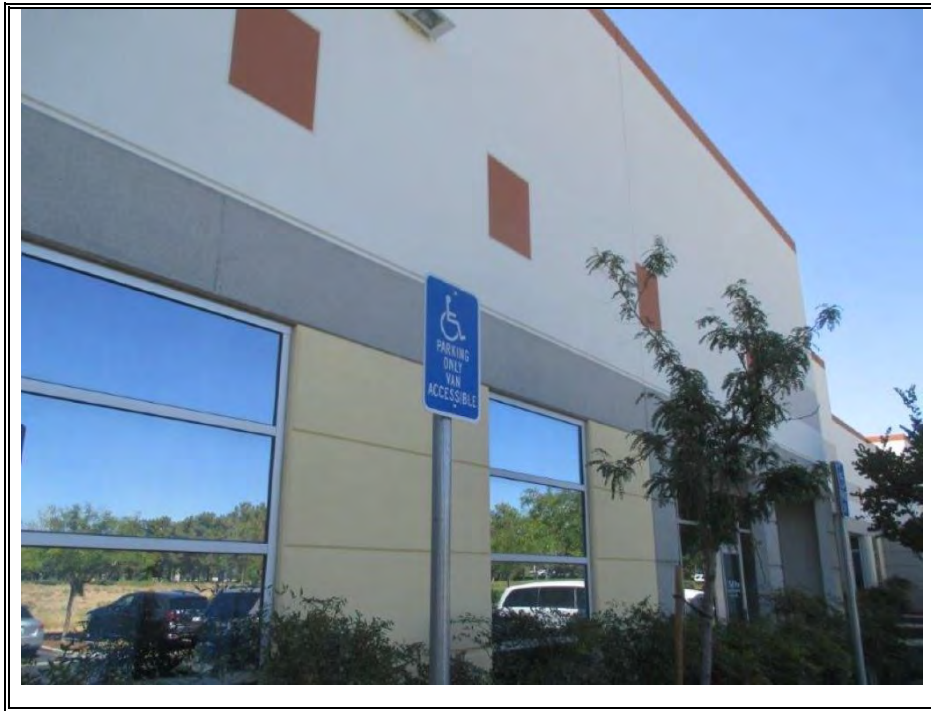
**SIGNS (TYPICAL)**

**OBSERVATIONS:** *This component includes the metal handicap signs at the common parking areas. They appeared to be in good condition for their age.*
