Subject: <u>Corrologic[™] Vapor Corrosion Inhibitor System</u>

Technical Proposal

With reference to the above subject, we are pleased to hereby submit our proposal for the supply and installation supervision of the Corrologic System for Tank No. F50-T35 as follows:

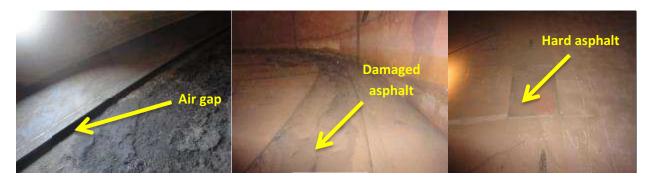
After our site inspection we found out

that asphalt layer is extremely hard and in some areas eroded and damaged, we also found out that air gaps exist between the bottom plates and the asphalt layer, mainly at the center and periphery that will facilitate the injection of the VpCI powder.
