# FIELD SUPERVISION REPORT

#### **GENERAL INFORMATION ENGINEER:** CONTRACT NUMBER: F01-113-01-09 Jessica McNeil DATE: 2022-10-12 **ENGLOBE TECHNICIAN:** Ghosn, Jean-Paul ENGLOBE SUPERVISOR: WEATHER: Arsenault, Charline Sunny TIME ARRIVED: 08:30 AM (-3 GMT) SUPPLIER: OSCO TIME DEPARTED: 10:00 AM (-3 GMT) PLANT LOCATION: Bedford

Light post base section A of new EHS Driveway. This pour consist of 35MPa concrete adhering to the NSPW's division 5 section 7 of the standard specifications. The concrete was supplied by Osco concrete and the contractor was Black and McDonald.

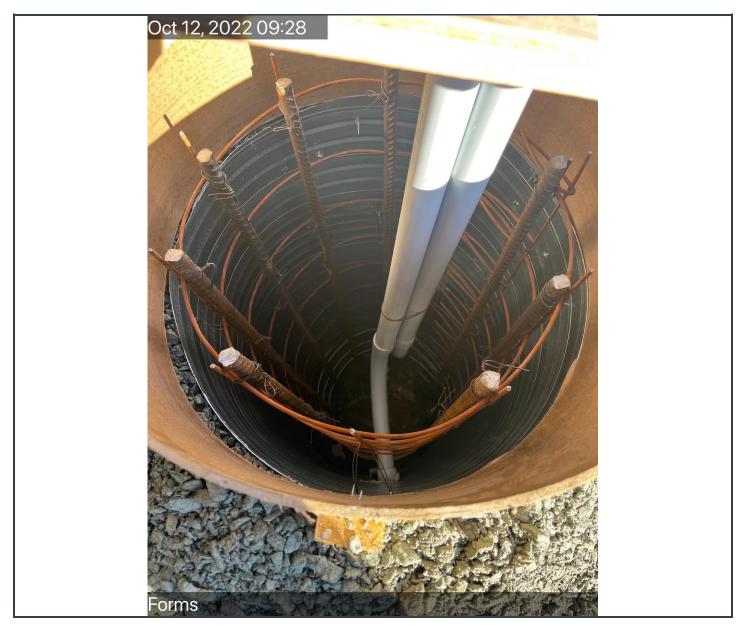
RECOMMENDATIONS
No recommendations at this time.
COMMUNICATIONS
PHOTO LOG
Photo 1 - Light post base

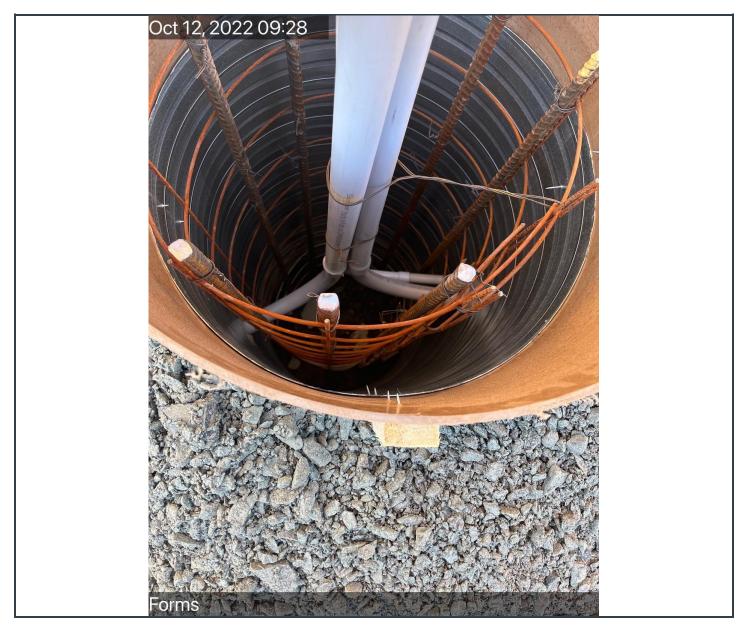
The concrete was poured from the chute into the forms. The forms consist of sonotubes. The sonotubes were backfilled with gravel prior to pouring the concrete. Black rebars were tied with black ties. Rebars and sonotubes appeared to be clean and properly secured. Vibratory whip used to consolidate concrete. The vibratory was inserted in a vertical motion at approximately every foot to allow for proper consolidation. The concrete was vibrated from the bottom to top as the sonotubes was being filled with concrete. Concrete was open aired cured after anchor bolts were installed.
