John Doe Site Report Pro 24 Jul 2020

3 Main Street Name: Client Company:

Extend and renovate internally and externally Mr A Smith Summary: Client Name:

Reference: 2017/04/0001S Client Telephone: 07700900000

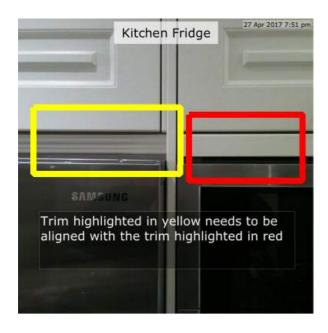
## Kitchen Trim

Description: Trim needs adjusting
