# Geometric DFM — review pack

12 findings across 6 real parts, for T / F / N marking — generated 2026-08-07

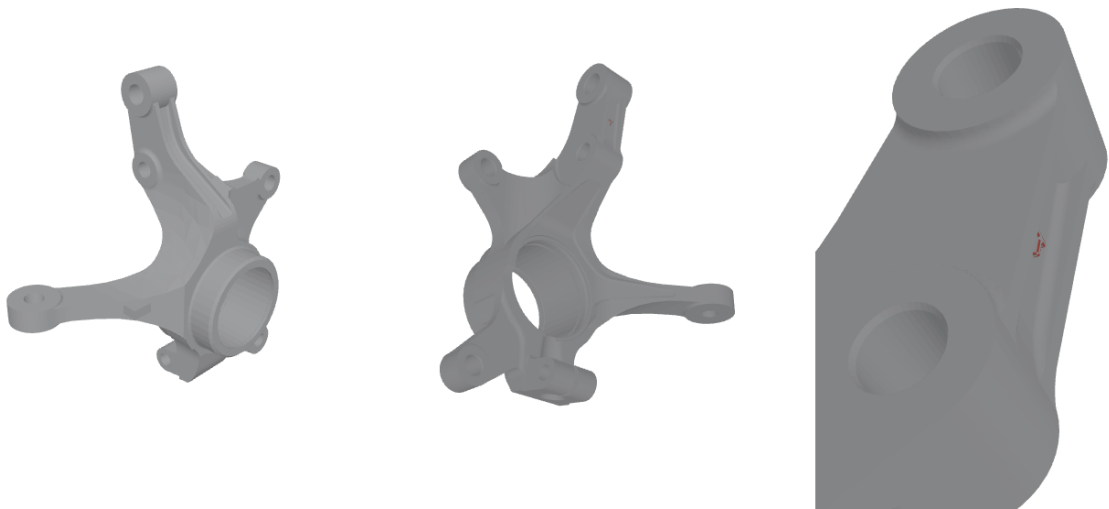
4. Sharp internal corner MINOR

| Instances | Measured | Threshold | £/part |
|---|---|---|---|
| 14 | radiusMm 0.25–0.25mm | < 1mm | — |

Offending faces in red. Left: front isometric. Middle: rear isometric (the opposite side — half the findings on a real part sit where one view cannot see them). Right: close-up on the worst instance, aimed down the feature's own axis. 14 face(s): 89, 94, 96, 98, 100, 102, 106, 108, 110, 112, 114, 116, 118, 120

**Note:** The feature is very small at part scale — 168 of the mesh's 18,448 triangles carry it, so it reads as a few red pixels even zoomed in.

**Not priced:** A sharp corner is a stress raiser and a hot spot — a fatigue and yield risk, not a cost line.

**Suggested fix:** Increase the fillet toward half the adjoining wall thickness to relieve the stress concentration and the local hot spot.

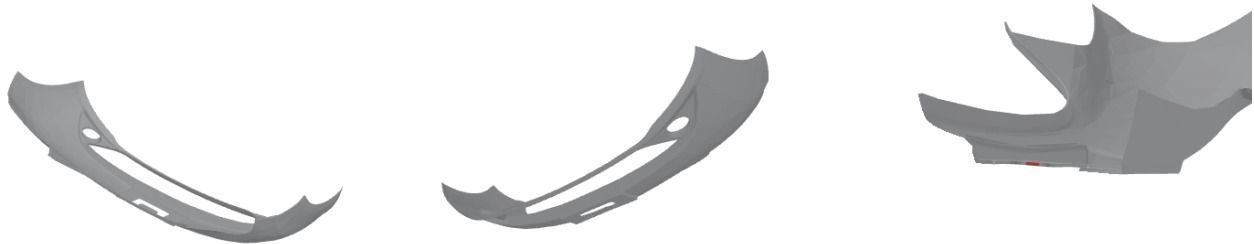
## 1. Moulded wall below minimum draft MINOR

| Instances | Measured | Threshold | £/part |
|---|---|---|---|
| 2 | draftDeg 0.04–0.04° | < 0.5° | — |

Offending faces in red. Left: front isometric. Middle: rear isometric (the opposite side — half the findings on a real part sit where one view cannot see them). Right: close-up on the worst instance, aimed down the feature's own axis. 2 face(s): 218, 284

**Note:** Right-hand view is a CUT-AWAY: the material between the camera and the feature is removed, because the feature is on an internal surface. The feature is very small at part scale — 4 of the mesh's 24,427 triangles carry it, so it reads as a few red pixels even zoomed in.

**Not priced:** Ejector drag marks are a cosmetic reject risk, not a modelled cost.

**Suggested fix:** Add draft to at least 0.5° per side — more if the face is textured, roughly 1° per 0.025 mm of texture depth. Otherwise expect ejector drag marks.
