# Visual Inspection Report - Sample Site

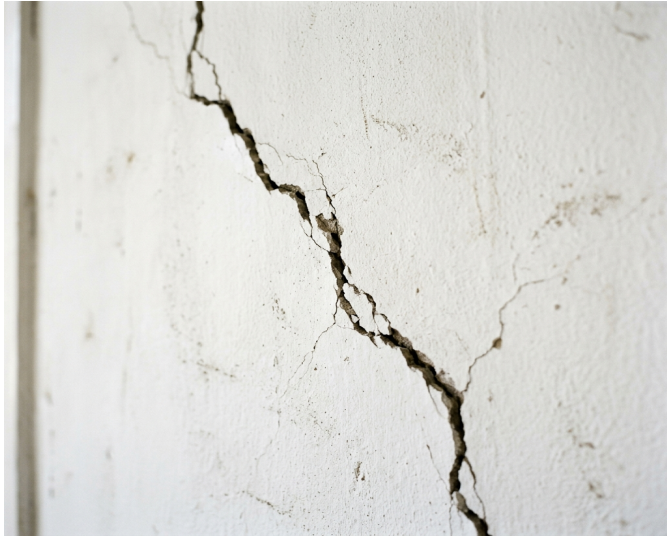
Observation 1: The Master Bedroom shows significant cracking on the east wall. This appears to be structural settling.
