| | <b>MPS Engineering Work Order for In-kind Replacement (Non MOC)</b><br><b>Инженерная Инструкция для Работ MPS по Аналогичной Замене (Без КЗИ)</b> | | | | | | | | |
| <b>Area:</b><br><b>Участок:</b> | Export | <b>WO:</b><br><b>РЗ:</b> | 2180860 | <b>P&amp;ID #:</b><br><b>СТИКИП</b> | 0-3200-B-1077 | <b>Title:</b><br><b>Название:</b> | Tee branch replacement / Замена тройникового ответвления | | |

| <p>It is necessary to eliminate the leak detected in the above-ground line of the fuel gas purge valve.</p> <p>Необходимо устранить утечку, обнаруженную в надземной линии продувочной свечи топливного газа.</p> <p>Solution / Решение:<br/>Follow the steps below / Следовать шагам ниже:</p> |

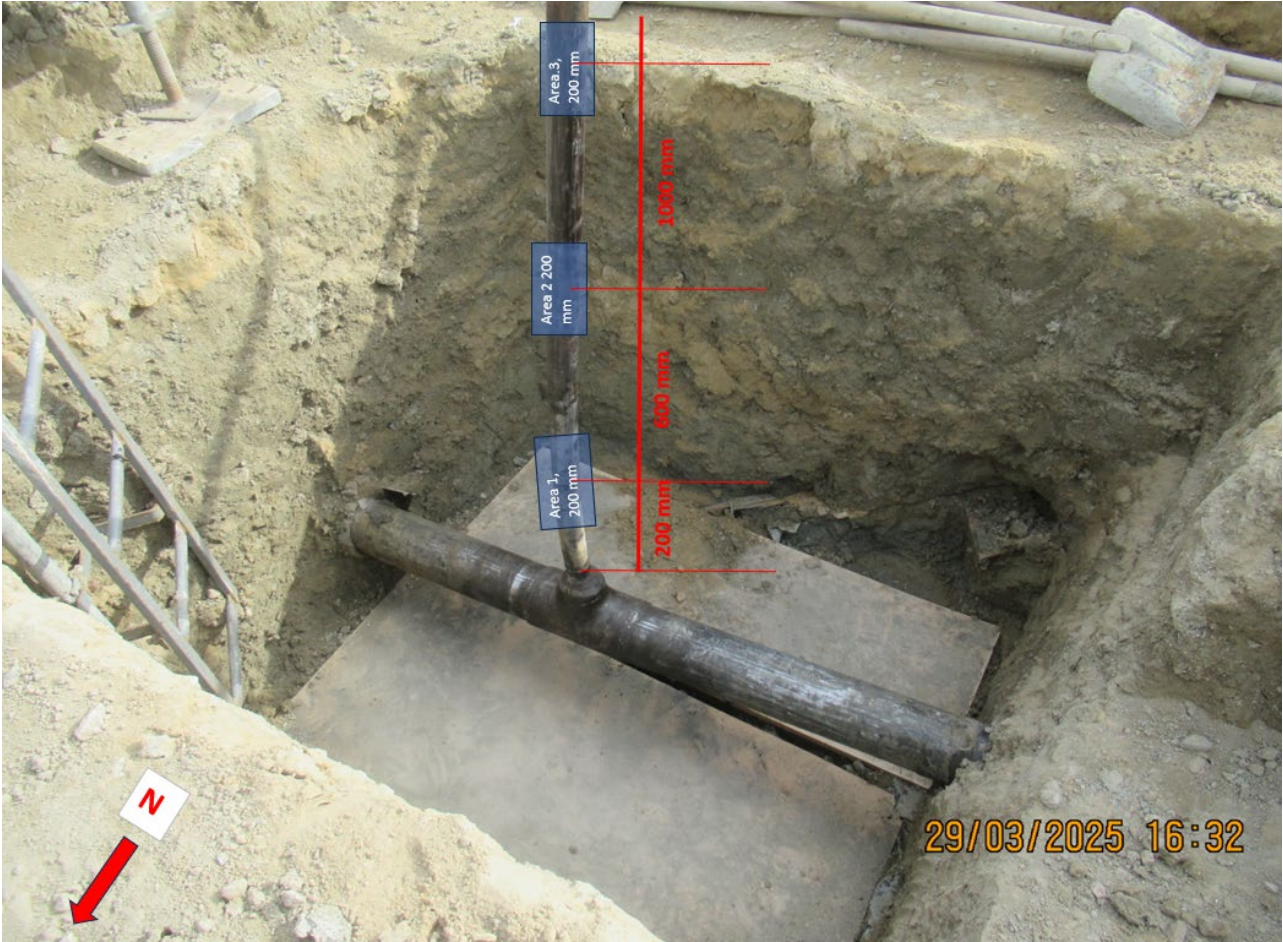
DRAWING Area 1, 2, 3

| <p>Phased Array Corrosion Mapping inspection was carried out on the locations according to request AIS-25-003317. All areas were scanned in increments of 25 mm giving an overlap of approx. 7 mm to ensure full coverage of area of interest. The locations are shown in the drawing below for clarity.</p> <p>Zero point of the start of the scan for the vertical locations of the pipe is at North side. Scans were done in the flow direction in a clockwise all around the length of the circumference. For pipe to fitting welds scans were done in clockwise when looking at the fitting from pipe side.</p> | | | | | | | | | | | |

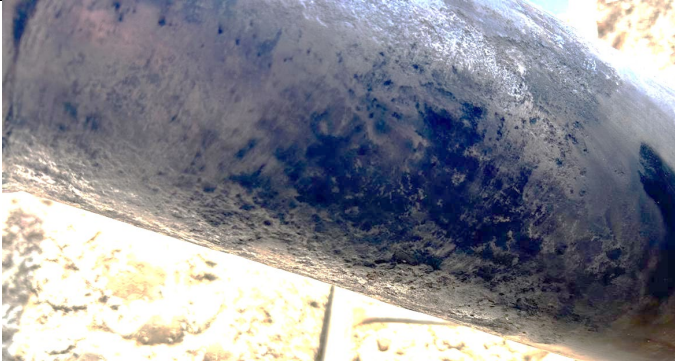
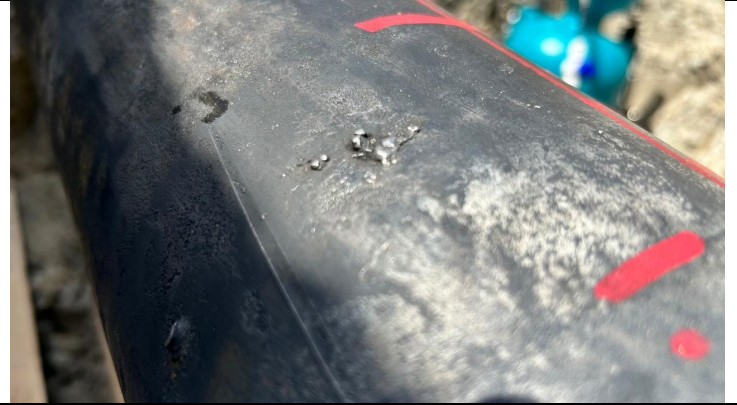
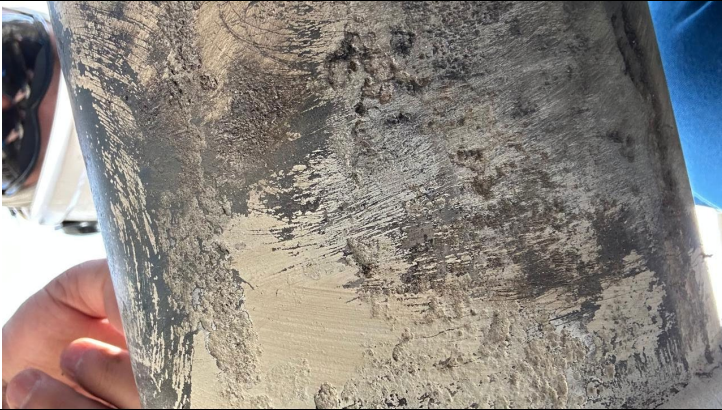
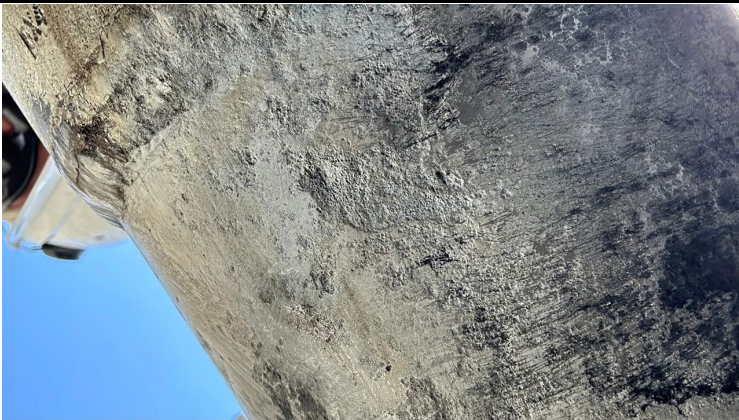
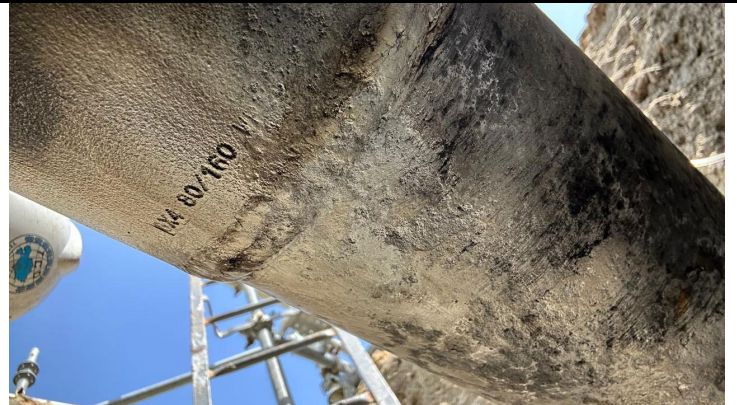
### PHOTO Surface condition

Surface condition was unsatisfactory in some places, there are areas with data loss due to surface condition (surface corrosion, deposits, roughness).
