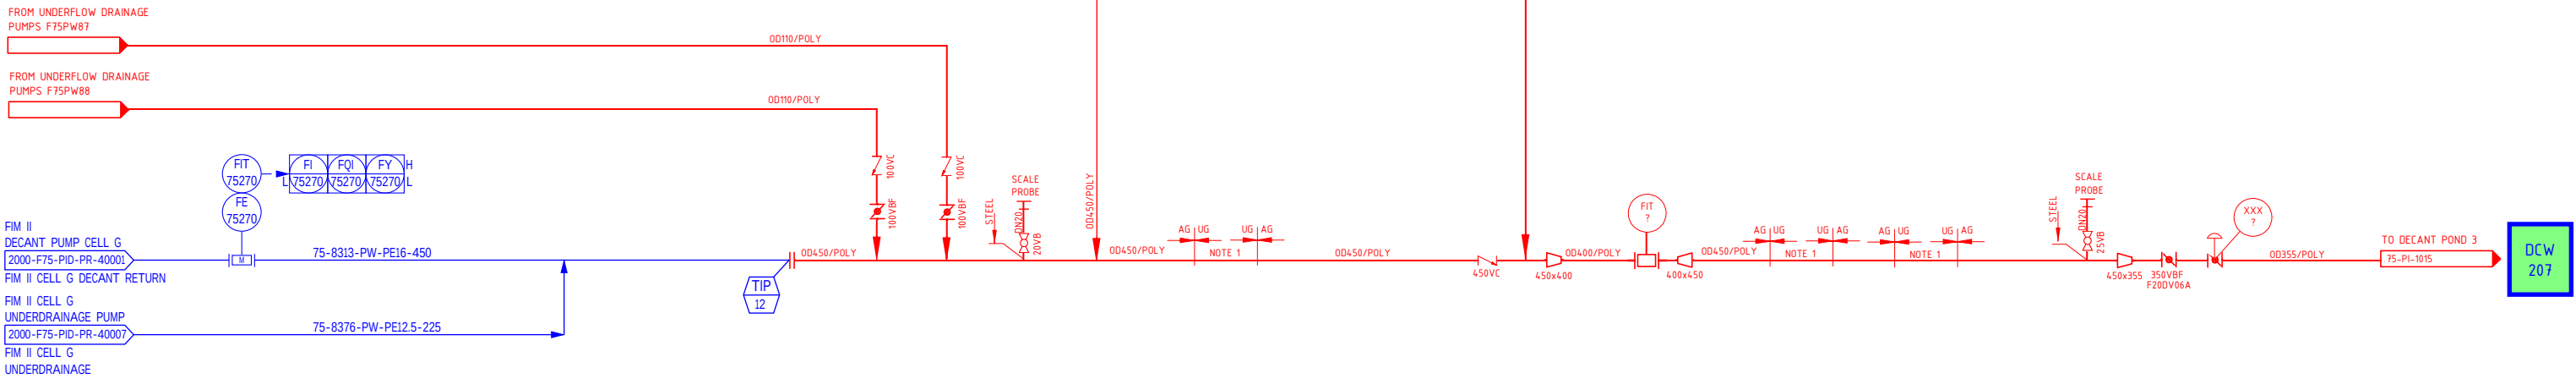
- NOTES:
1. FOR DETAILS OF VENDOR SKID, REFER TO SUPPLIER DOCUMENTATION.
  2. UNDERGROUND PIPING CANNOT BE VERIFIED VISUALLY AND SO CANNOT BE CONFIRMED. TBC - BY CLIENT.
  3. NO LEVEL INSTRUMENT SEEN IN FIELD.
  4. NO ANTISCALANT DOSING SYSTEM SEEN IN FIELD.
  5. NO POTABLE WASH UNIT SEEN IN FIELD.
  6. PUMP NUMBER, INSTRUMENT DESCRIPTION/TAG NUMBERS NOT FOUND IN FIELD.
  7. UNIDENTIFIED FITTING
