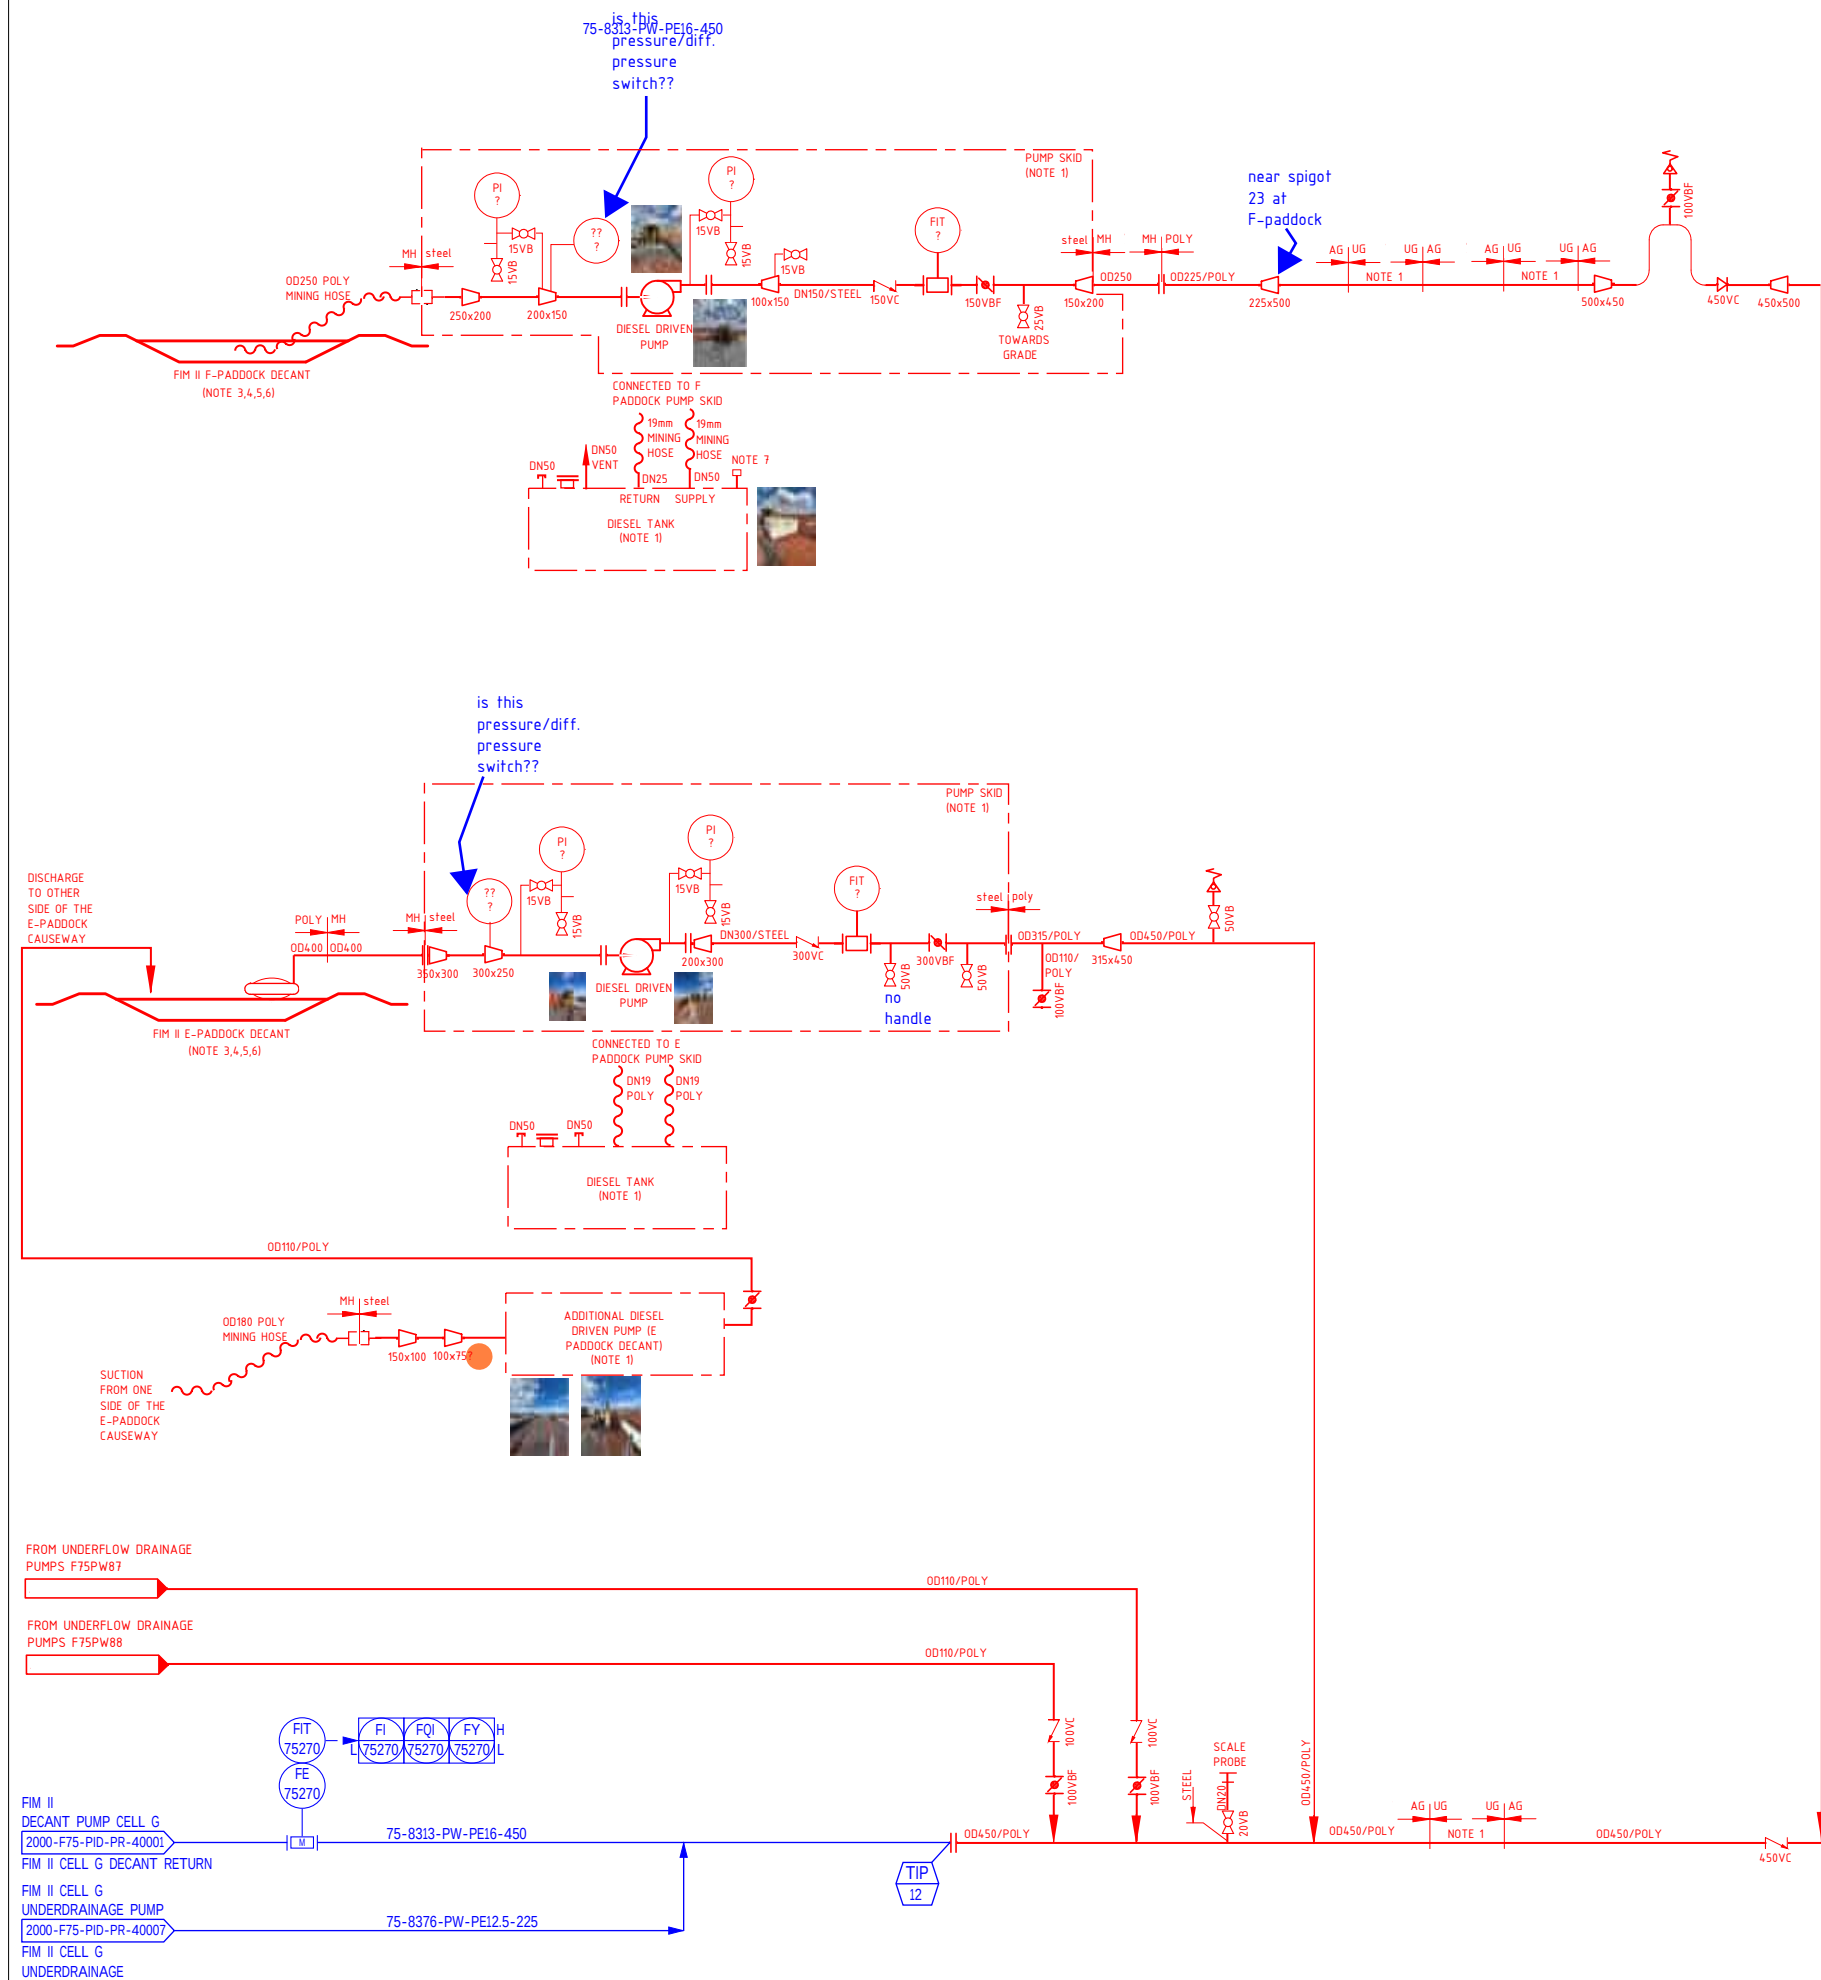
- NOTES:
1. FOR DETAILS OF VENDOR SKID, REFER TO SUPPLIER DOCUMENTATION.
  2. UNDERGROUND PIPING CANNOT BE VERIFIED VISUALLY AND SO CANNOT BE CONFIRMED. TBC – BY CLIENT.
  3. NO LEVEL INSTRUMENT SEEN IN FIELD.
  4. NO ANTISCALANT DOSING SYSTEM SEEN IN FIELD.
  5. NO POTABLE WASH UNIT SEEN IN FIELD.
  6. PUMP NUMBER, INSTRUMENT DESCRIPTION/TAG NUMBERS NOT FOUND IN FIELD.
  7. UNIDENTIFIED FITTING
