FORCADOS TERMINAL SPM MAINTENANCE REPORT

1 MONTHLY SPM INSPECTIONS AND MAINTENANCE CHECK LIST

SPM: Date: 27TH August, 2023

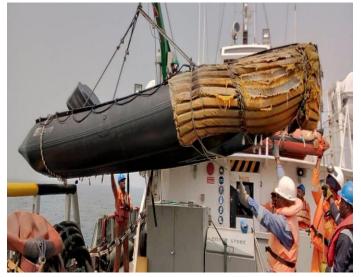
Launching of zodiac work boat

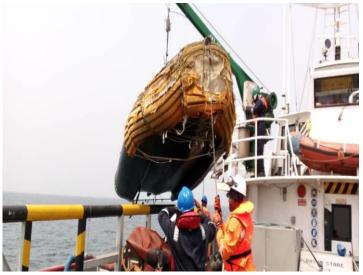
Swinging of zodiac work boat into the sea

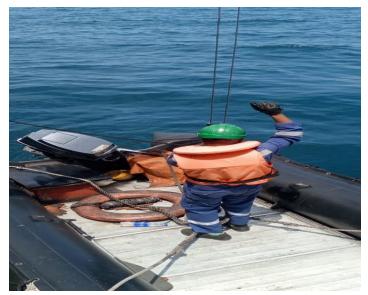
Zodiac boat in water

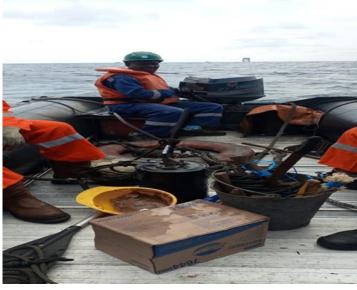
Personnel on zodiac going for inspection

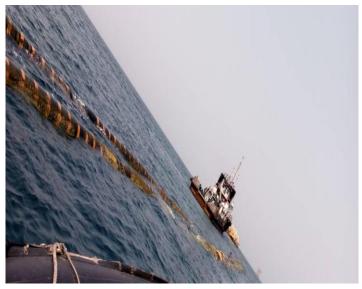
Close visual inspection of Hosestring

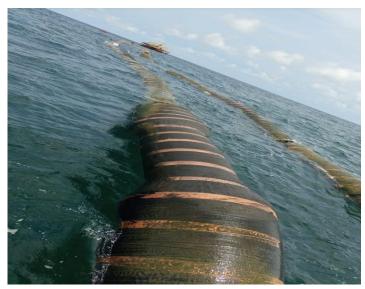
Close visual inspection of Hosestring/TRH

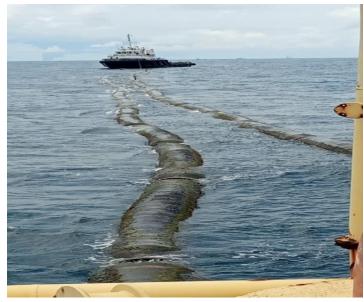
Hosestring inspection from SPM to lineboat

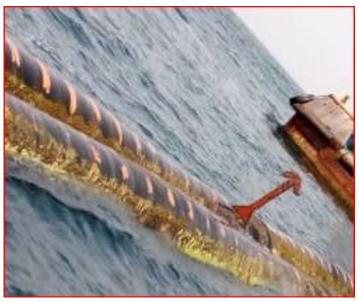
Inspection of cactus spike

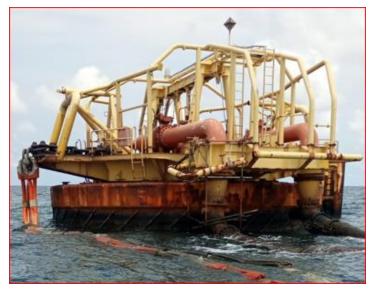
CVI of mooring Hawser / Buoy body

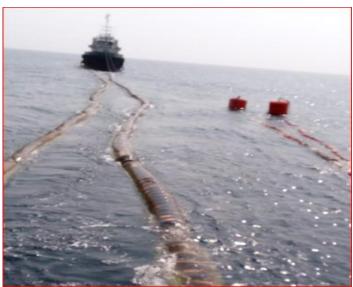
Inspection of hosestring/Mooring Hawsers

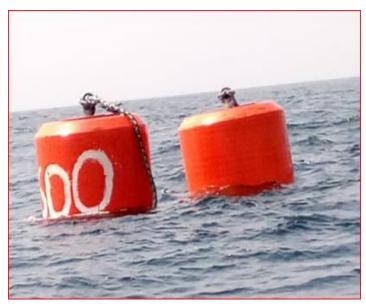
Insp of 300'/600' ropes and Support buoys, ok

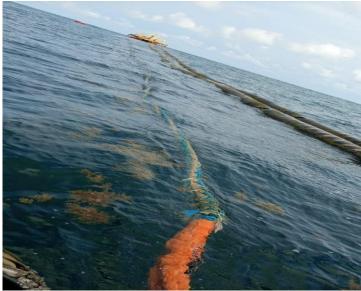
Mooring pickup ropes properly lined up ready for mooring

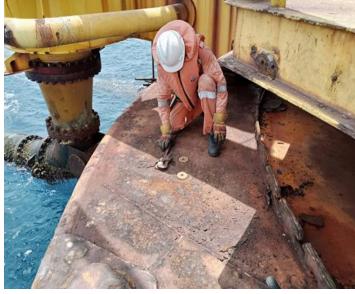
Opening of watertight compartment for sounding.

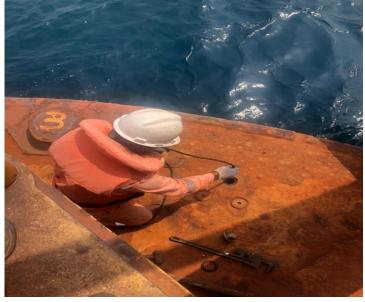
Sounding of watertight compartment, dry and ok

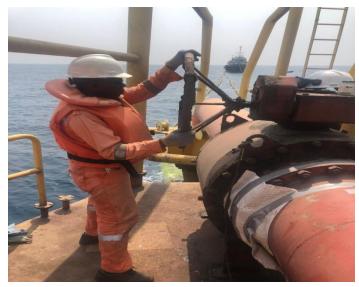
Inspection and Recycling of overboard arm valve

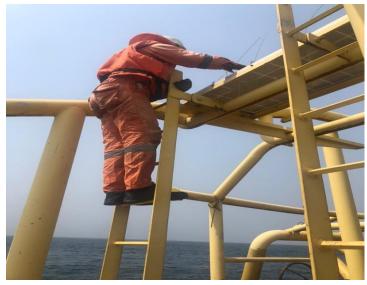
Inspection and cleaning of solar panel

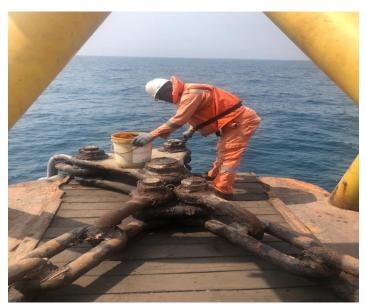
Inspection and Greasing of mooring bridle

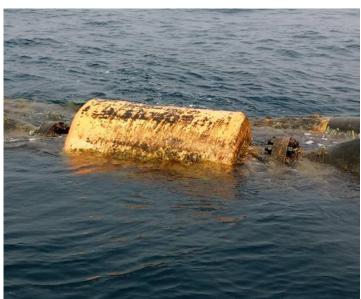
Inspection of 20" < 16" floating hose reducer

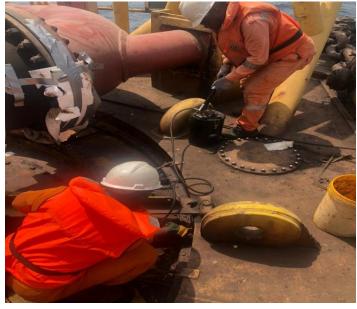
Inspection and greasing of main bearing

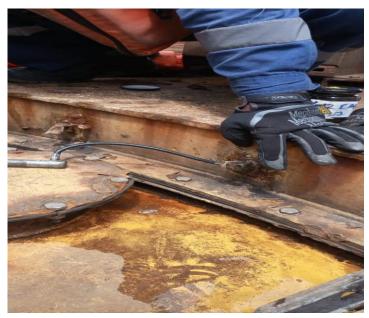
Grease shoe connected to nipple for greasing

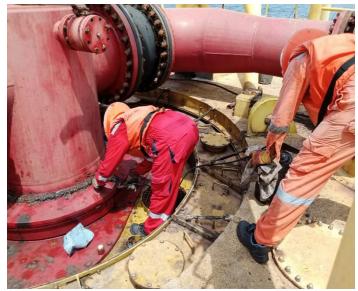
Greasing of PDU

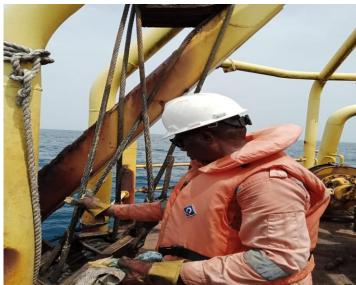
Inspection and greasing lifting Equipment on SPM1

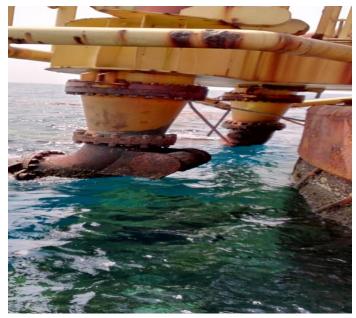
Inspection of Goose neck

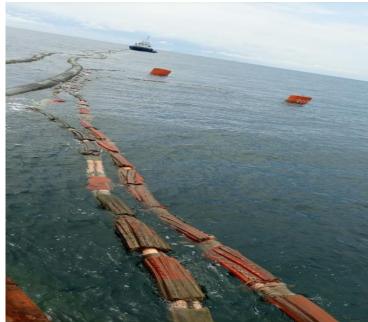
Close visual Inspection of mooring Hawser
