Certificate of Visual Inspection of Lifting / Lifted Equipment

Certificate Details						
Certificate No.:	VER-21-426.68	Job No.:	VER-21-426	Certificate Revision:	0	
Client:	HURACAN	Location:	Vertech Roma Workshop			
Inspector Name	Signature			Report Date		
DUANE JOHNSON				7 June 2021		
Equipment Details						
Identification Mark	QTY	Description	WLL	Test / Inspection Specification	Result	Next Examination Date
LEA L23	1	HOOK				
TAG#1624 WHITE	ADDITIONAL MARKINGS: PROOFLOAD:	7./8-8 N/A	2T	AS 3777 - 2008	PASSED	4 June 2022

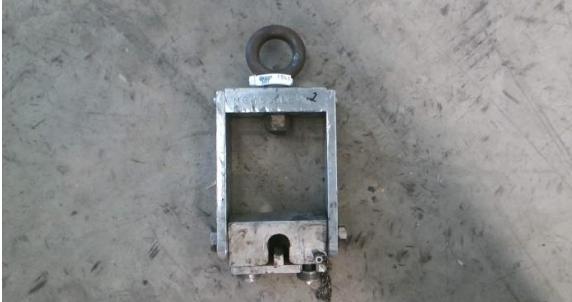
Certificate Details									
Certificate No.:	VER-21-426.2	Job No.:	VER-21-426	Certificate Revision:	0				
Client:	HURACAN	Location:	Vertech Roma Workshop						
Inspector Name		Signature		Report Date					
DUANE JOHNSON				7 June 2021					
Equipment Details									
Identification Mark	QTY	Description		WLL	Test / Inspection Specification	Result			
ALK001	1	LIFTING DEVICE		495lbs	CLIENT SPECIFICATION	PASSED			
TAG#1541 WHITE		ADDITIONAL MARKINGS: MGW PROOFLOAD: N/A

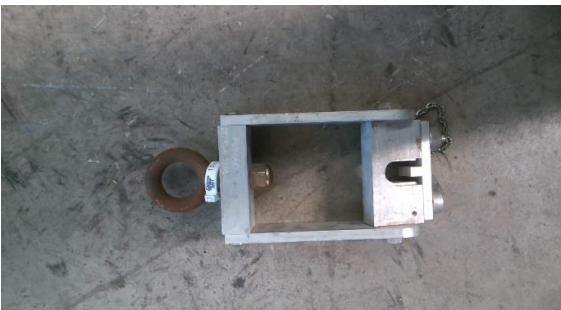
Certificate Details									
Certificate No.:	VER-21-426.3	Job No.:	VER-21-426	Certificate Revision:	0				
Client:	HURACAN	Location:	Vertech Roma Workshop						
Inspector Name		Signature		Report Date					
DUANE JOHNSON				7 June 2021					
Equipment Details									
Identification Mark	QTY	Description		WLL	Test / Inspection Specification	Result			
ALK001	1	LIFTING DEVICE		495lbs	CLIENT SPECIFICATION	PASSED			
TAG#1542 WHITE		ADDITIONAL MARKINGS: MGM PROOFLOAD: N/A

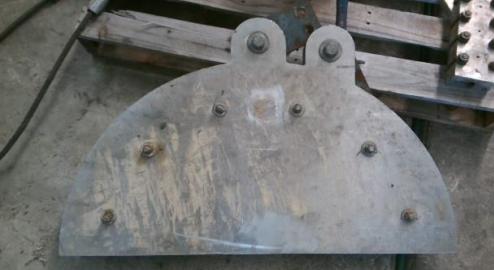
Certificate Details						
Certificate No.:	VER-21-426.4	Job No.:	VER-21-426	Certificate Revision:	0	
Client:	HURACAN	Location:	Vertech Roma Workshop			
Inspector Name		Signature		Report Date		
DUANE JOHNSON				7 June 2021		
Equipment Details						
Identification Mark	QTY	Description		WLL	Test / Inspection Specification	Result
P4412	1	SHEAVE FRAME. REASON FOR FAIL: NO WLL OR SWL MARKED ON ITEM ADDITIONAL MARKINGS: N/A PROOFLOAD: N/A		N/A	AS 4991 - 2004	FAILED
