Wild Desert

Downhole Equipment Audit

1275548869WLD

GENERAL REPORT

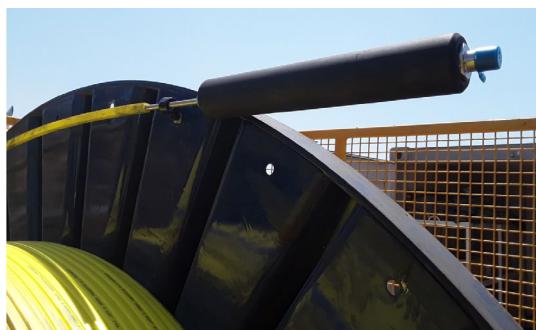
Figure 5 - Pressure Sensor Final Assembly

The Down Hole Gauge (DHG) is assembled by the Huracan technicians prior to the sensor going into the well. There is one connection which is made which connects the Stainless Steel tube sheathed single core cable (with yellow protective coating) to the pressure sensor. Prior to making this connection the cable on the drum is 'meggered' (insulation tested) to ensure the integrity of the insulation prior to use. The final assembly can be seen in Figure 5 below. This assembly is then banded to the String every 1 metre and lowered to the bottom of the well.

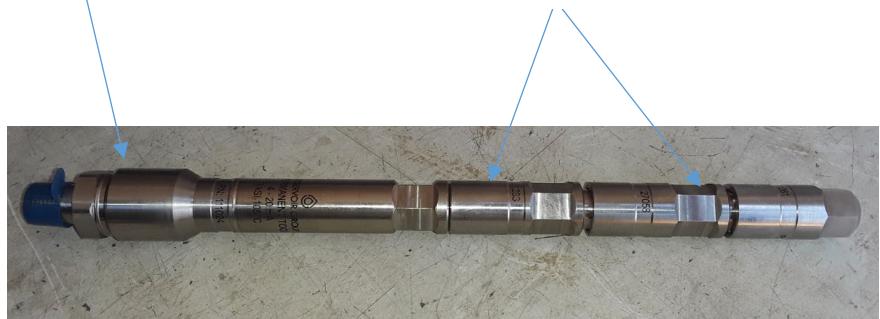
Figure 7 - Pressure Sensor Assembly

This pressure sensor is not certified. It operates on a 4-20mA loop (28V dc maximum) whose output is proportional to the pressure in the well. Inside the well itself is not considered to be a hazardous area as an explosive atmosphere cannot form due to the Oxygen content being below the LOC for methane (LOC = Limiting Oxygen Concentration ~10.7%).

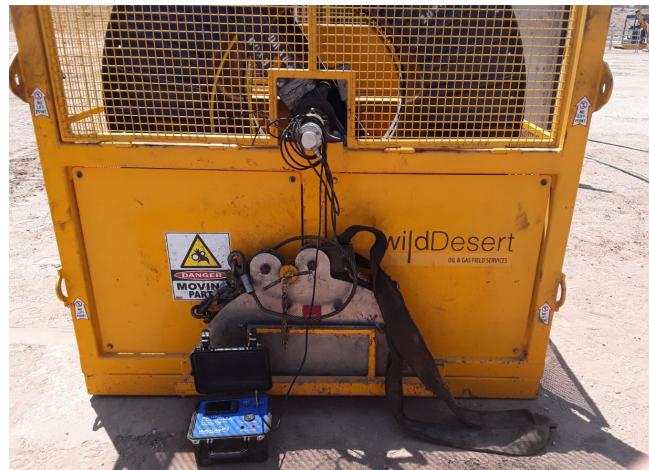
Figure 8 – Reservoir Monitor Attached to the Drum

When the DHG is lowered into the well, the cable drum is located approximately 30 metres from the wellhead. The pressure is constantly being measured to ensure that the sensor is operating correctly as it is lowered. This is monitored using the Huracan test box (IRO-15DO) which is connected to the cable drum. (Figure 8).

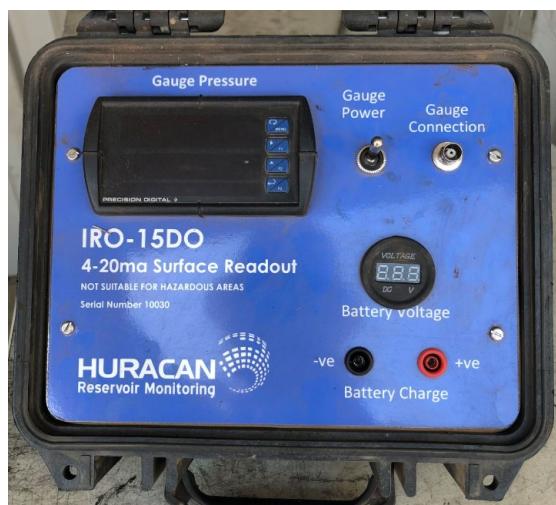
Figure 9 - Huracan's Reservoir Monitor

The Test Box (IRO-15DO) is not suitable for use within a hazardous area, which is clearly stated on the device.

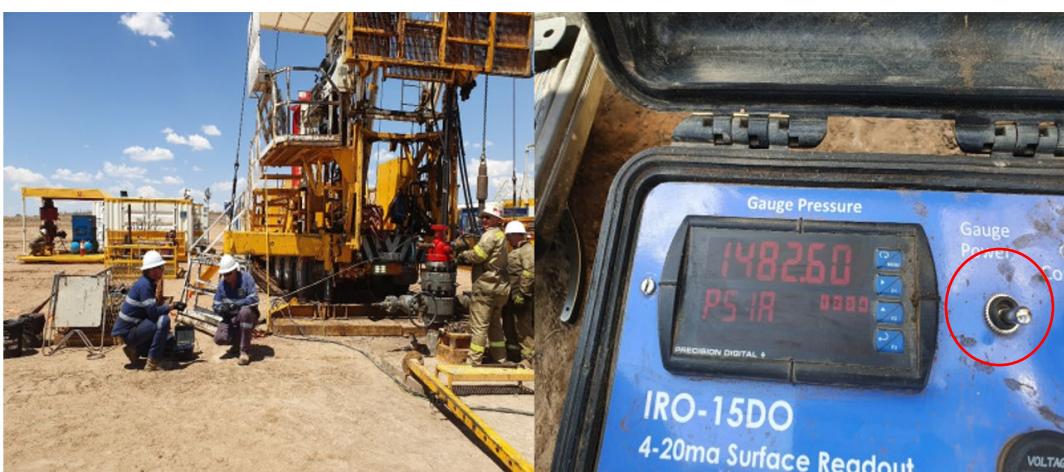
Figure 10 - Final Reading

When at depth, the cable is cut and the reservoir monitor is used to prove for the last time that the DHG is operational. To do this, a connection was made to the monitor and the gauge switch (Figure 10 red circle) is energised. This process takes less than three minutes.

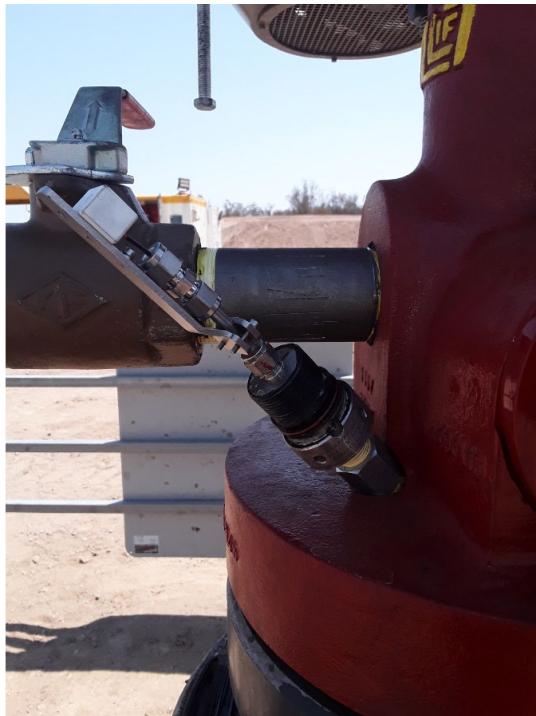
Figure 11 - Wellhead Outlet Assembly

The Antech Type CB Wellhead outlet is an adaptor which is a screwed connection to the wellhead. Figure 11 depicts the final location and how the connection is made. When connected to the wellhead the entire assembly is pressure tested to verify there are no leaks present. The outlet is rated at 10,000 psi (68948 kPa). The procedure on how to make this connection is reproduced in Appendix A, as well as in the Antech document “DC-00611 Wellhead Outlet Manual Type CB Single Line”.

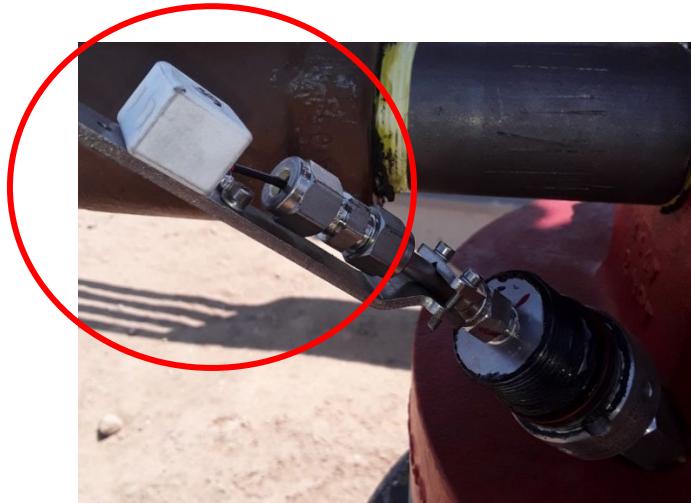
Figure 12 - Terminal Block

The Huracan technicians are responsible for the assembly and connection to the Outlet Terminal Block (Figure 12). The technicians have no specific trade or competencies, over and above on the job training. The installation is not energised at this point.

The process of connecting the Outlet has been revised, since the DNRME visit to another rig. The Procedure is now to have at more than 4 meters of cable slack from the well-head for testing the DHG due to the 4 metre Zone 2 hazardous area extent. This then places the uncertified equipment outside of the hazardous area. The reservoir monitor (Figure 9) is used to confirm the DHG is operating correctly - basically a quality check prior to handing the installation over to Santos. Note that there are two terminals in the connection block where the equipment Earth is connected at the factory.

Huracan do not fit any cables to the outlet side of the terminal block nor do they fit any gland to the outlet, as this is conducted by another contractor engaged by Santos.

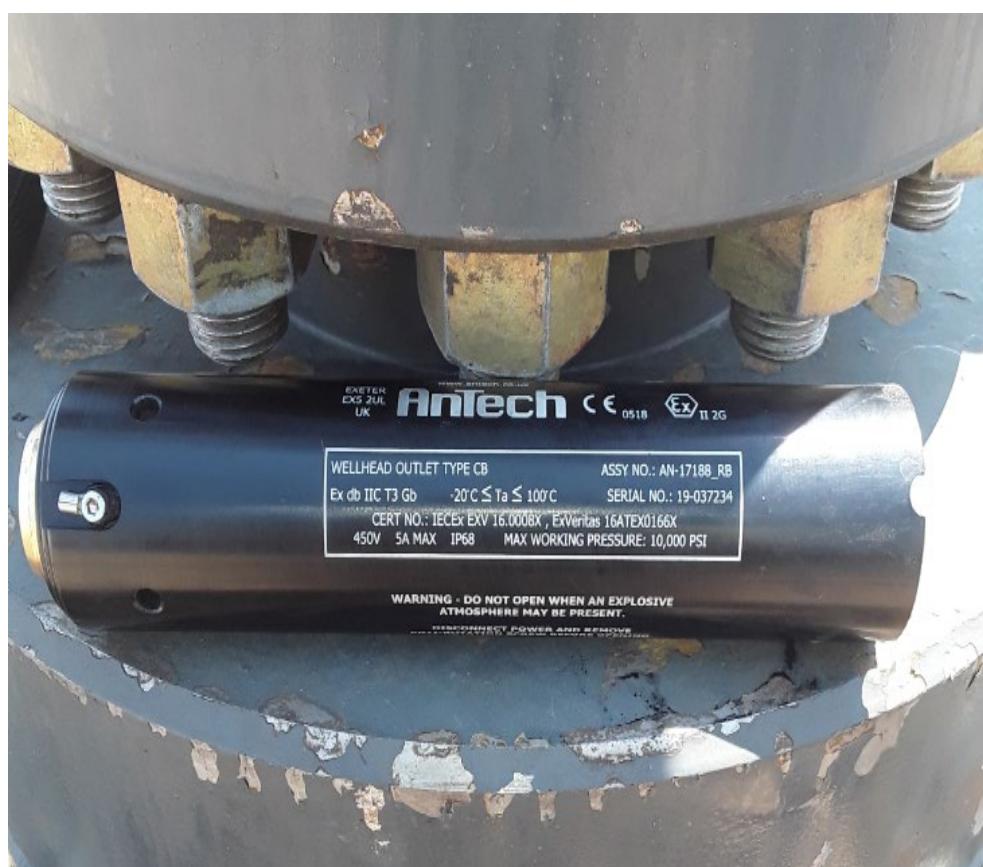
Figure 13 - Antech Certification Details

The Antech Outlet is an IECEx certified equipment (IECEx EXV 16.0008X). This certificate can be found on the IEC website (<https://www.iecex-certs.com/>). Two issues exist (0 & 1). The certification is still current.

The “X” at the end of the certificate number indicates there are special conditions (of Safety and of Use) which must be complied with, in order for the equipment to be used in a safe manner. The Conditions, as stated in the original certificates, can be found below, which have been taken from IECEx EXV 16.0008X – Issue 1.

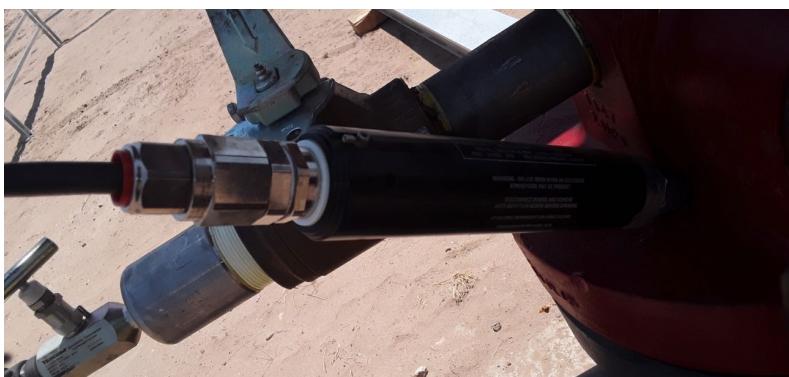
Figure 15 - Cable and Gland Installed

There were other well installations, which had been completed, in the same area as the Rig 4 location. This provided HAZ an opportunity to see the completed product. It must be emphasised, that the final connection works **CANNOT be completed by the Huracan Technician**, but by an **Electrical Contractor engaged by Santos** with the **correct hazardous area competencies** and a **valid Queensland Electrical Licence**.

Speaking to the OCR and Huracan representative the personnel who wire up the final installation are licenced electricians who hold EEHA qualifications. This was taken at face value as there was no representative onsite at the time of the visit to confirm this, although Santos should follow this up to ensure this work is completed by a Licenced Electrician with EEHA qualifications.

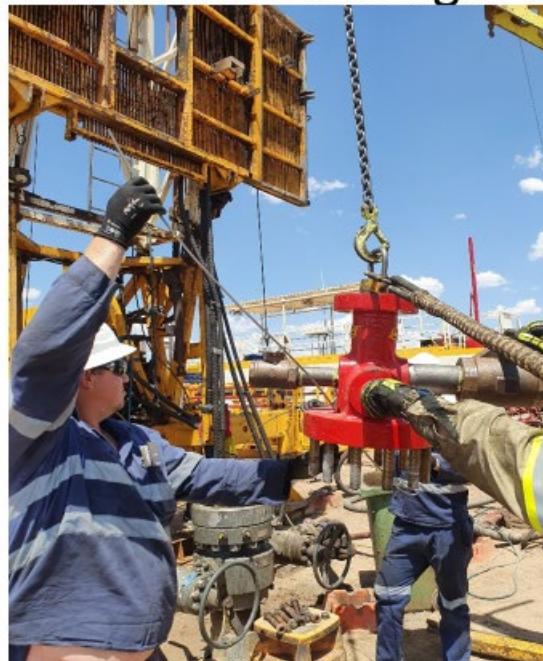
Take cable end outside of 3m zone & conduct final test
