## Element B

Creating a functional and plausible heavy animal lift for the Nashville Zoo Veterinary Hospital has been a goal of Brentwood High for two years and counting. Our goal for this project was essentially to redesign some of last year's flaws in the designs while re-incorporating their successes. What this means, however, is that we spent a lengthy amount of time researching past attempts, including last year's Brentwood High engineers, and documenting ideas that we liked and believed could be utilized in our design.

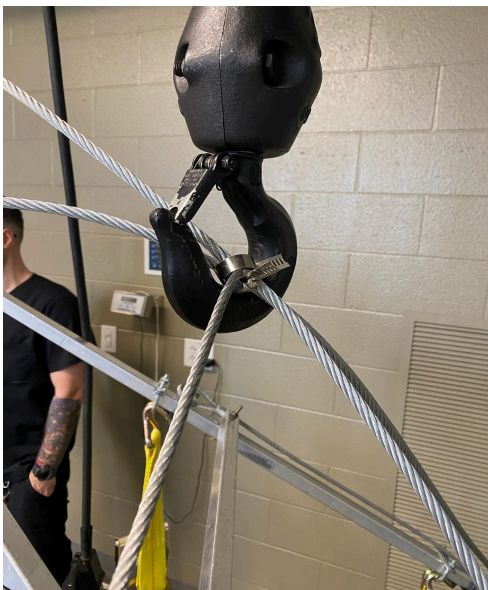
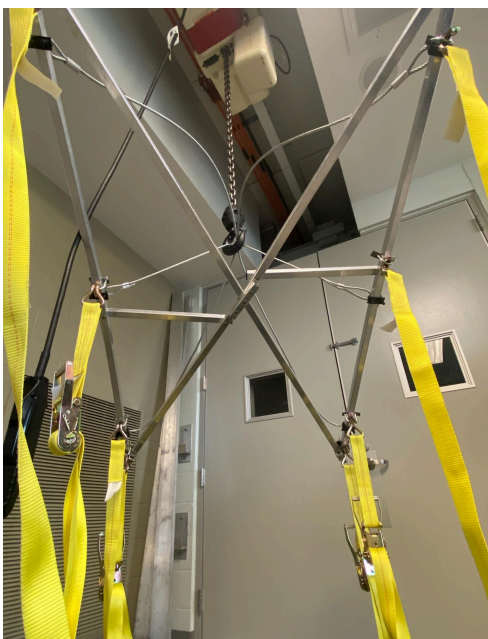
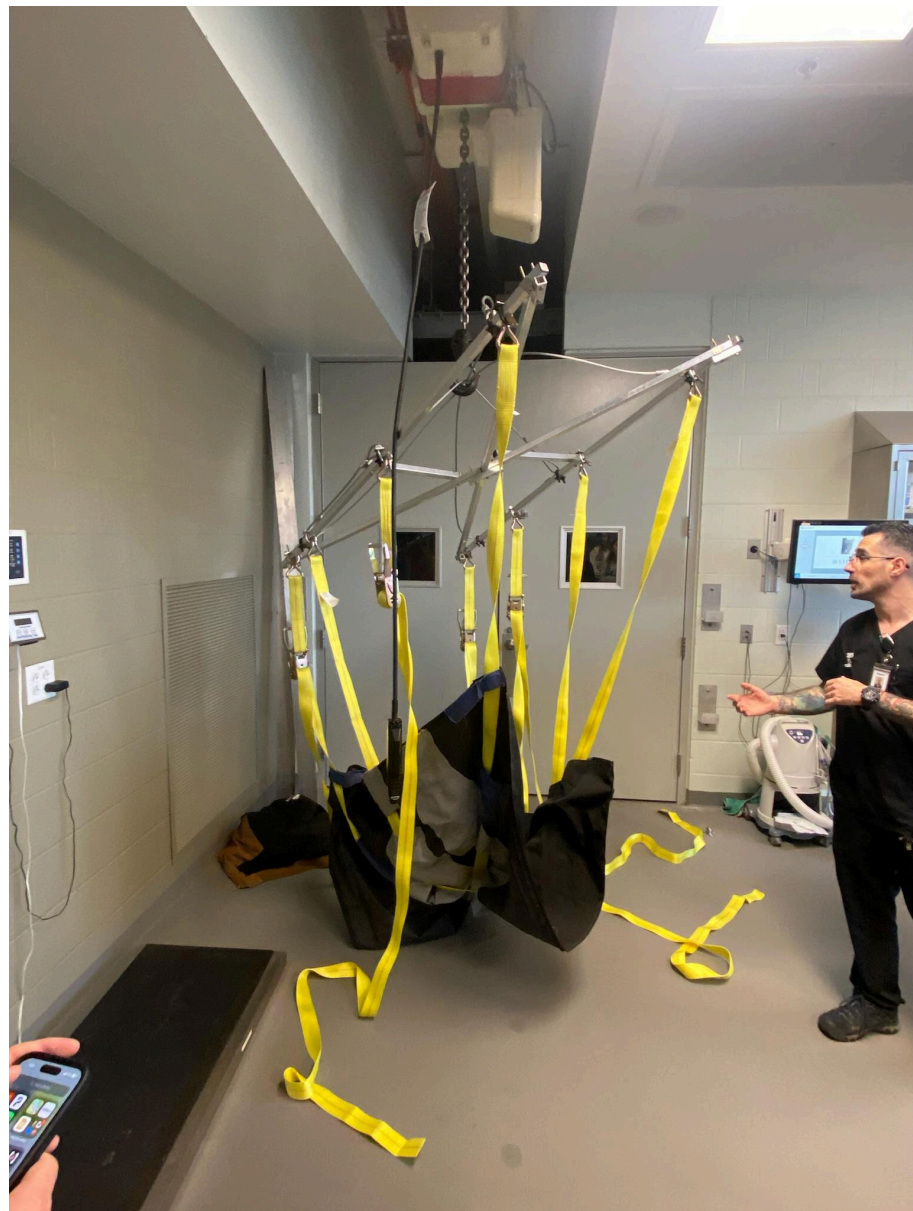
We quickly learned that they had found a couple detrimental flaws to the design, and we made sure to note them and make them a top priority in our new design. As it is shown in the top left photo, the base of the lift was connected to the lift hook by a metal wire clamp that clamps the metal wires together in a relatively central position. This in itself caused a major problem in the design because the clamp would shift to one side of the hook, causing the entire lift to lean. Additionally, as shown in the large photo on the right, the straps all connected to the tarp in an “X” shape, creating a focus point in the middle. What this means in context of the lift is that all of the animal’s weight is centered at the middle of their body, causing an extremely unpleasant and hazardous--and possibly lethal--experience for the animal. We noted these as the two biggest flaws in the old design, and we made them our top priorities to improve for our redesign.

On the other hand, the old design did have successes as well; the overall design of the top frame and the utilization of straps and ratchets for the connectors were effective, and we plan on using a similar approach. They successfully allow the user to change the length of the ropes and adjust the connection points of the straps as well. Unfortunately, the top frame tended to bend and deform under heavy weight, as tested and recorded by the group last year, so we knew we would need to redesign the material and shape accordingly.
