## 2019 Troubleshooting Guide for DJI Agras Products

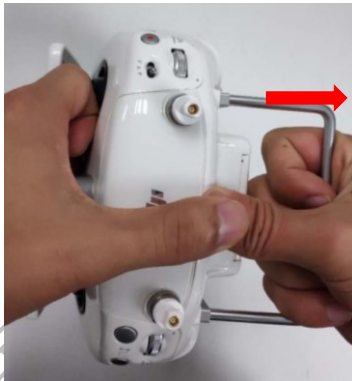
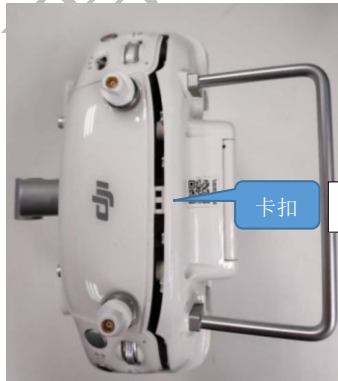
- Issue: There is a buckle inside the remote controller's front shell and rear shell, and it is difficult to separate them during the repair.
- Aircraft model: T16 and MG-1P series
- Solution:
  1. Remove the eight screws on the remote controller's rear shell.
  2. Press the middle of the remote controller rear shell (there is a buckle inside) down vertically with the right hand thumb, and hold the handle with the other four fingers. Hold the screen bracket with the left hand and press down the right thumb with the left thumb. Then pull the handle to the right to separate the front and rear shell. Do not press down on the front shell.
  3. Gently pull the handle, or the flat cable may be damaged.

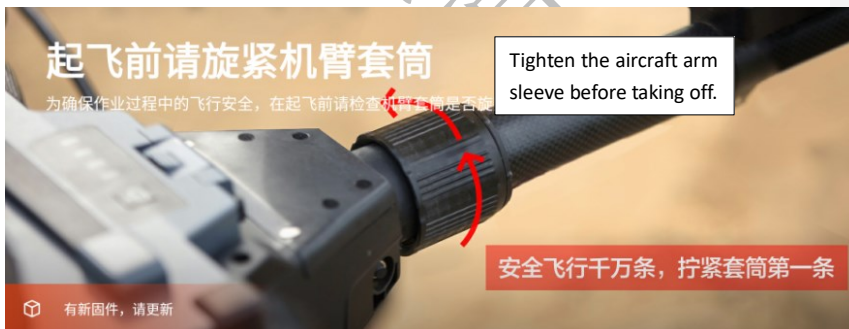
- Issue: The T16 may crash if the sleeve on the aircraft arm is not tightened.
- Aircraft model: T16
- Solution: It is recommended to attach the arm sleeve until the thread is completely covered. Then carefully check the tightness of the sleeve. If the sleeve is loose, the drone may crash.

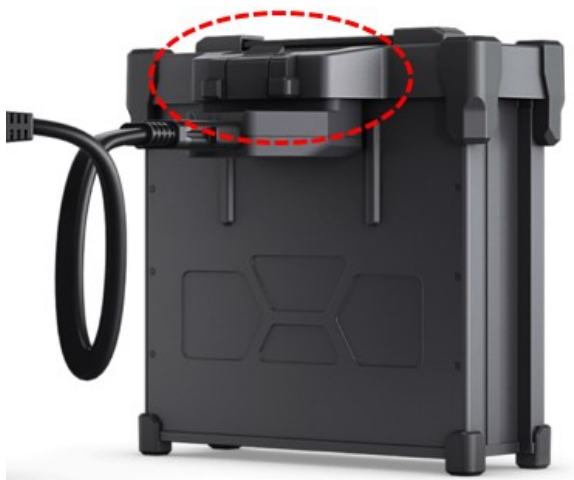
- Issue: The aircraft may crash if the battery is not mounted in place.
- Aircraft model: T16
- Note: When a click sound is heard, it indicates that the battery is mounted in place.

There is a buckle in the red circle.

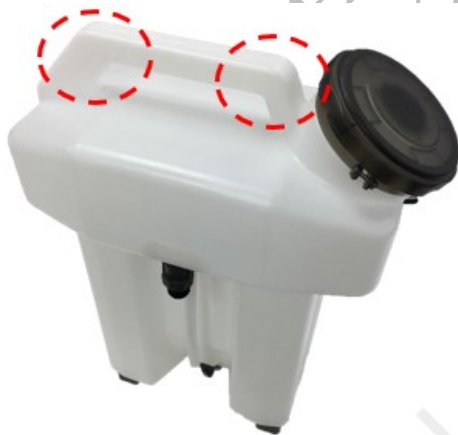
- Issue: There is air in the spraying system or the calibration fails if the spray tank is not mounted in place.
- Aircraft model: T16
- Notices:
  1. After the spray tank is placed in the back of the drone, hold the spray tank (red circle areas) with both hands and press the spray tank down lightly until it is tightened.
  2. If the spray tank is not mounted in place, there will be bubbles when pumping.

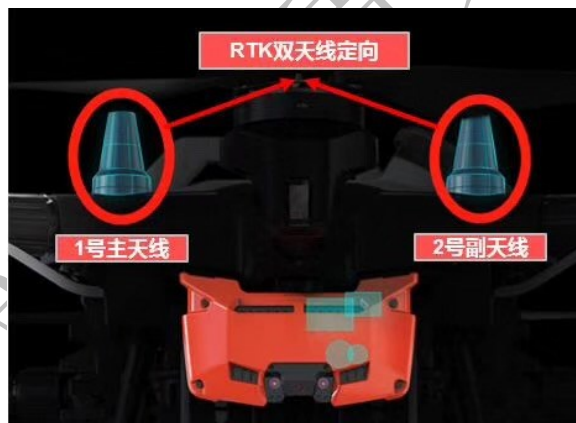
- Issue: A “RTK dual antennas not ready” warning is shown on the app.
- Aircraft model: T16
- Notices:
  1. Make sure that the RTK signal or GPS signal is strong when operating in an open area.
  2. Disconnect and reattach the RTK feeder connector which connects the aerial-electronics board.
  3. Update the firmware to the latest version.
  4. Check whether antenna 1 and antenna 2 can search satellites normally. If the satellite count is 0, replace the RTK feeder and RTK antenna. (Stand at the end of the drone and face towards the direction of aircraft’s nose. The antenna 1 is on the right side, and the antenna 2 is on the left side.)

5. Guide the customers to contact their dealers and replace the RTK antenna to see if the issue is fixed. If not, replace the RTK feeder.
6. Replace the RTK antenna, RTK feeder, and aerial-electronics board to see if the issue is fixed.
7. If the hardware is working normally, update the firmware to the latest version.
8. If the issue persists, link the remote controller with the drone, and send the QR code shown in the DJI MG2 app to DJI Support for diagnosis.

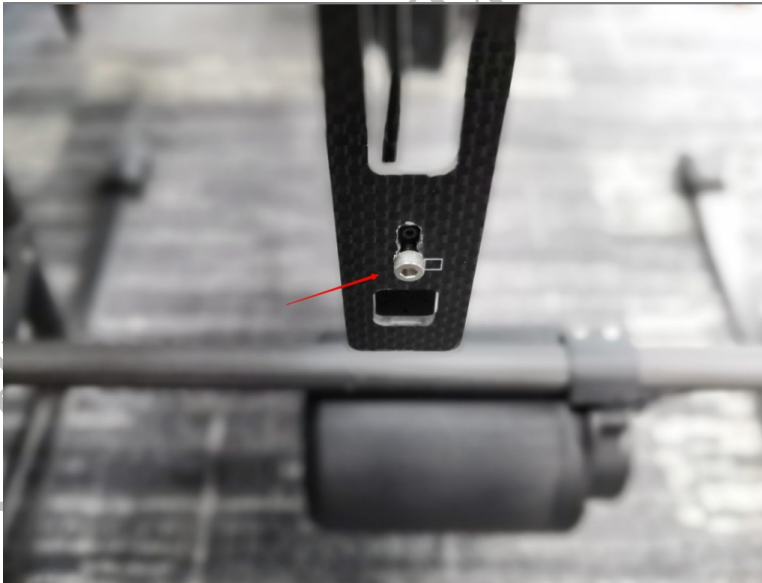
## Inspecting the Liquid Level Meter Sensor

1. Mount the spray tank to another drone and check if the issue is fixed. If yes, adjust the lower sensor's installation position.
2. Adjust the sensor's position up or down to see if the issue is fixed.
3. If not, replace the liquid level meter's cable.
4. If the issue persists, link the remote controller with the drone and send the QR code shown in the app to DJI Support for diagnosis.

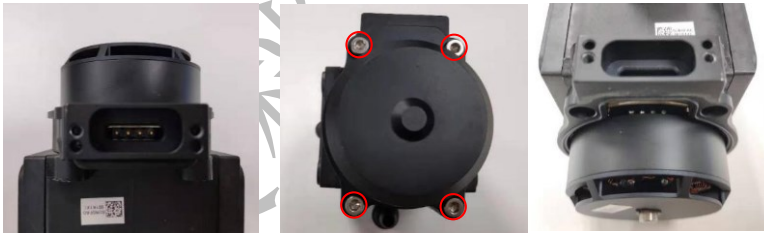
- Issue: There is water or sand inside the T16 delivery pump, or the delivery pump is powerless.
- Related delivery pumps for this issue: Delivery pumps that are out of warranty. For delivery pumps under warranty, disassembling the delivery pump as follows will affect its warranty repair service.
- Solution  
If the delivery pump is water damaged, the connector of the cable which connects the delivery pump and spraying board might be poorly connected. In this case, remove the motor's external shell and check whether it is water damaged. Please disassemble the shell as follows:
  1. Use a 2.5 hexagonal socket screwdriver to remove the four screws securing the motor's external shell. Then remove the shell.
  2. Make the motor face downward to check whether it is water damaged. If necessary, dry the inside with a hair dryer (set to room temperature).

If the delivery pump is powerless, check whether the diaphragm is damaged. Please disassemble the pump as follows:

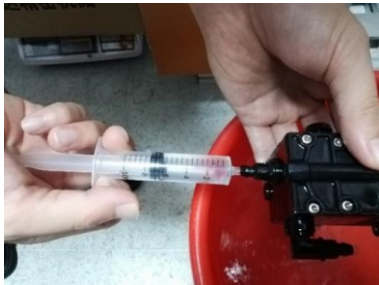
- Cause: Since the pump is not used for a long time, the spool is stuck to the liquid or the gap is large, and the closed loop space cannot be formed.
- Aircraft model: All
- Solution
  1. Add some water to the water outlet to restart the delivery pump for a pressure closed loop.
  2. The user can use a syringe to fill the water to the inlet of the pump as shown below.

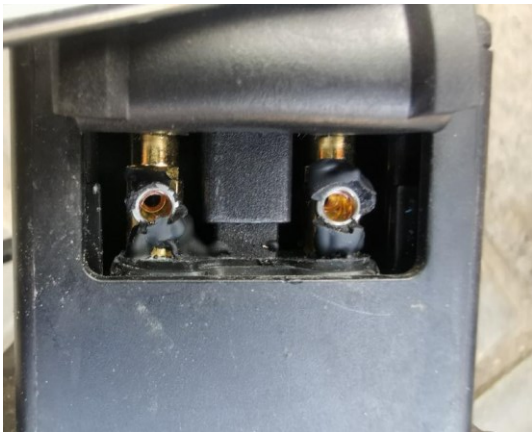
- Issue: The new MG-1P battery power cable cannot be attached.

- Related accessory: MG-12000P battery power cable
- Solution:
  1. Check the cable's middle signal port and its waterproof rubber stopper. If the waterproof rubber stopper is not mounted in place, the cable cannot be attached. A specific tool is required to push the rubber stopper to the end and ensure that the rubber stopper is mounted in place.
  2. If the issue persists, contact DJI Support.

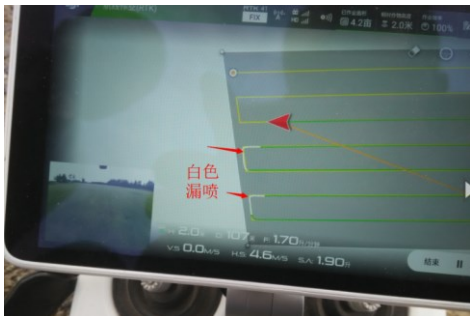
## 45. Some areas around corners are not sprayed by the T16 (as shown by the white lines in the figure below)

- Aircraft model: T16
- Cause: The calibration data is wrong, causing the delivery pump to not rotate promptly and the flow rate to be low.
- Solution:
  1. Calibrate the delivery pump. For more details, visit <https://www.skypixel.com/videos/t16-0bf01265-a50d-433f-8254-82dab021aa7a>.
  2. To check whether the calibration is successful, toggle the spray rate dial and press the spray button to start spraying. After the water volume is stable, the maximum flow rate is 3.4 L/min - 3.8 L/min, and the minimum flow rate is 1.16 L/min - 1.4 L/min (original nozzle).
  3. If the issue persists, link the remote controller with the drone, export the QR code, and send it to DJI Support.

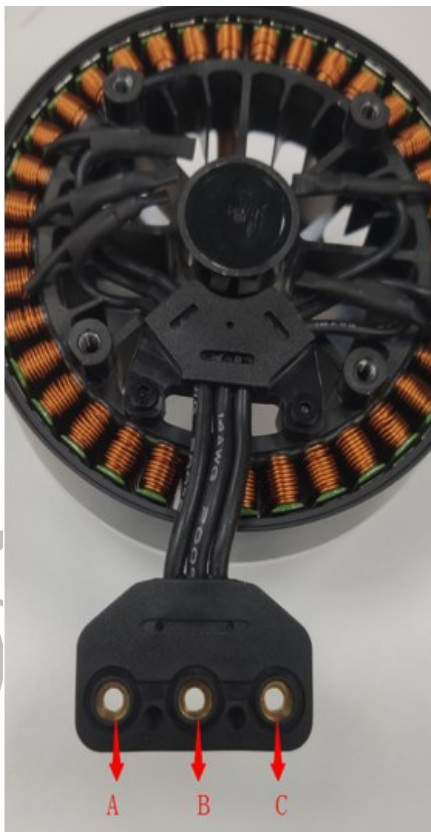
Standards: The resistance of A-B, B-C, and A-C is  $80 \pm 3.2 \text{ m}\Omega$ .
