# **DJI Agras – Troubleshooting Agras Drones, Edition #4 (2021)**

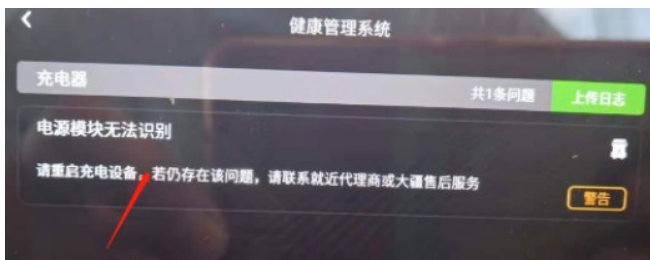
- Issue Description: The T30 battery station is charging slowly, and the Agras app prompts a “Battery Module Not Recognized” warning.

- Reason: The AC cable is attached and removed when the battery station is powered on, which may cause an app bug.
- Troubleshooting Steps:
  1. When the battery station is powered off, remove the AC cable, and wait about 5 minutes. Then attach the AC cable again and power on the battery station.
  2. If the issue persists, export the battery station log and contact DJI after-sales for analysis.

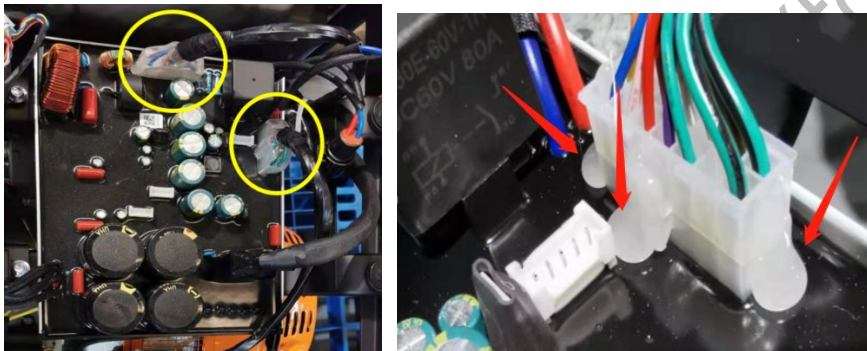
- Issue Description: The charging speed of the generator is slow or the generator cannot be used to charge.
- Reason: The cable of the inverter may be loose, there is no output from the power module, the carburetor is stuck, or the valve module is damaged.
- Troubleshooting Steps:
  1. Check whether the cable of the inverter is loose. If yes, apply the glue.

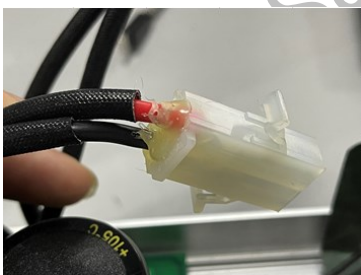
2. Check whether the cable connecting the power module and inverter is loose. If yes, apply the glue.

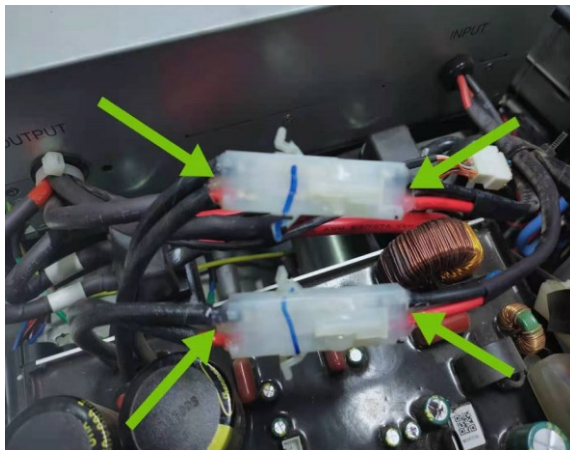
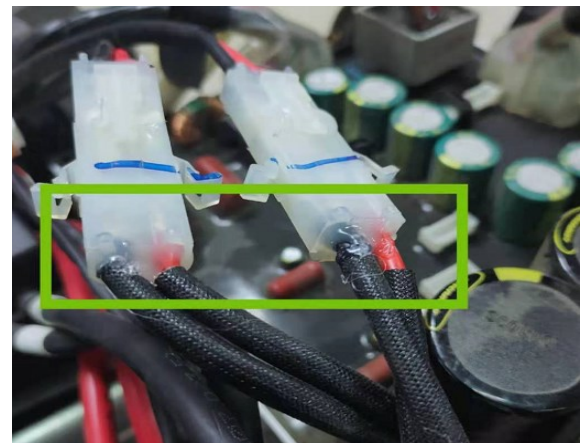
- Issue Description: The generator cannot be used to charge or the charging speed is slow.
- Reason: The connection of the cable terminal between the inverter and power module is poor. In this case, apply the glue.
- Tools: Hot glue gun and hot melt glue stick
- Operations:
  1. Position: Apply glue to the cable connectors between the inverter and power module as shown below.

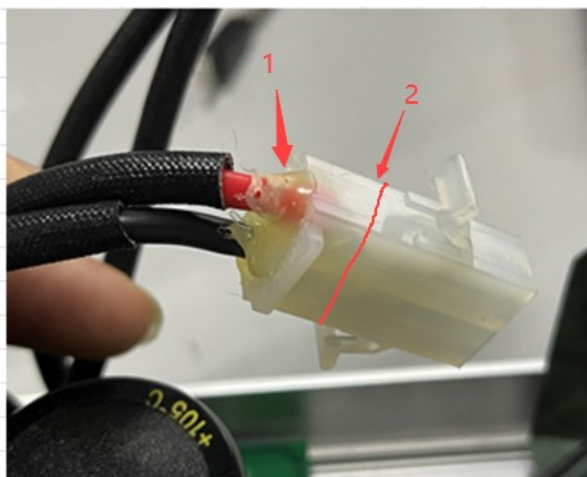
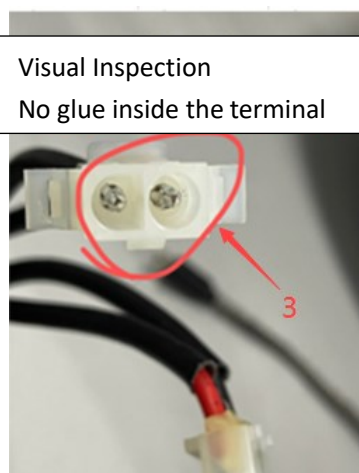
2. After the hot melt glue stick turns into molten form, apply glue to the inlet position of the DC cable. (Standard: The hot melt glue goes down along the inlet position.)
3. Inspection:
  - 1) Make sure that the corresponding inlet is sealed by the holt melt glue, as shown in arrow 1.
  - 2) Make sure that there is glue at the bottom of the core, as shown in arrow 2.
  - 3) It is not allowed to have hot melt glue enter the internal terminal, as shown in arrow 3.

Visual Inspection  
No glue inside the terminal
