# DJI Agras – Troubleshooting Agras Drones 2022

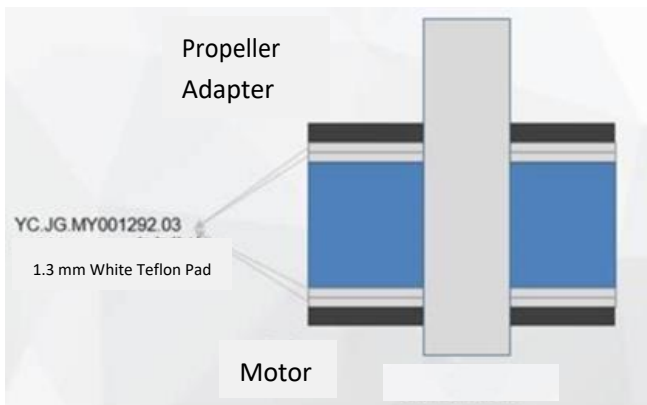
Gaskets include: 1.3 mm Teflon Pad (C.JG.MQ001292.03) ×4 (two pads on the upper part and two on the lower part)

- Solution: When replacing the propellers, if there is a 1.3 mm Teflon Pad (C.JG.MQ001292.03) on the original product, please use the propeller gaskets following the Type 2.

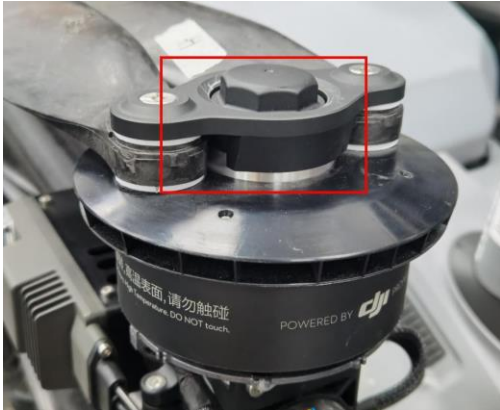
- **Phenomenon:** The T20P motor cannot rotate smoothly.
- **Solution:** Replace the motor and check **whether there are debris inside the motor**. If yes, check there are debris inside the other motors, and replace them in time.
- **Background:** Water flushing will let the water in the specific position of the T40/T20P motor, which will cause the bearing to rust after using for a long time and the motor cable will be stuck.

Figure 1 Avoid flushing water into the position as shown.

- **Phenomenon:** After flushing the aircraft, leave it for a period of time, and rotate the motor by hand. It is found that the motor cannot rotate smoothly (the bearing is water damaged and rusty).
- **Note:** Advise users not to directly flush to the position shown in the figure 1 (you can wipe it off if there are residual liquid);
- **The following information need to be provided:** Please record the information according to the template when the motor is stuck.
  - a) Describe whether it is the motor on the upper position or lower position, and provide the motor's serial number.
  - b) Actual operating time and conditions: For example: 14:50 Feb 21, 2022, fertilization for wheat
  - c) Describe whether the drone was washed.
  - d) Describe how the drone is stored (carrying case or indoor environment).
  - e) Describe whether there are any warnings shown in the Agras app.

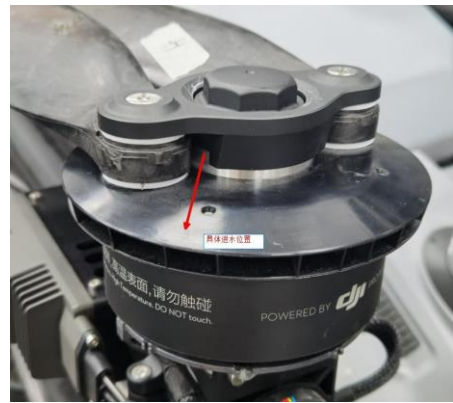
Figure 2 The water may enter into this part as shown.

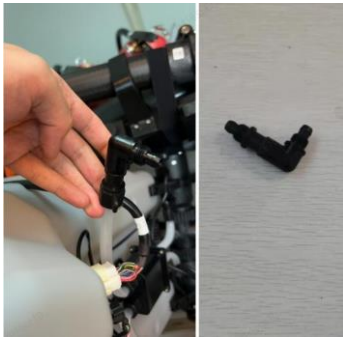
- **Phenomenon:** The T20P dual atomized sprinkler is leakage after spraying is turn off.
- **Cause:** It is easy to accumulate pesticides under the **spinner disk gasket**, and the gasket may be **swollen and worn**; The one-way valve cannot intercept the residual moisture due to pesticides accumulation.
- **Solution:**
  1. The one-way valve is stuck or malfunctioning. In this case, it is recommended to **remove the hose and clean it**, or try to replace the valve.

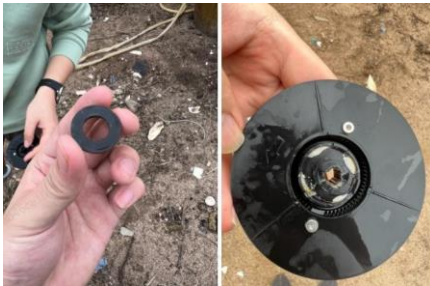
2. The spinner disk gasket is **worn due to residual pesticides under the gasket**. It is recommended to replace the gasket and clean the spinner disk (the gasket is included in the accessory kit).

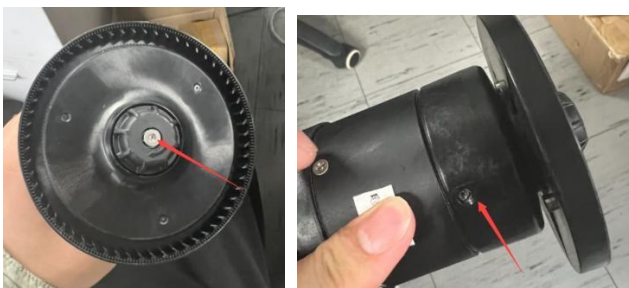
## 8. There is a self-check error with the T40/T20P centrifugal ESC/The voltage is too low/The rotational speed is not displayed under Spraying System Settings in the HMS.

- **Disassembly & Assembly Method:**
  1. Remove the hand screw at the bottom of the centrifugal sprinkler, rotate to remove the bottom cap, and then remove the spinner disk, as shown in the left figure.
  2. Remove the screw below the motor and then remove the motor lower cover, as shown in the right figure.

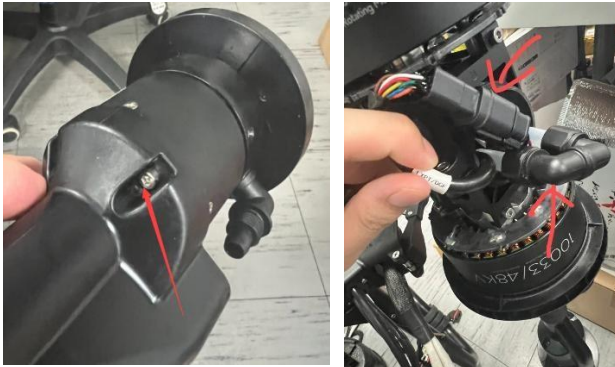
1. Check whether the spinner disk and motor **lower cover are worn or scorched**.
2. **Remove and attach the cable again**. Then check whether the cable connection is normal.
3. If no error is found, replace the dual atomized sprinkler. If the app prompts the sprinkler is malfunctioning, try to install it to the other position. If the warning is still displayed, replace the sprinkler motor. After the sprinkler motor is replaced and the issue persists, it is recommended to **replace the aircraft arm cable and power distribution board**.
4. If none of the above solutions works, export the QR code data, and contact DJI after-sales team for data analysis.

3. Remove the screw securing the motor upper cover, and then remove the upper cover, as shown in the left figure.
4. Remove the motor protective cover, pull out the centrifugal motor cable, remove the centrifugal spray rod sleeve (be sure to fix the spray rod), and pull out the hose curving connector, and then remove the spray rod.

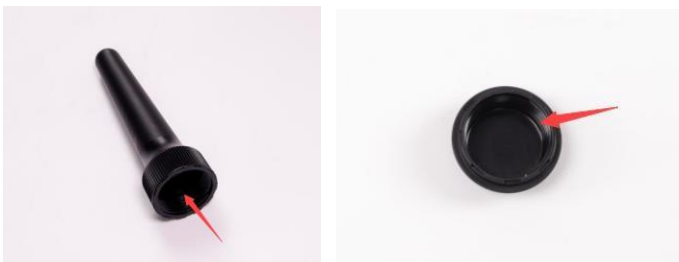
- Phenomenon: The T20P SDR protective sleeve or motor shaft cover is loose.

1. Apply a circle of glue to the inner thread of the SDR protective sleeve (YC.JG.ZS002416.03) or motor shaft cover (YC.JG.ZS002292.02).

2. Glue Model: Kafuter K-5911B Glue

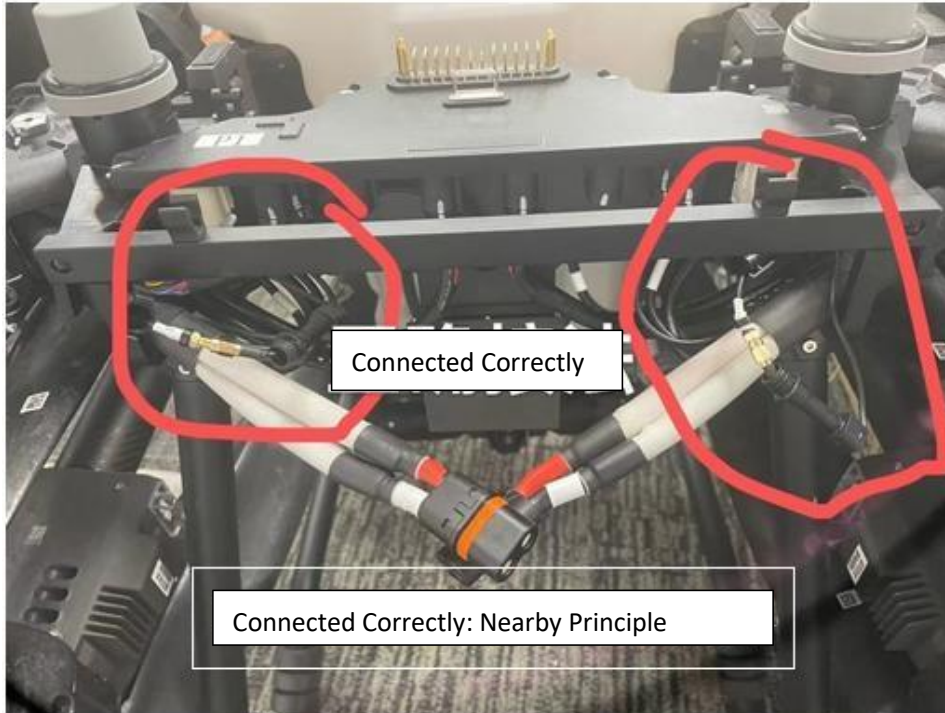
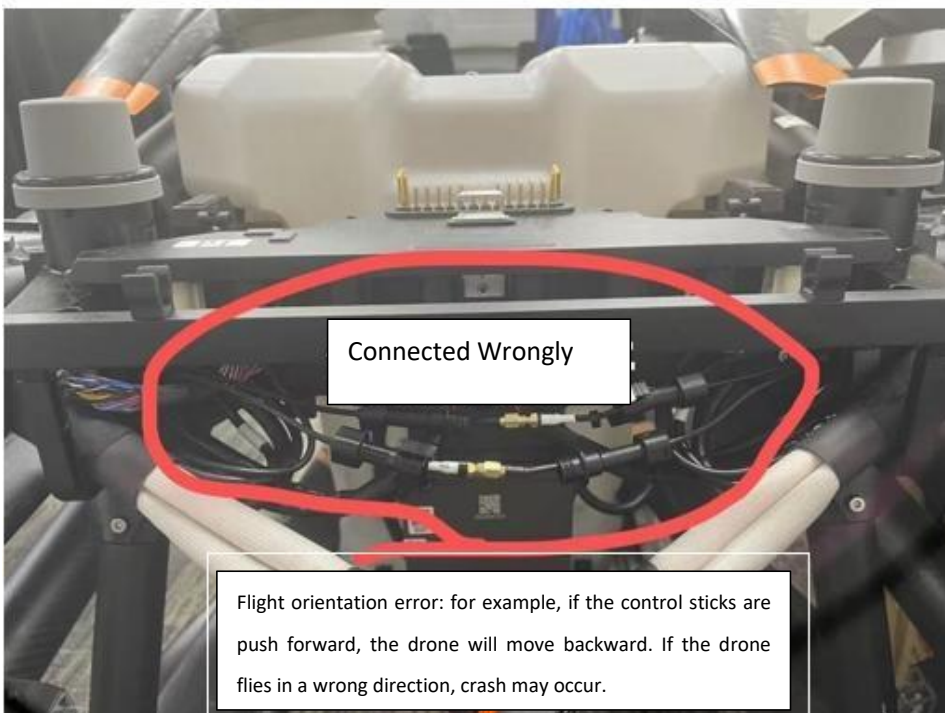
## 10. T20P RTK Antenna Connection Method

**T20P RTK Antenna Connection Method:** The RTK antennas need to be connected following the nearby principle, that is, the RTK antenna should be connected to the other antenna closer to it. If the RTK antennas are connected wrongly, **there may be an error with the flight orientation**. For example, if the control sticks are push forward, the drone will move backward. If the drone flies in a wrong direction, crash may occur. So please make sure that the RTK antennas are connected correctly.

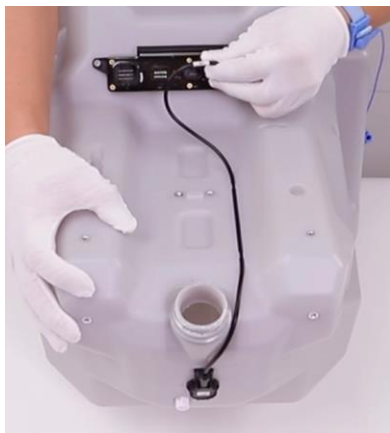
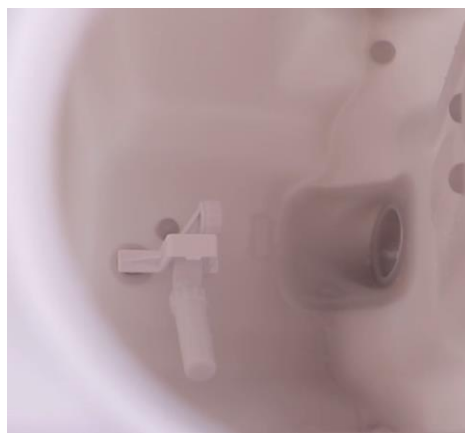
## 11. What should I do if the remaining liquid payload in the T20P spray tank is shown 0?

- **Phenomenon:** The remaining liquid payload in the T20P spray tank is shown 0.
- **Troubleshooting Plan:**
  1. If the remaining liquid payload is displayed 0, the Tare Calibration is successful, but the Weight Calibration fails, or the remaining liquid payload is displayed 0 after filling in the water, it can be determined that the **liquid level gauge is damaged**. It is recommended to replace the **liquid level gauge and hall sensor** (at the bottom of the spray tank). The problem is prone to occur after unboxing, and it is suspected that the issue is caused by transportation.
  2. If none of the above solutions works, export the QR code data, and contact DJI after-sales team for data analysis.

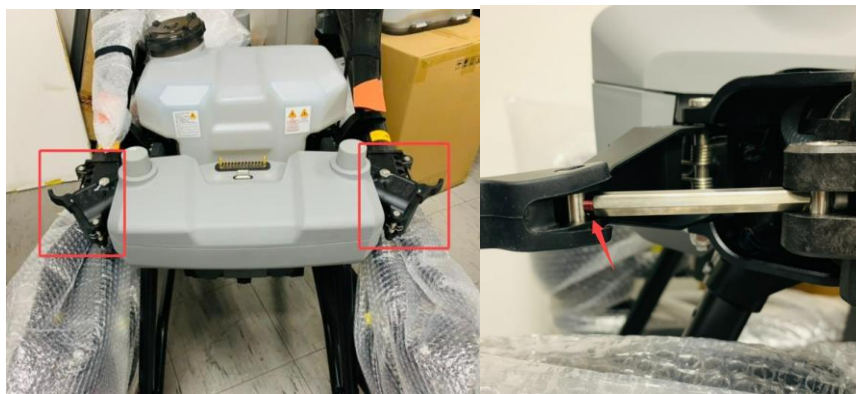
- **Related Product:** T40/T20P
- **Troubleshooting:**
  1. Check whether the red screw glue is applied to the **connection rods** on the four aircraft arms. If not, disassemble the aircraft arm and apply the glue again.

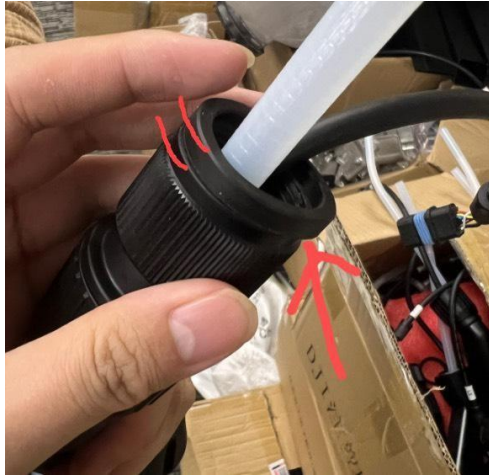
- **Phenomenon:** The T20P centrifugal spray rod comes off.
- **Solution:** Install the damping rubber ring (Material Number: YC.JG.MY000814.02) to the fixing nut of the spray rod, as shown below:
