# DJI Agras – Troubleshooting Agras Drones 2022

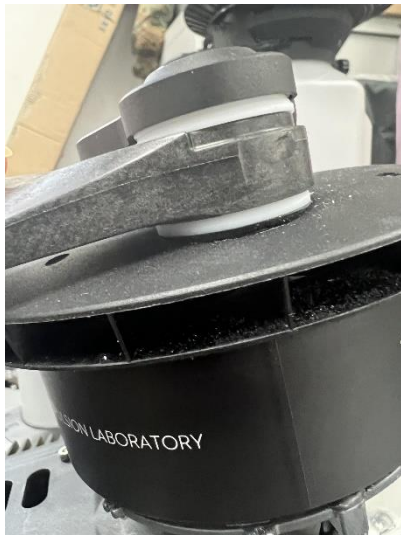
The gasket/rubber pad needs to be replaced if the T40&T20P propellers are replaced, as the **propeller gasket is a consumable part**. After using the gasket for a long time or if the gasket is misshapen or damaged, the aircraft arm may vibrate abnormally, resulting in aircraft crash. Therefore, it is necessary to replace the gasket together when replacing the propeller during the repair, and check whether the **gaskets on other propellers are misshapen**. If the gasket is not replaced after propeller replacement, which may result in the aircraft crash, and the dealer will be held accountable.

**Teflon Gasket** (YC.JG.MQ001292.03) (0.13mm; **two gaskets** on the upper part and two on the lower part)

**Black Rubber Pad** (YG.JG.MQ001280.03) (**one pad** on the upper part and one on the lower part)

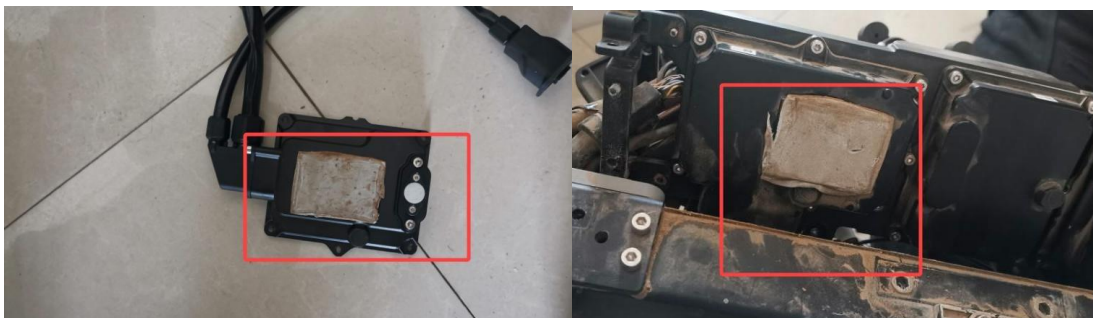
If the cable distribution module, aerial-electronics module, or RF module is replaced, the corresponding **thermal conductive pad** needs to be replaced and the location of the conductive pad must be cleaned.

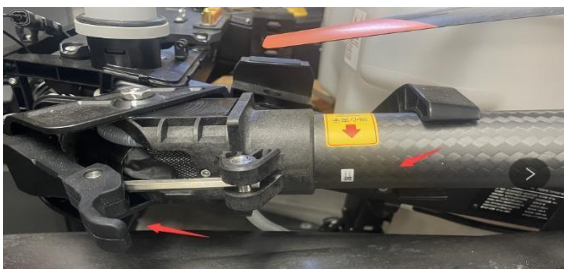
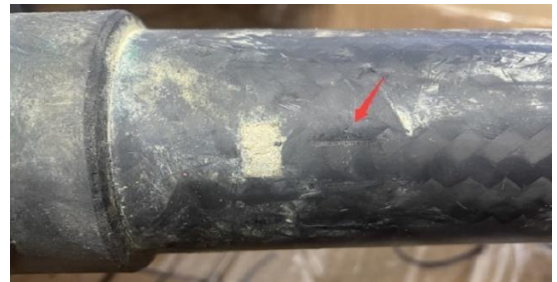
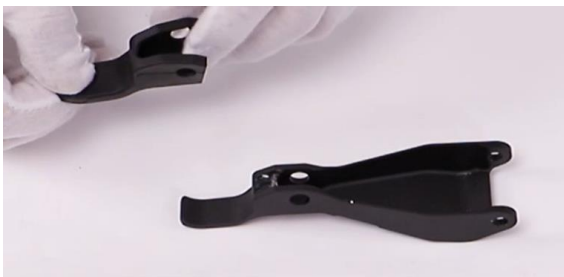
- **Check the root of the aircraft arm.**
  - **Operating Steps and Inspection Frequency:**
1. Check whether the **rubber sleeve** of the locking part is broken when unfolding the aircraft arm or during repair, and check whether the **contact surface between the locking part and the aircraft** is worn, cracked or underlayer material **is exposed**.

- **Solution:**
1. If the rubber sleeve of the locking part is broken, please replace it immediately. Otherwise, the **aircraft**

arm may be damaged by the locking part.

2. If the root of the aircraft arm is worn, cracked or underlayer material is exposed, **please replace the aircraft arm.**

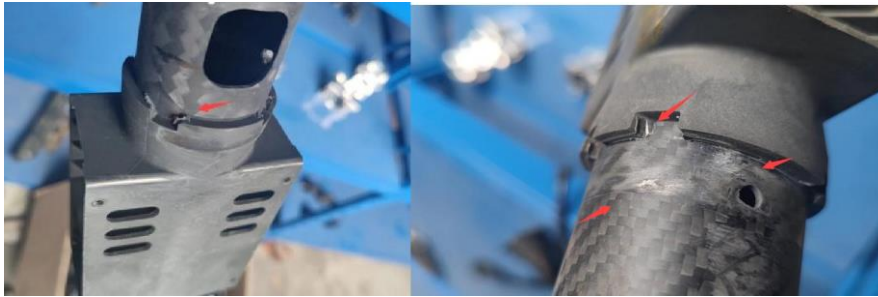
1. During repair, check whether the **motor fixing base is loose**, whether there is a gap in the slot of the ESC bracket, and whether the **fixing slot of the motor base is worn or cracked.**

- Solution: If the issues mentioned above occur, please **replace the corresponding aircraft arm.**

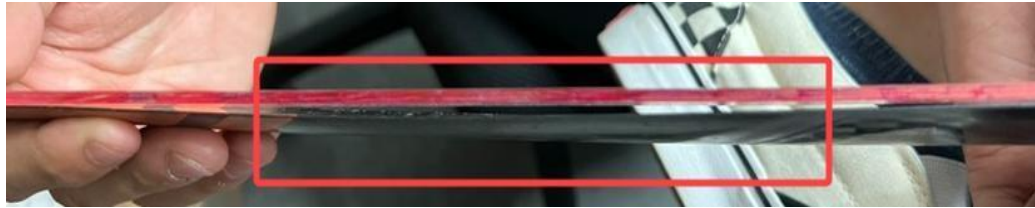
There is a large gap between the propeller and ruler as shown below, which can be determined that the propeller is bent. In this case, replace the propeller.

- If the propeller is bent, please replace it as soon as possible. After repair, perform flight testing and take off the drone with full payload, make the drone hover in place or fly to the left or right. Then check whether there are abnormal propeller sounds.

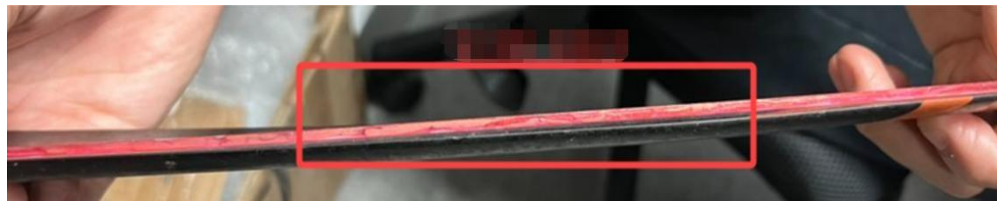
There is a small gap between the propeller and ruler as shown below, which can be determined that the propeller is not bent.

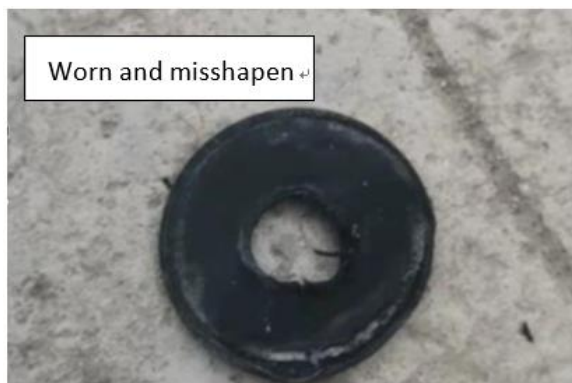
1. Check whether the order of propeller gaskets is correct: From top to bottom, **black pad x1 + white gasket x2 + propeller + white gasket x2 + black pad**.
2. If the propeller is replaced, make sure all gaskets and pads are replaced.
3. During repair, check whether the black rubber pad is misshapen. If yes, replace it immediately. Otherwise, the drone may vibrate abnormally, causing the drone crash.

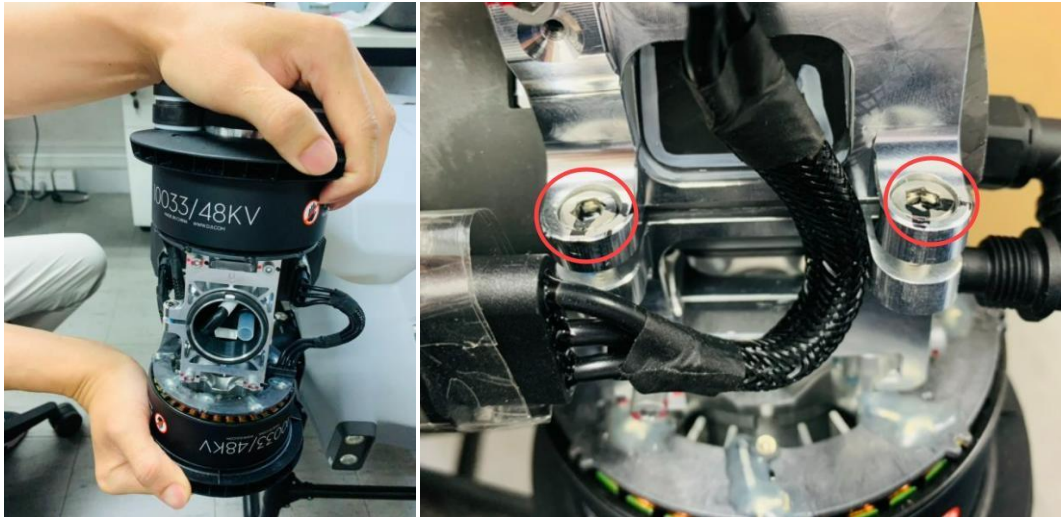
- Check whether the motor base is loose.

First, hold the upper and lower motors with your hands, turn the motors counterclockwise and clockwise respectively, and check whether the motor rotates. If yes, use the dedicated tool to tighten the screws securing the motor base.

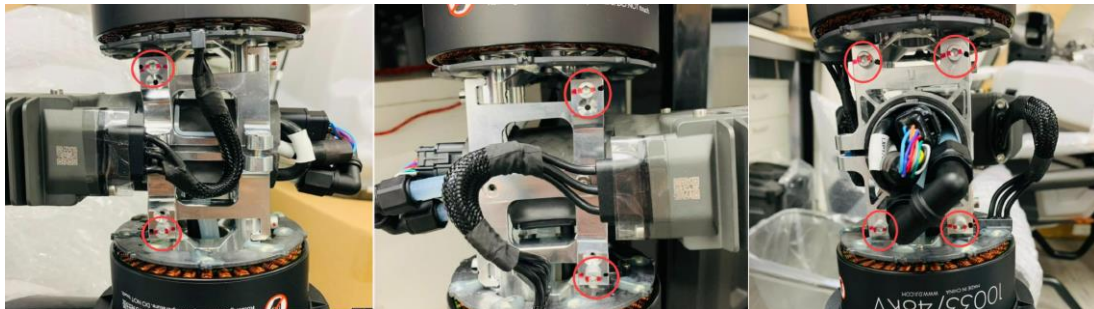
- Check whether the screw securing the motor is broken.

1. Detach the four motor protection foam pads respectively, and check whether the screws are missing. If necessary, replace the screws. After the assembly is completed, **use a red pen to mark them**.
2. Use the electric screwdriver to tighten the screws and confirm that the screws are secured. If the screw is broken, replace the screws. After the assembly is completed, use a red pen to mark them.

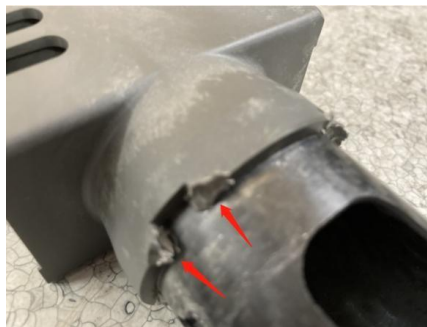
1. First, check whether the **motor base limit slots** (as shown in the arrow) of the four aircraft arms are misshapen or broken. If yes, the corresponding aircraft arm needs to be replaced.

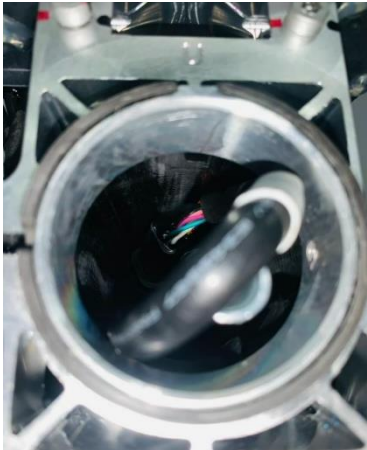
2. Check whether the **inside of the aircraft arm is broken**. If yes, the corresponding aircraft arm needs to be replaced.

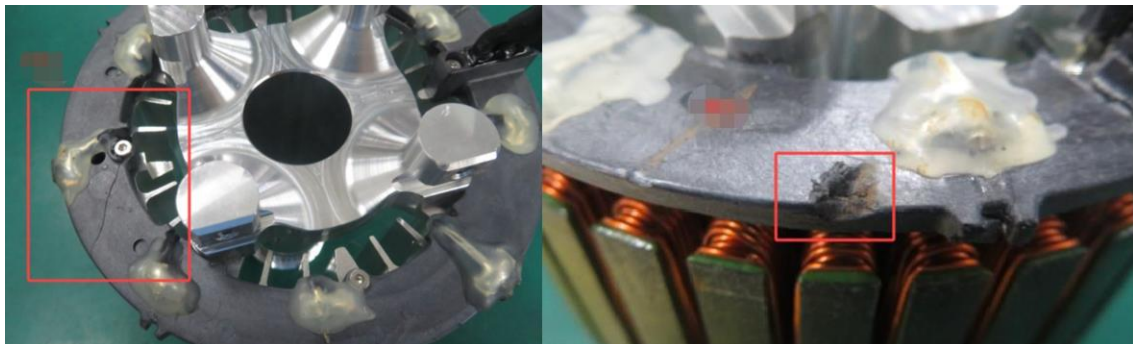
- **Check whether the motor is broken.**
- **Method:** If the motor terminal surface (as shown in the figure) is cracked or damaged, replace it immediately, which can prevent liquid from corroding the motor and cause the spontaneous combustion. As shown below: The motor cracks (left figure) and the motor is broken (right figure). In this case, the motor needs to be replaced.
