# A1466 Minor water inflow maintenance

A1466

[Fault  
phenomeno  
n] Do not  
start up

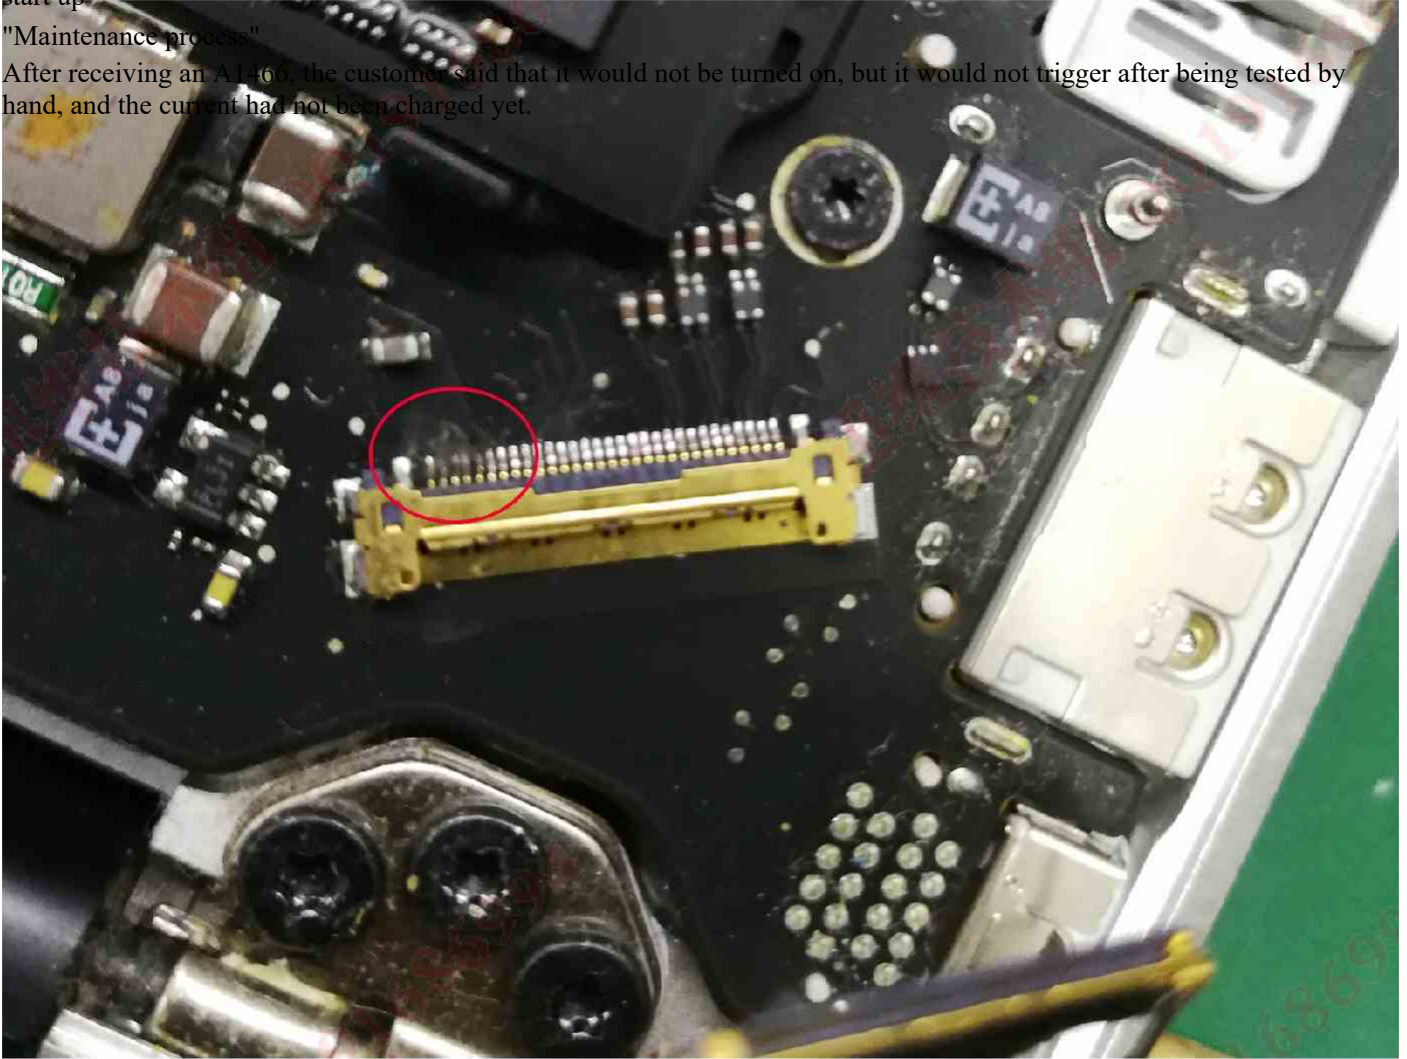
After receiving an A1466, the customer said that it would not be turned on, but it would not trigger after being tested by hand, and the current had not been charged yet.

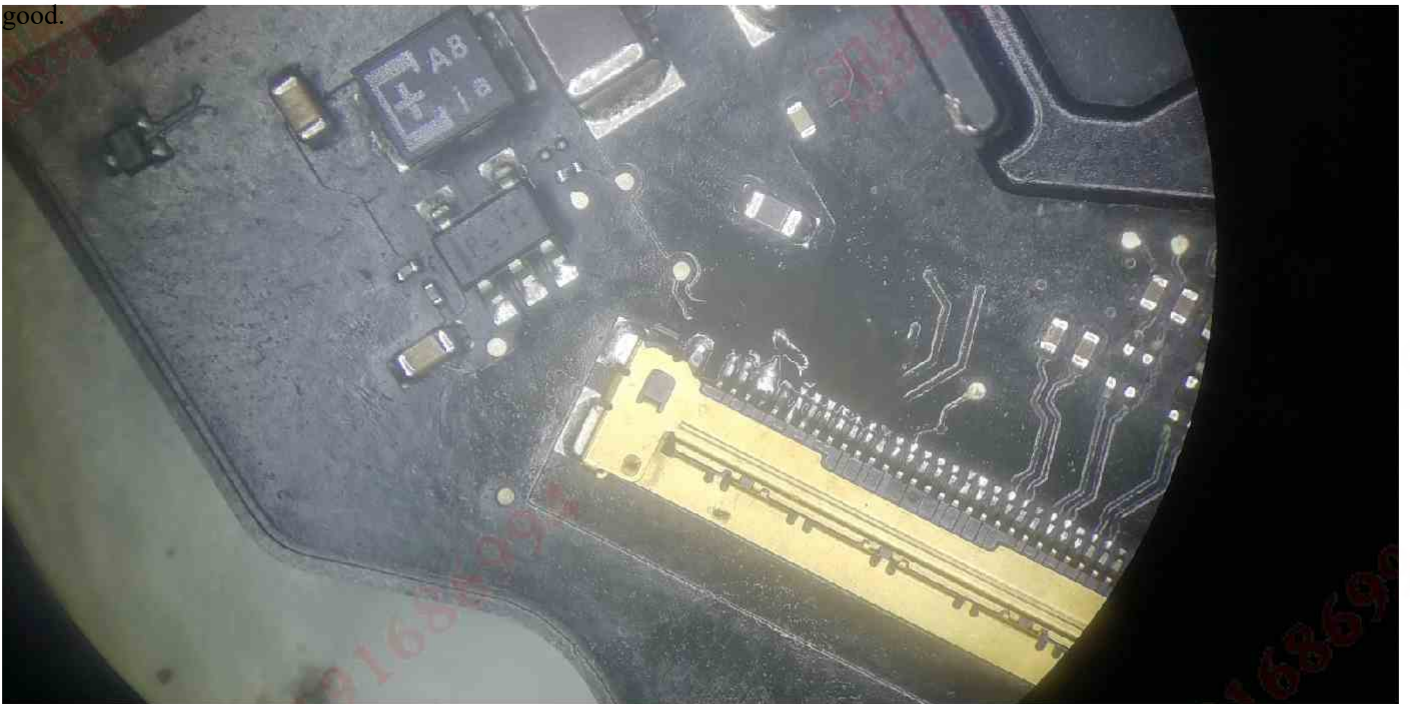
After the main board was removed, there were two places with water on the back. After cleaning, it was found that it was good.

The screen interface is also easy to handle.

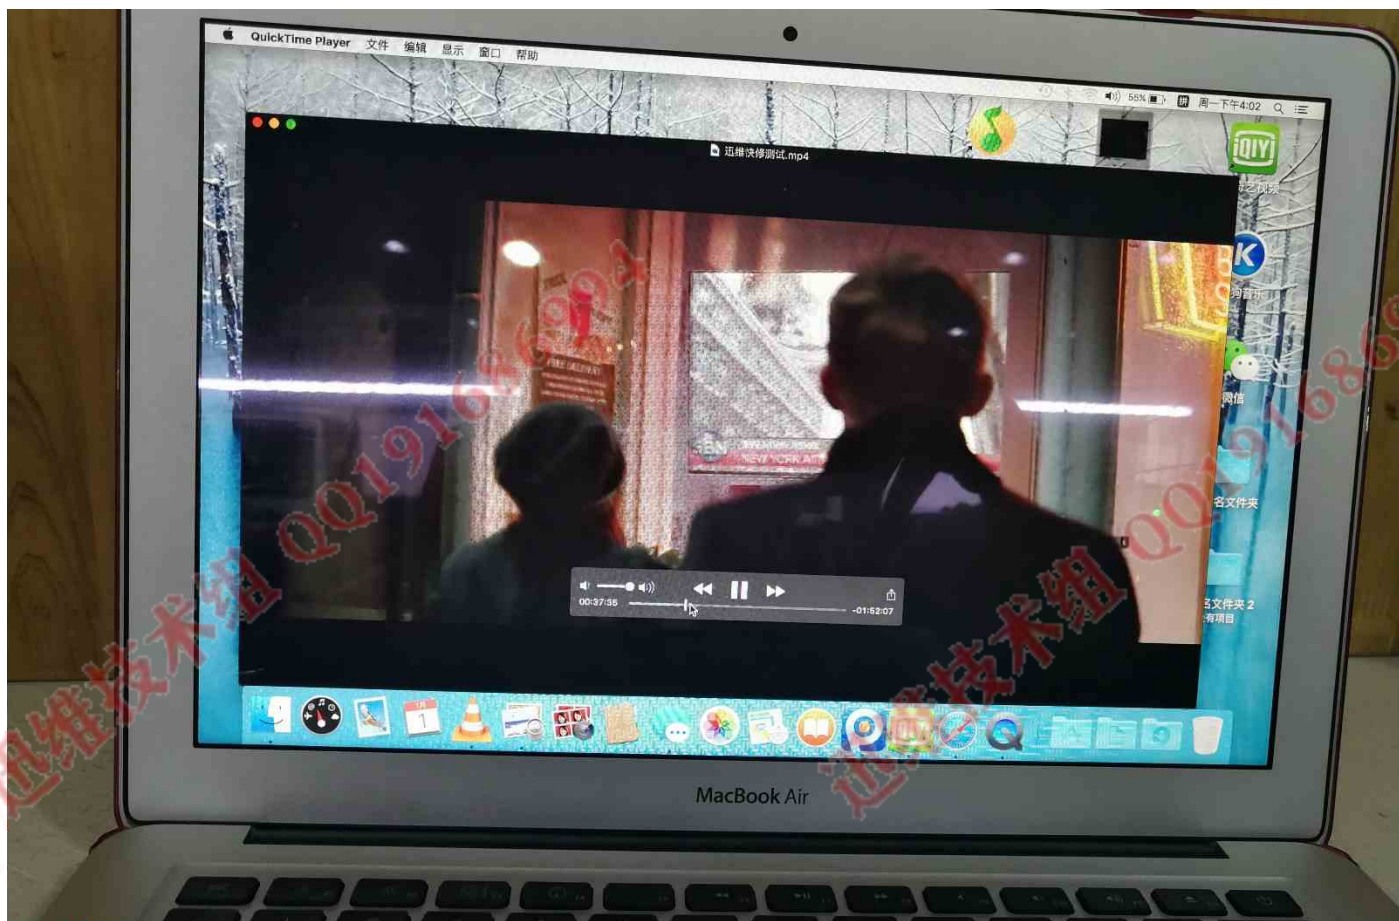
After processing, the power-on does not trigger automatically, but the upper battery has a slight current of 100MA, which seems to be charging, so after waiting for a while, the current jumps to 3A and seems to be charging

Electricity is normal.

When the battery is charged for a while, press boot again, which has started normally.
