## Assessment – Post-Trip Report

<b>Executive Summary</b>	
<b>Community:</b>	Kibuon
<b>Country:</b>	Kenya
<b>Chapter:</b>	Harvard SEAS Chapter
<b>Submittal Date:</b>	8/20/2019
<b>Authors:</b>	Billy Koech, Tatheer Adnan, Marwah Sabrah, Nicole Trenchard, Gavin Rees, Nisheet Reddy EIT, Christopher Lombardo
<b>REIC and other mentors:</b>	Christopher Lombardo (REIC, Faculty Advisor), Nisheet Reddy EIT (Travel Mentor), Avery Meyer EIT (Mentor)
<b>Scope of Work for the project (50 words)</b>	The Kibuon community consists of about 1600 members. Due to the lack of a nearby clean water source, community members in Kibuon travel long distances to collect water from nearby springs. This spring water is unclean and often leads to sickness in the community. The project aims to construct a water provision system, such as a well, within the community in order to address the need for safe and accessible water.
<b>Scope of Work for the trip (100 words)</b>	In the assessment trip: 1) The project team members met with the Community Based Organization to discuss the Project Partnership Agreement with the residents and the 5% community contribution, 2) Project alternatives were looked into and the corr

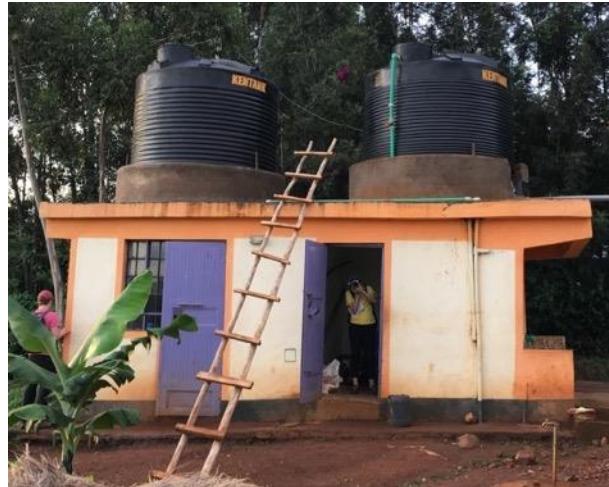
Figure 5.8: Kuria Tank Stand

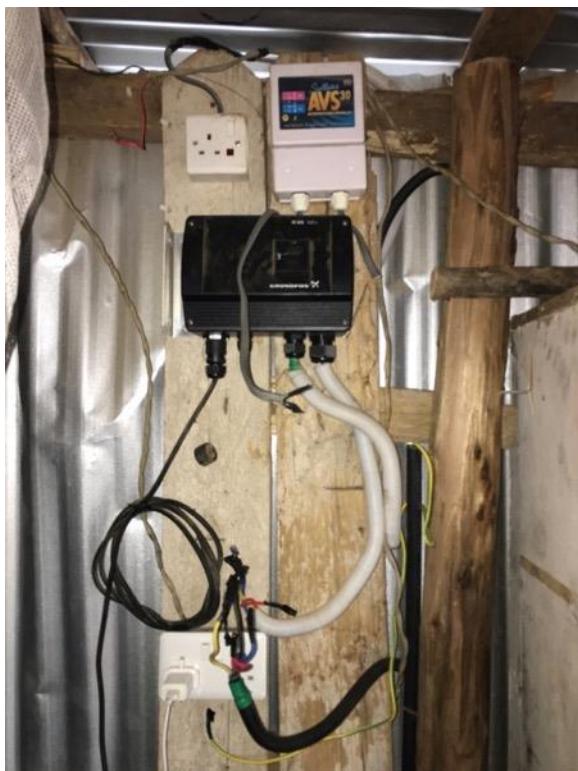
Figure 5.9: Electric Pump & Well

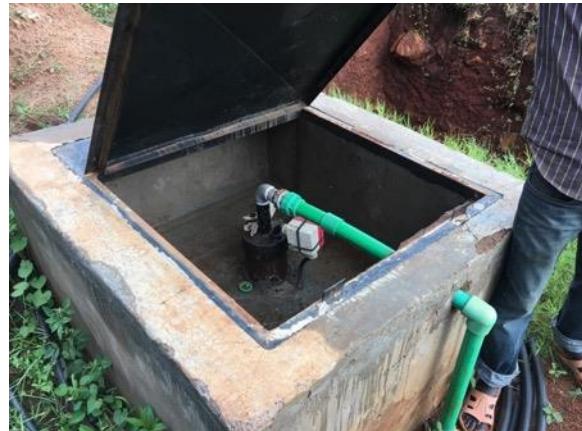
Figure 5.10: Private Electric Pump Installed by WECCO

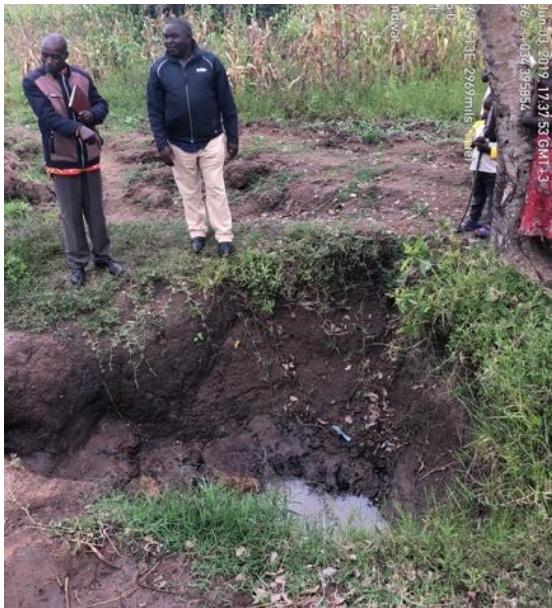
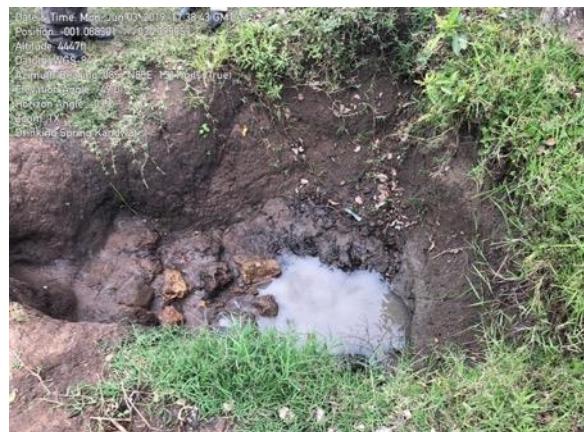
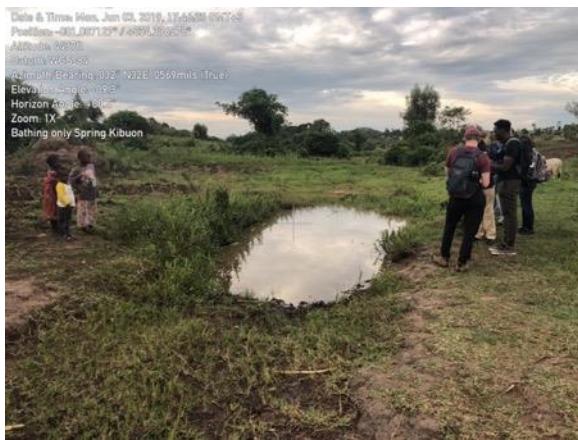
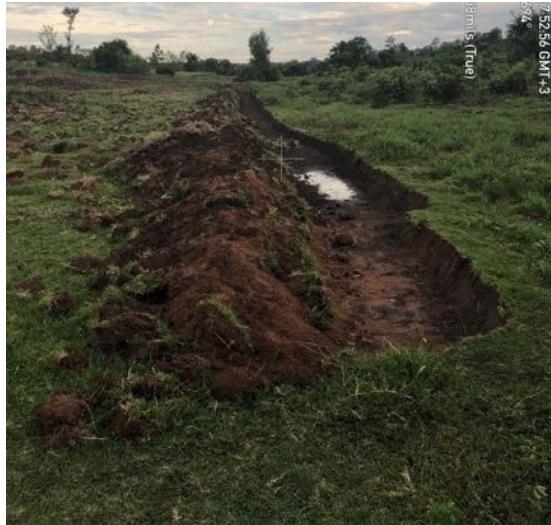
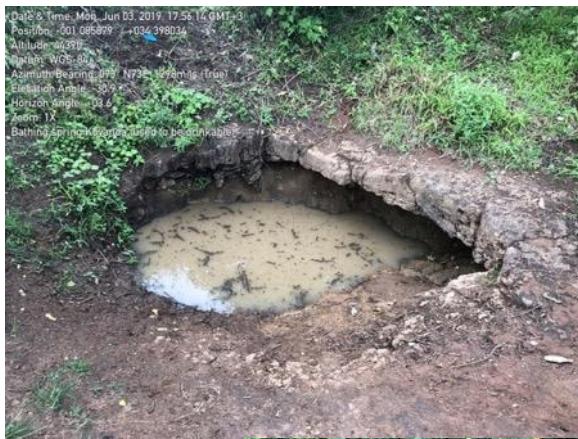
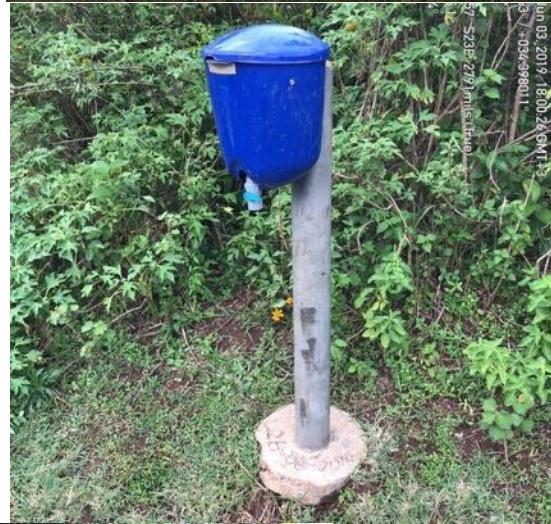
**Water Quality:** The spring water sources failed the test for appearance and quality; most sources had seemingly brown water- see appendix 5.2.3.6 (photographs). Chemical and biological test results can be found in appendix 5.2.1.

Figure 5.12: Springs seen on 6/3

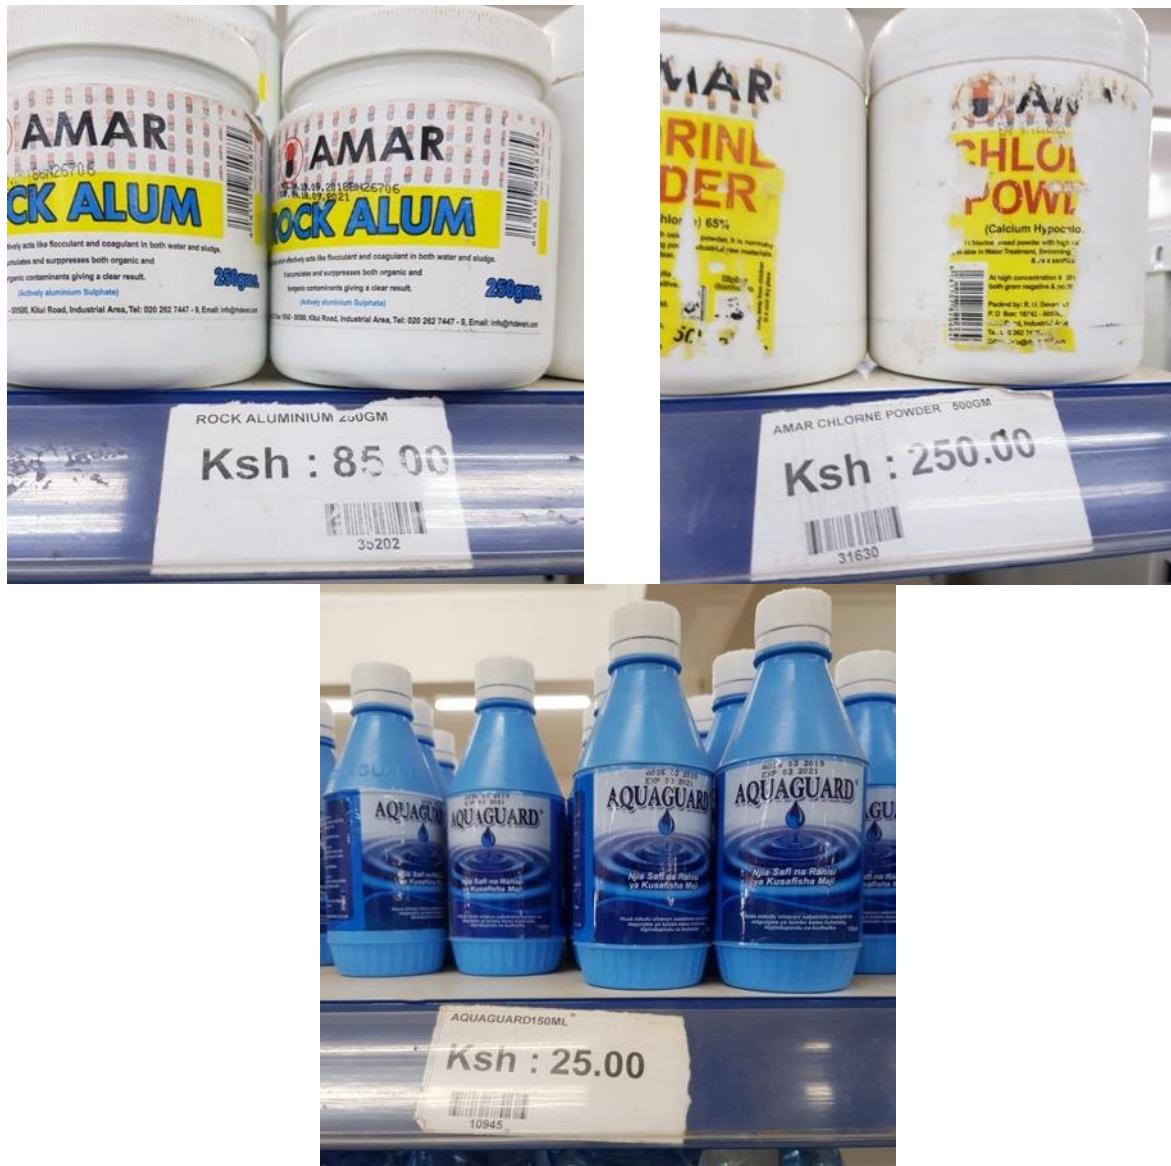
*Figure 5.14: Water Treatment Methods available at Grocery Store in Migori*

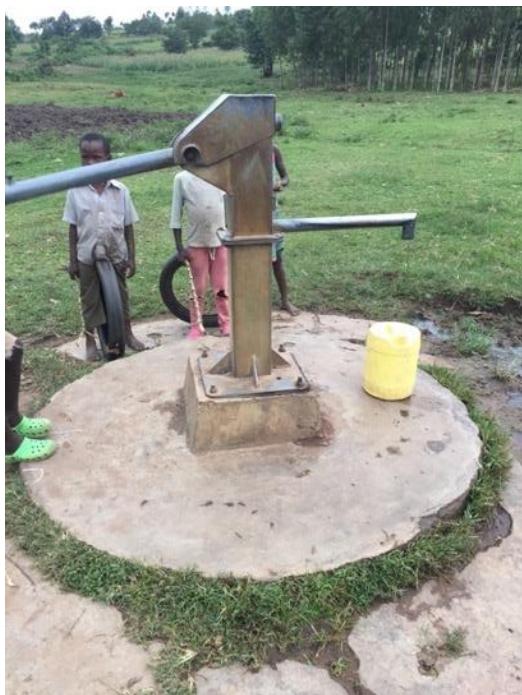
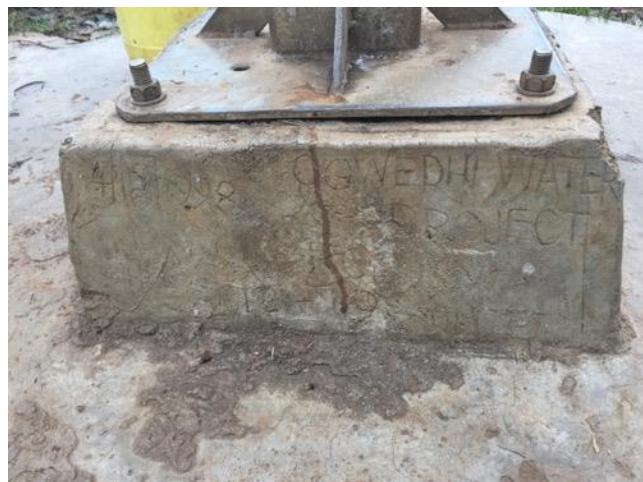
*Figure 5.16: Bondo Well Assessment*

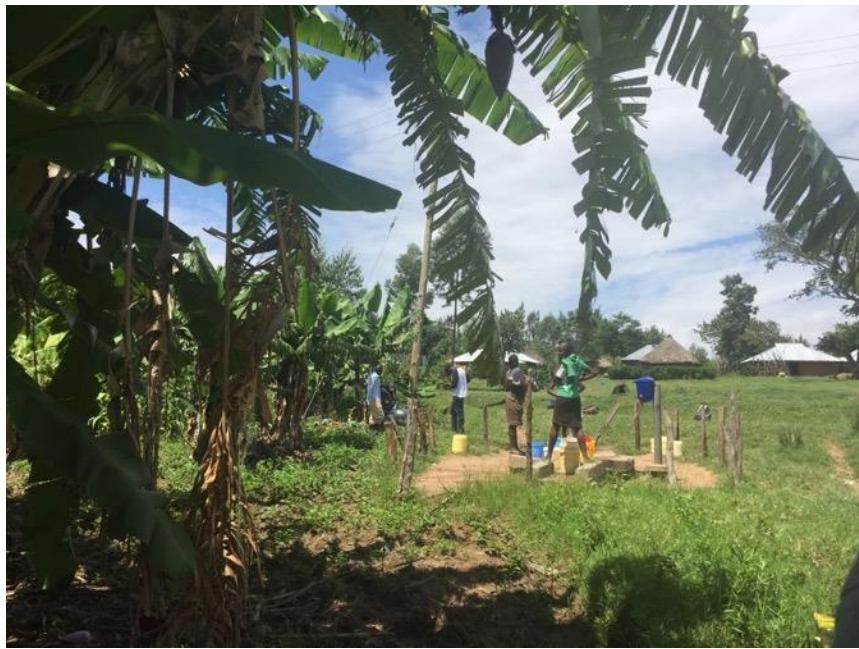
Figure 5.17: Bondo Hand Pump Assessment

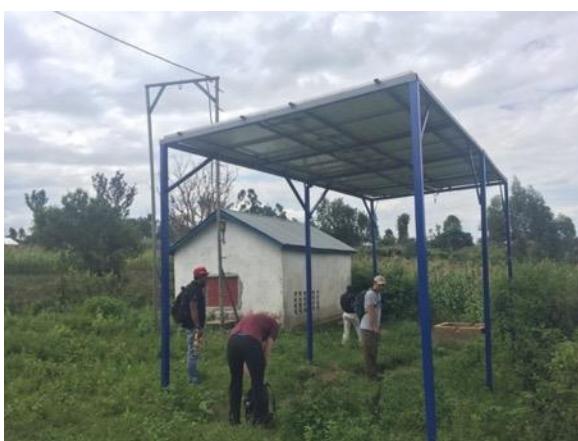
Figure 5.18: Municipal Tank & Pump

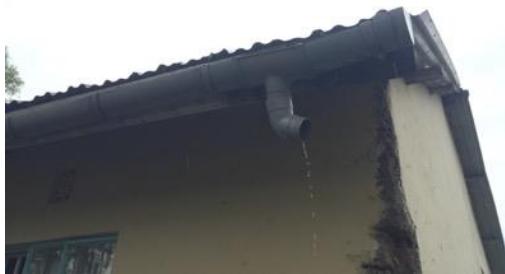
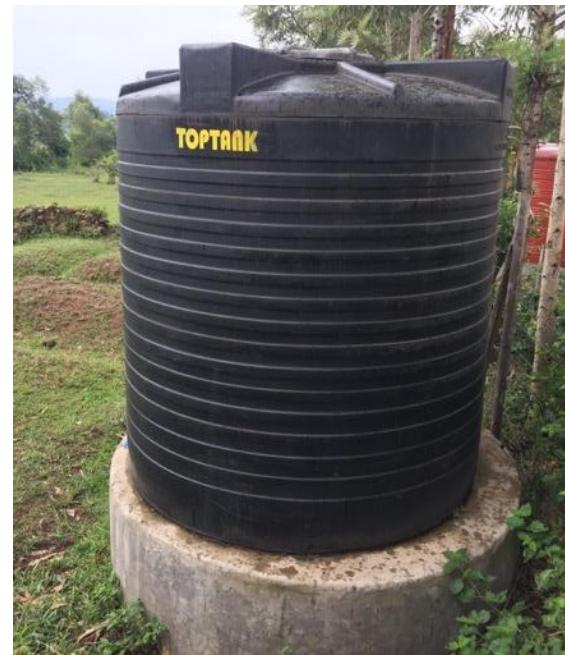
*Figure 5.21: Images of the damaged rainwater catchment system at the Lela Dispensary that serves as the only consistent water source for the clinic.*
