# METCALF SEPTIC SERVICES

## SEPTIC INSPECTION REPORT

38 Forest Knoll Dr  
Weaverville, NC 28787

06/30/2026

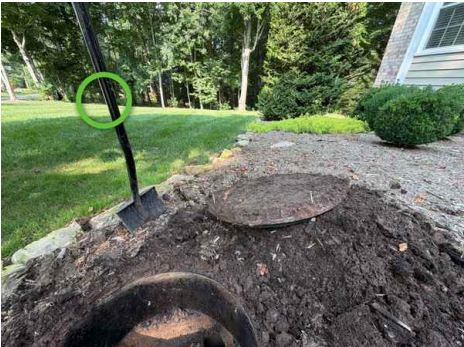
Well location

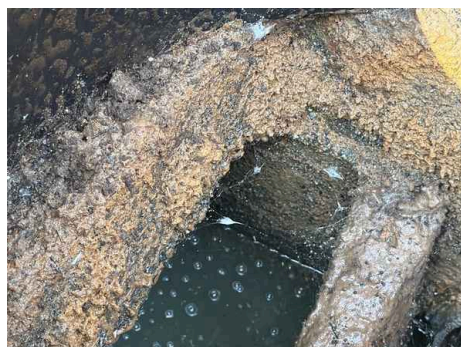
1000 gallons

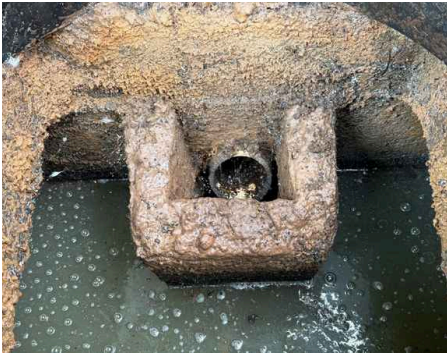
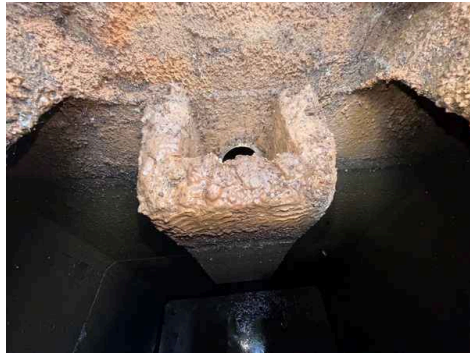
**Outlet T**

Concrete trap with pvc outlet

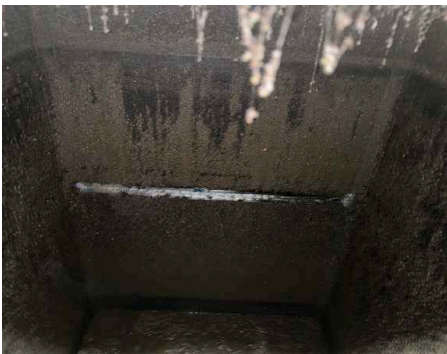
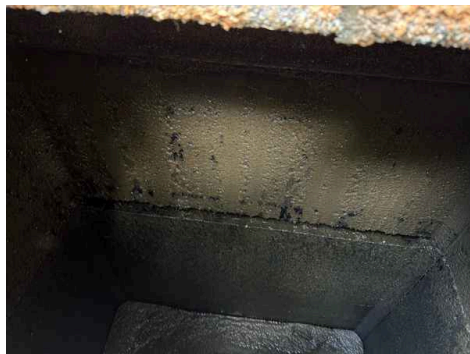
**Baffle wall**

Concrete, Intact

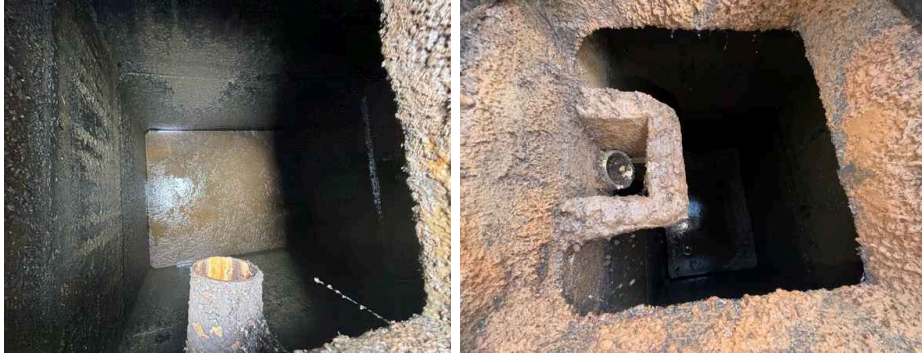
## Septic tank pumped

Yes - all tank compartments were pumped during inspection

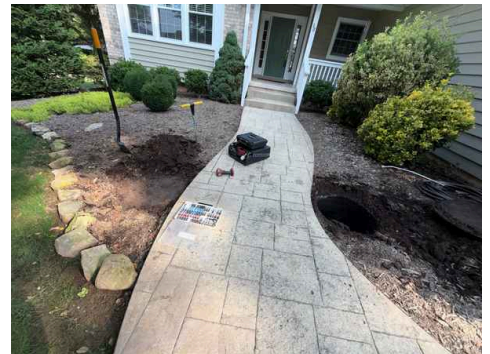
### 3.1.1 Exterior Components

#### GRADING/SURFACE OBSERVATIONS/DEFECT(S)

Rock walkway over top of septic tank

Grading repairs may be needed to prevent root damage and/or water infiltration into the tank. A septic contractor or landscaper can be consulted for repair.

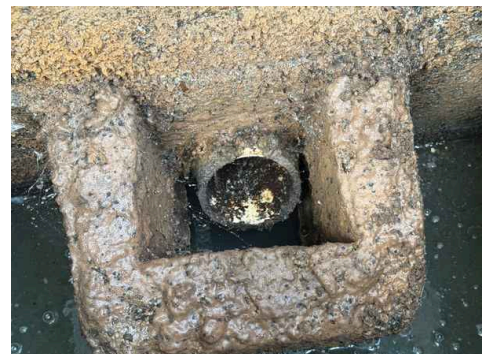
### 3.2.1 Interior Components

#### INLET/OUTLET PIPE DEFECT(S)

Too high, Outlet Pipe

The outlet pipe has settled causing it to be higher than it should be.

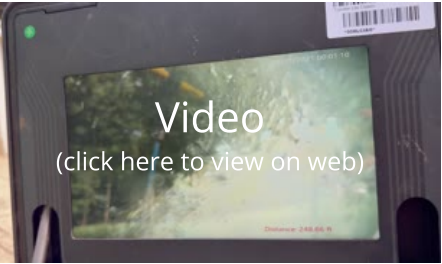
Overview Photos/Videos

Areas of the pipe after tank was observed to be offset or disconnected and could prevent proper flowing of the wastewater to the drain field. Refer to a septic contractor for repairs and maintenance.

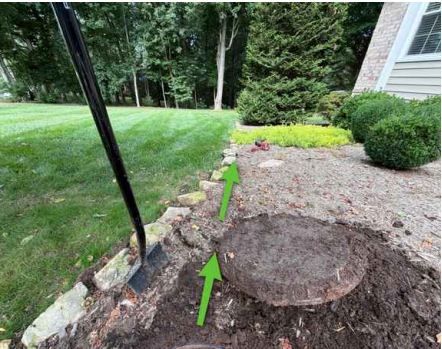
Pipe after tank location

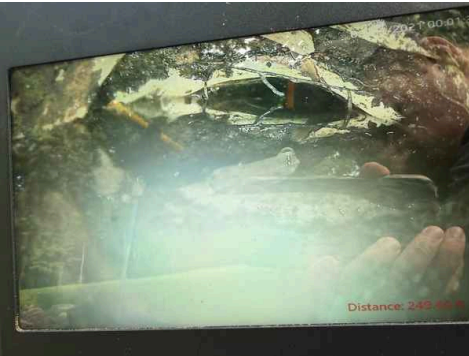
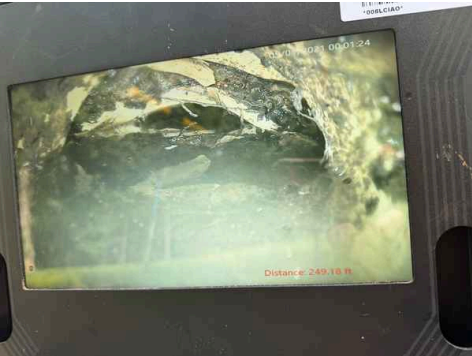
4.1.1 Pipe after tank

PIPE AFTER TANK DEFECTS

Pipe offset/disconnected
