NOTICE OF VIOLATION

ALICO RESORT AND WATERPARK

REPORT ON THE INSPECTION AND EFFLUENT SAMPLING CONDUCTED AT ALICO RESORT AND WATER PARK, BLANCA AURORA, SAN JORGE, SAMAR IN COMPLIANCE TO

24 September 2021

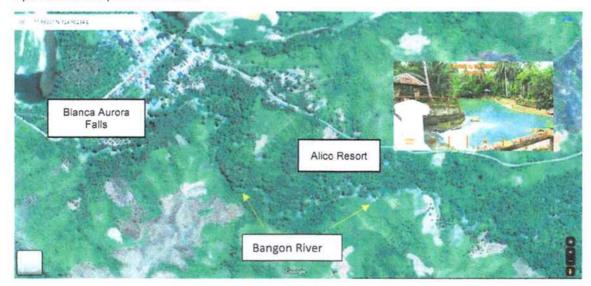
According to Ms. Alico, the resort has a total area of 10 hectares in which 4 hectares have been developed to date. Project development commenced in 2018; however, project was opened to the public in 2019.

The resort utilizes Bangon River as the primary contact recreation waterbody for tourists and guests. Bangon river traverses the resort premises. It is unclassified but is primarily used for contact recreation. Downstream of the river is the location of Blanca Aurora Falls, a tourist destination in the barangay.
