# Tractor ECU RE:

# When a "Noise-Triggered" Recall is Also a Security Patch

Safety-Impacting vulns patched in the recall of  
~450,000 Trucks via SAE J2497 (PLC4TRUCKS)

**Ben Gardiner**  
NMFTA Inc.

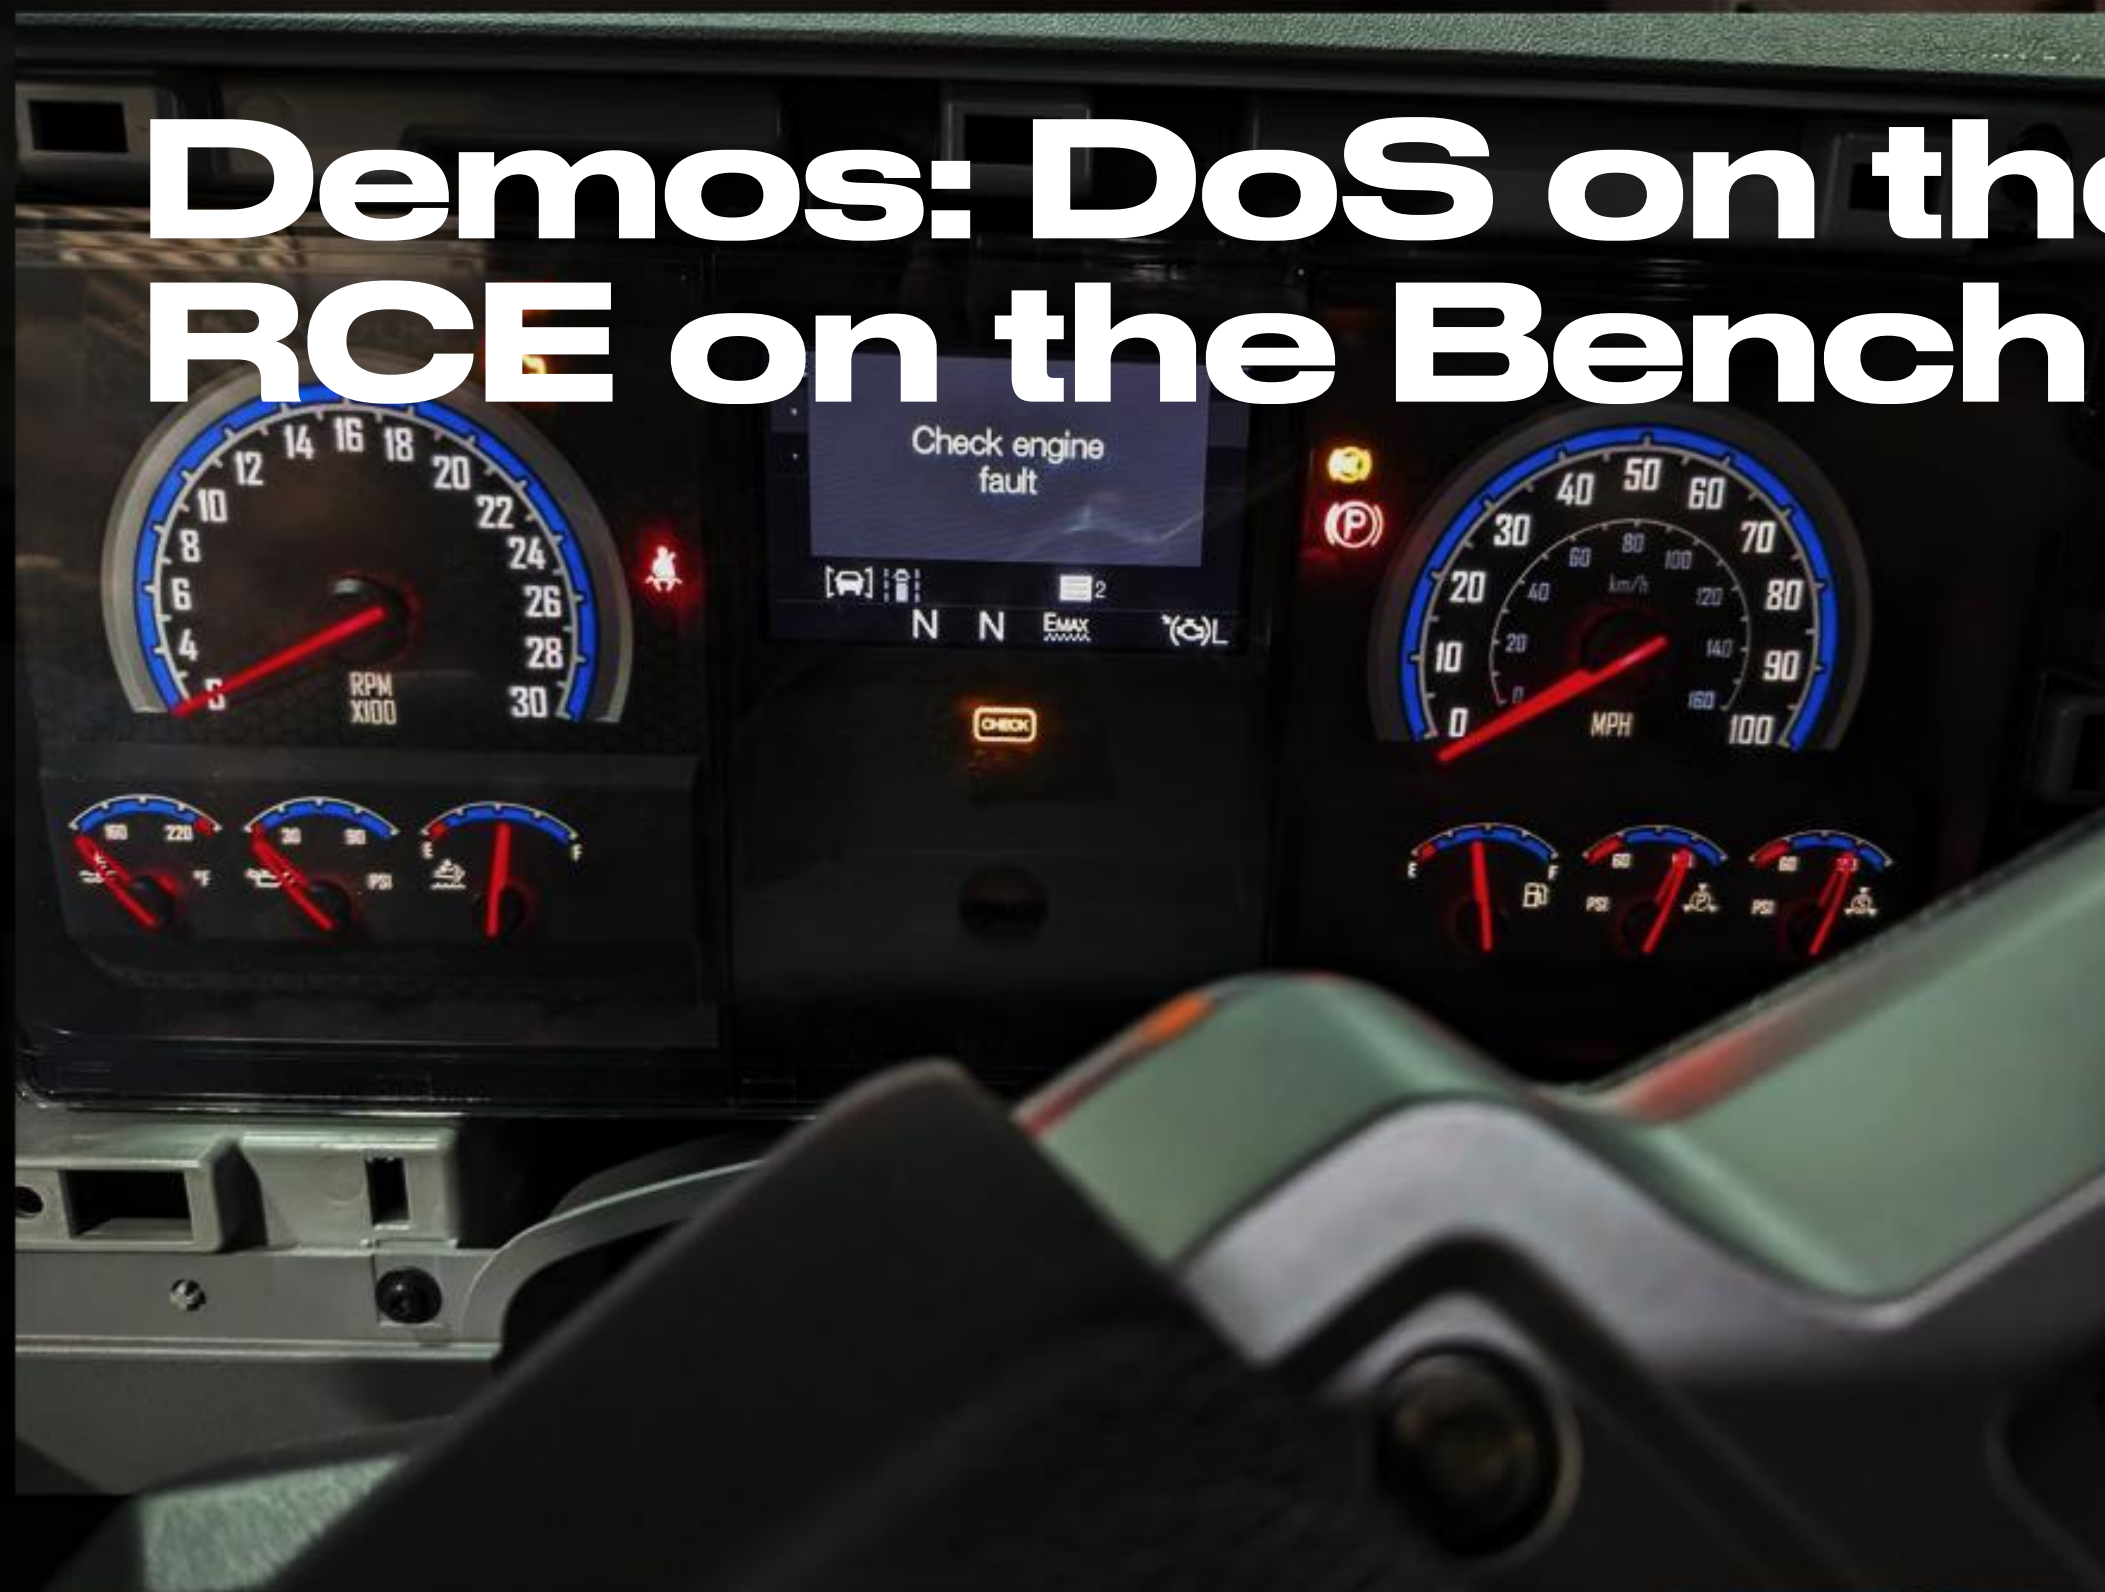
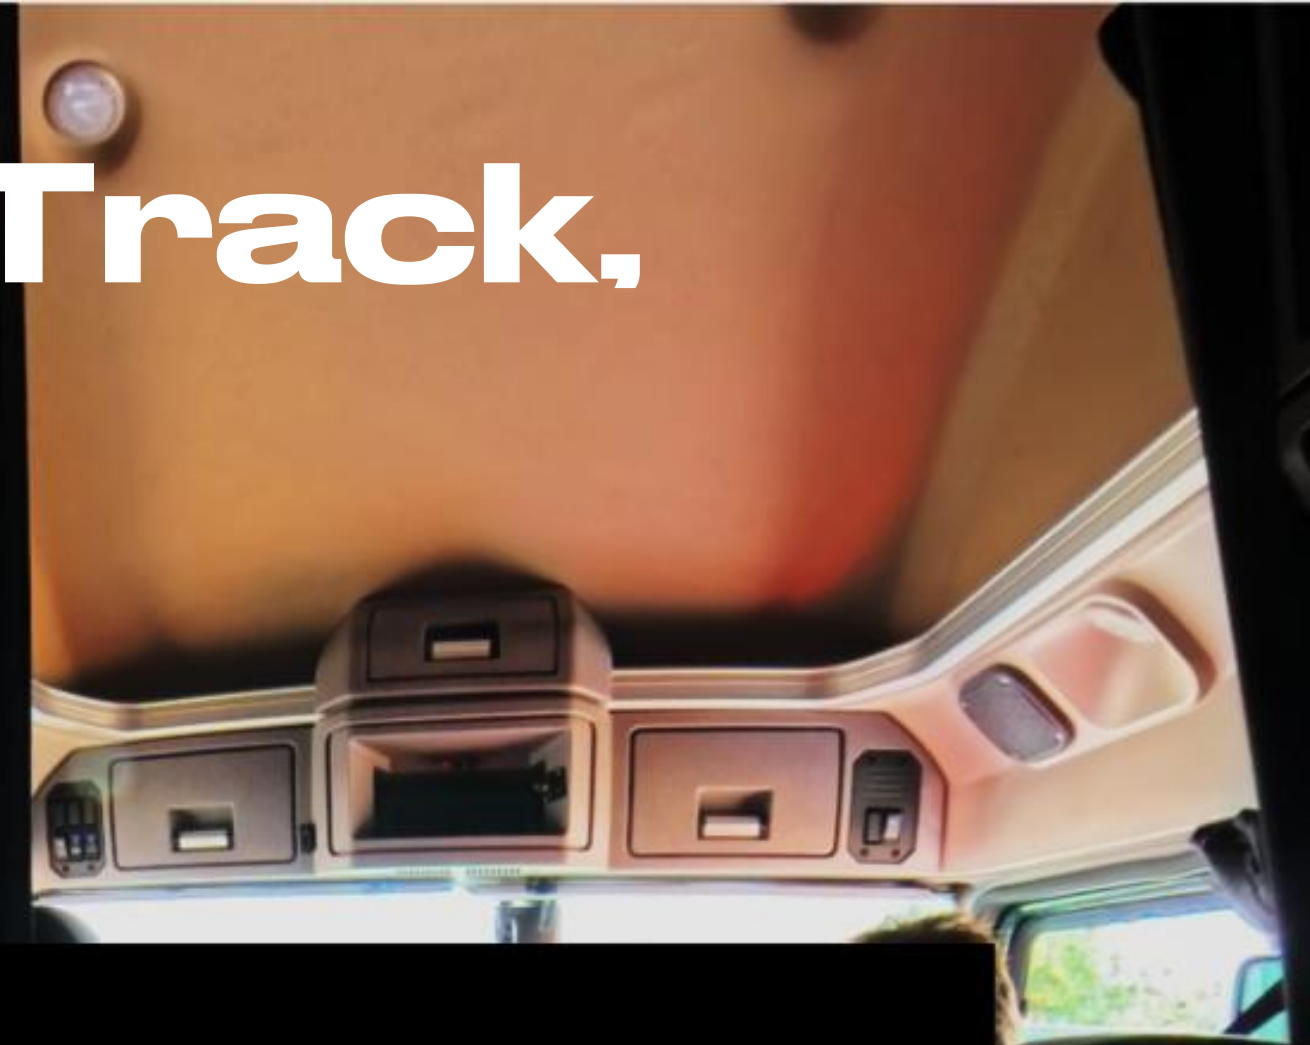
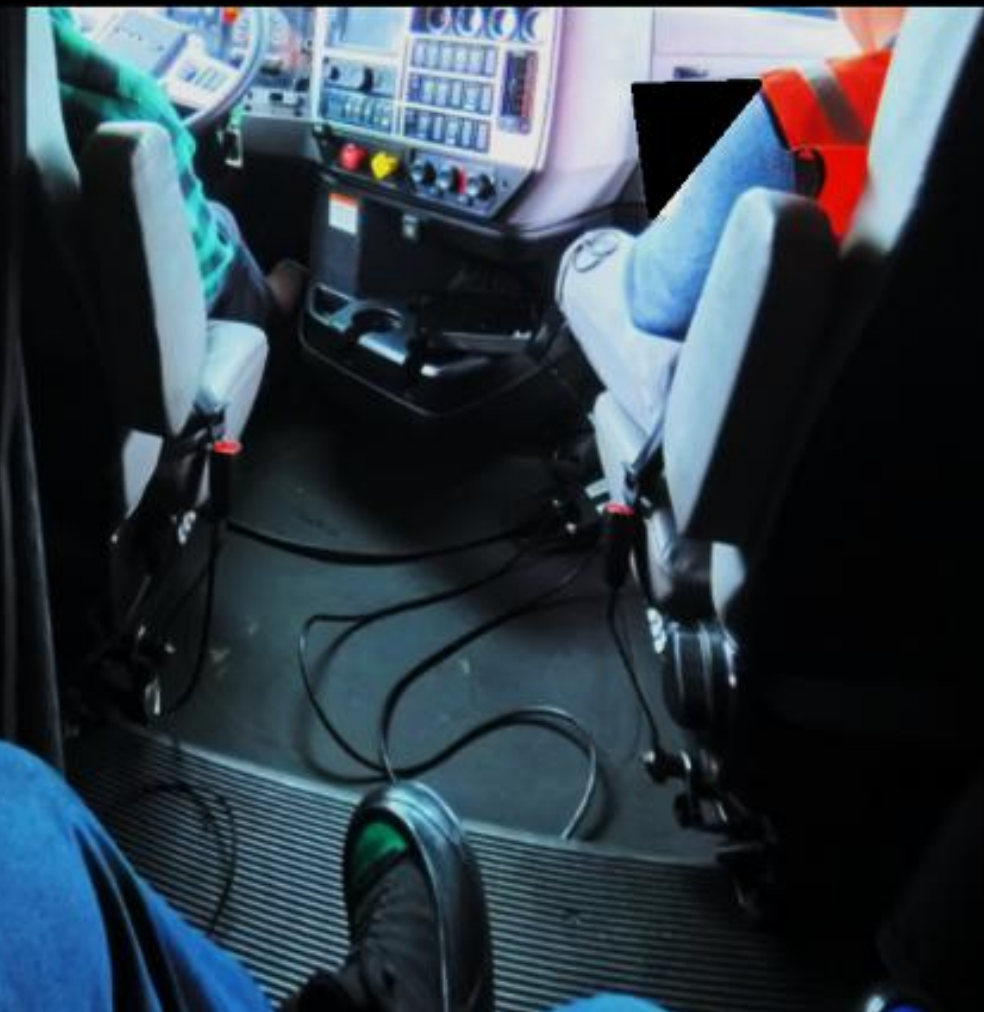
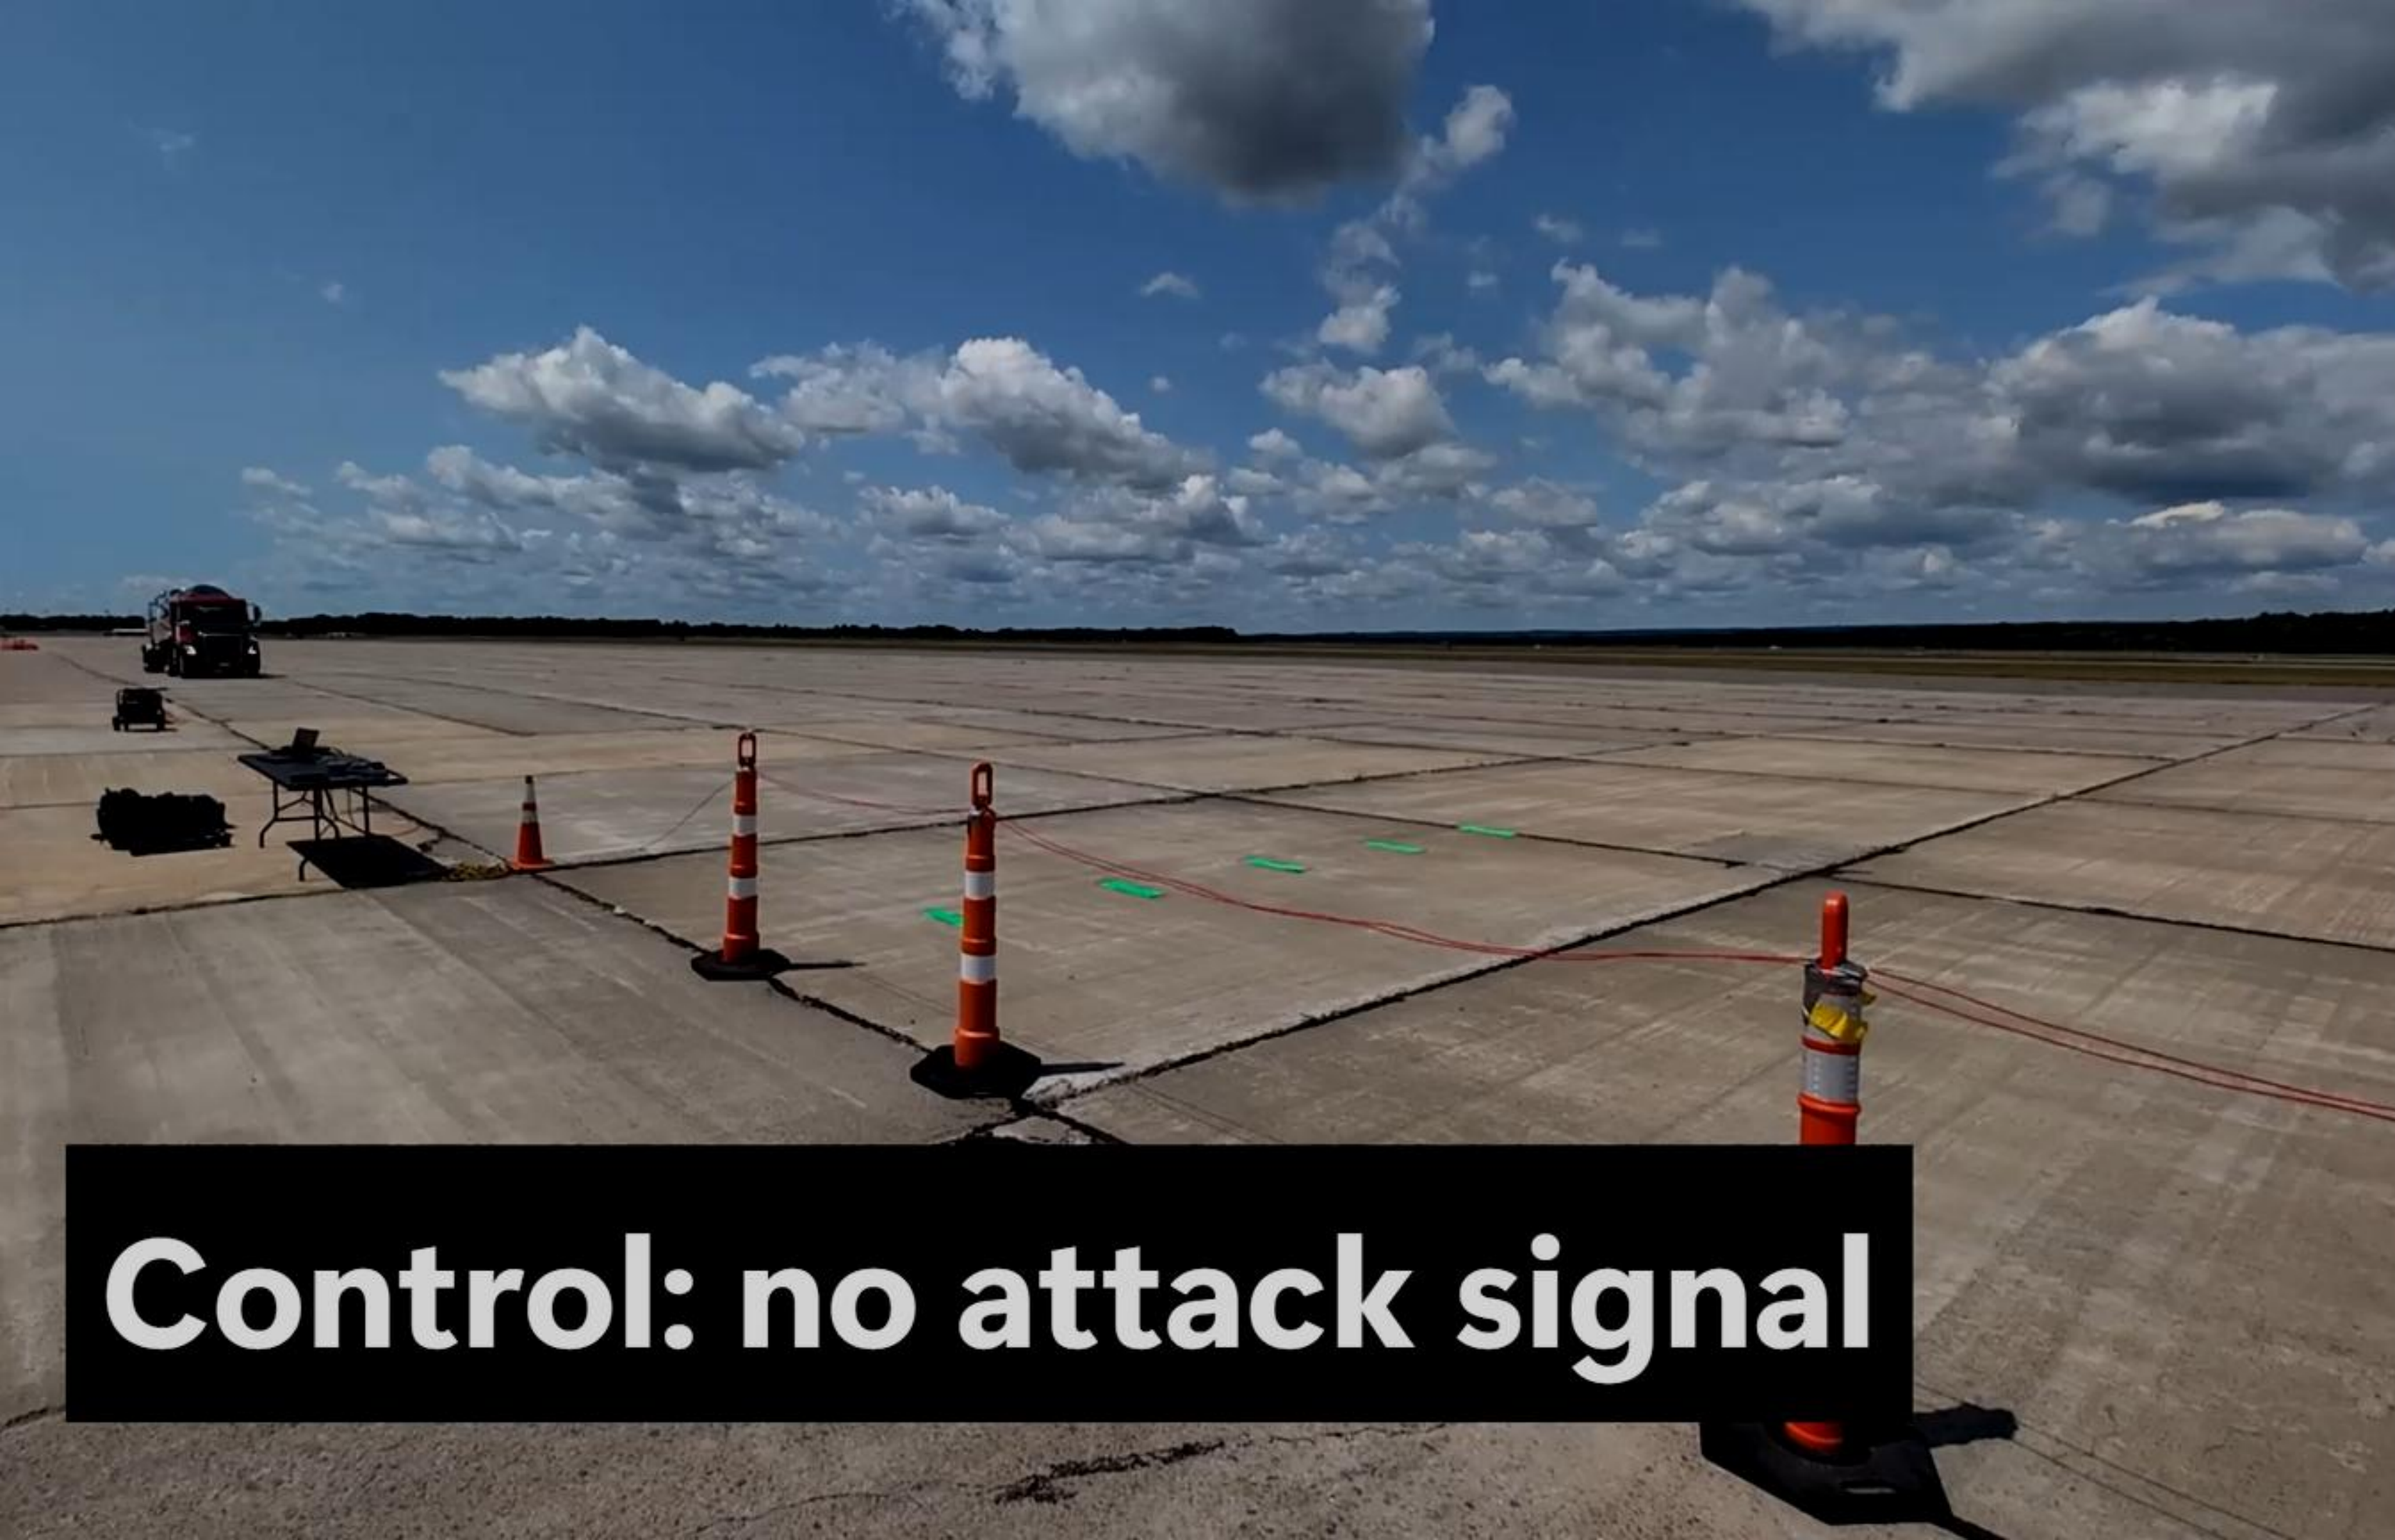
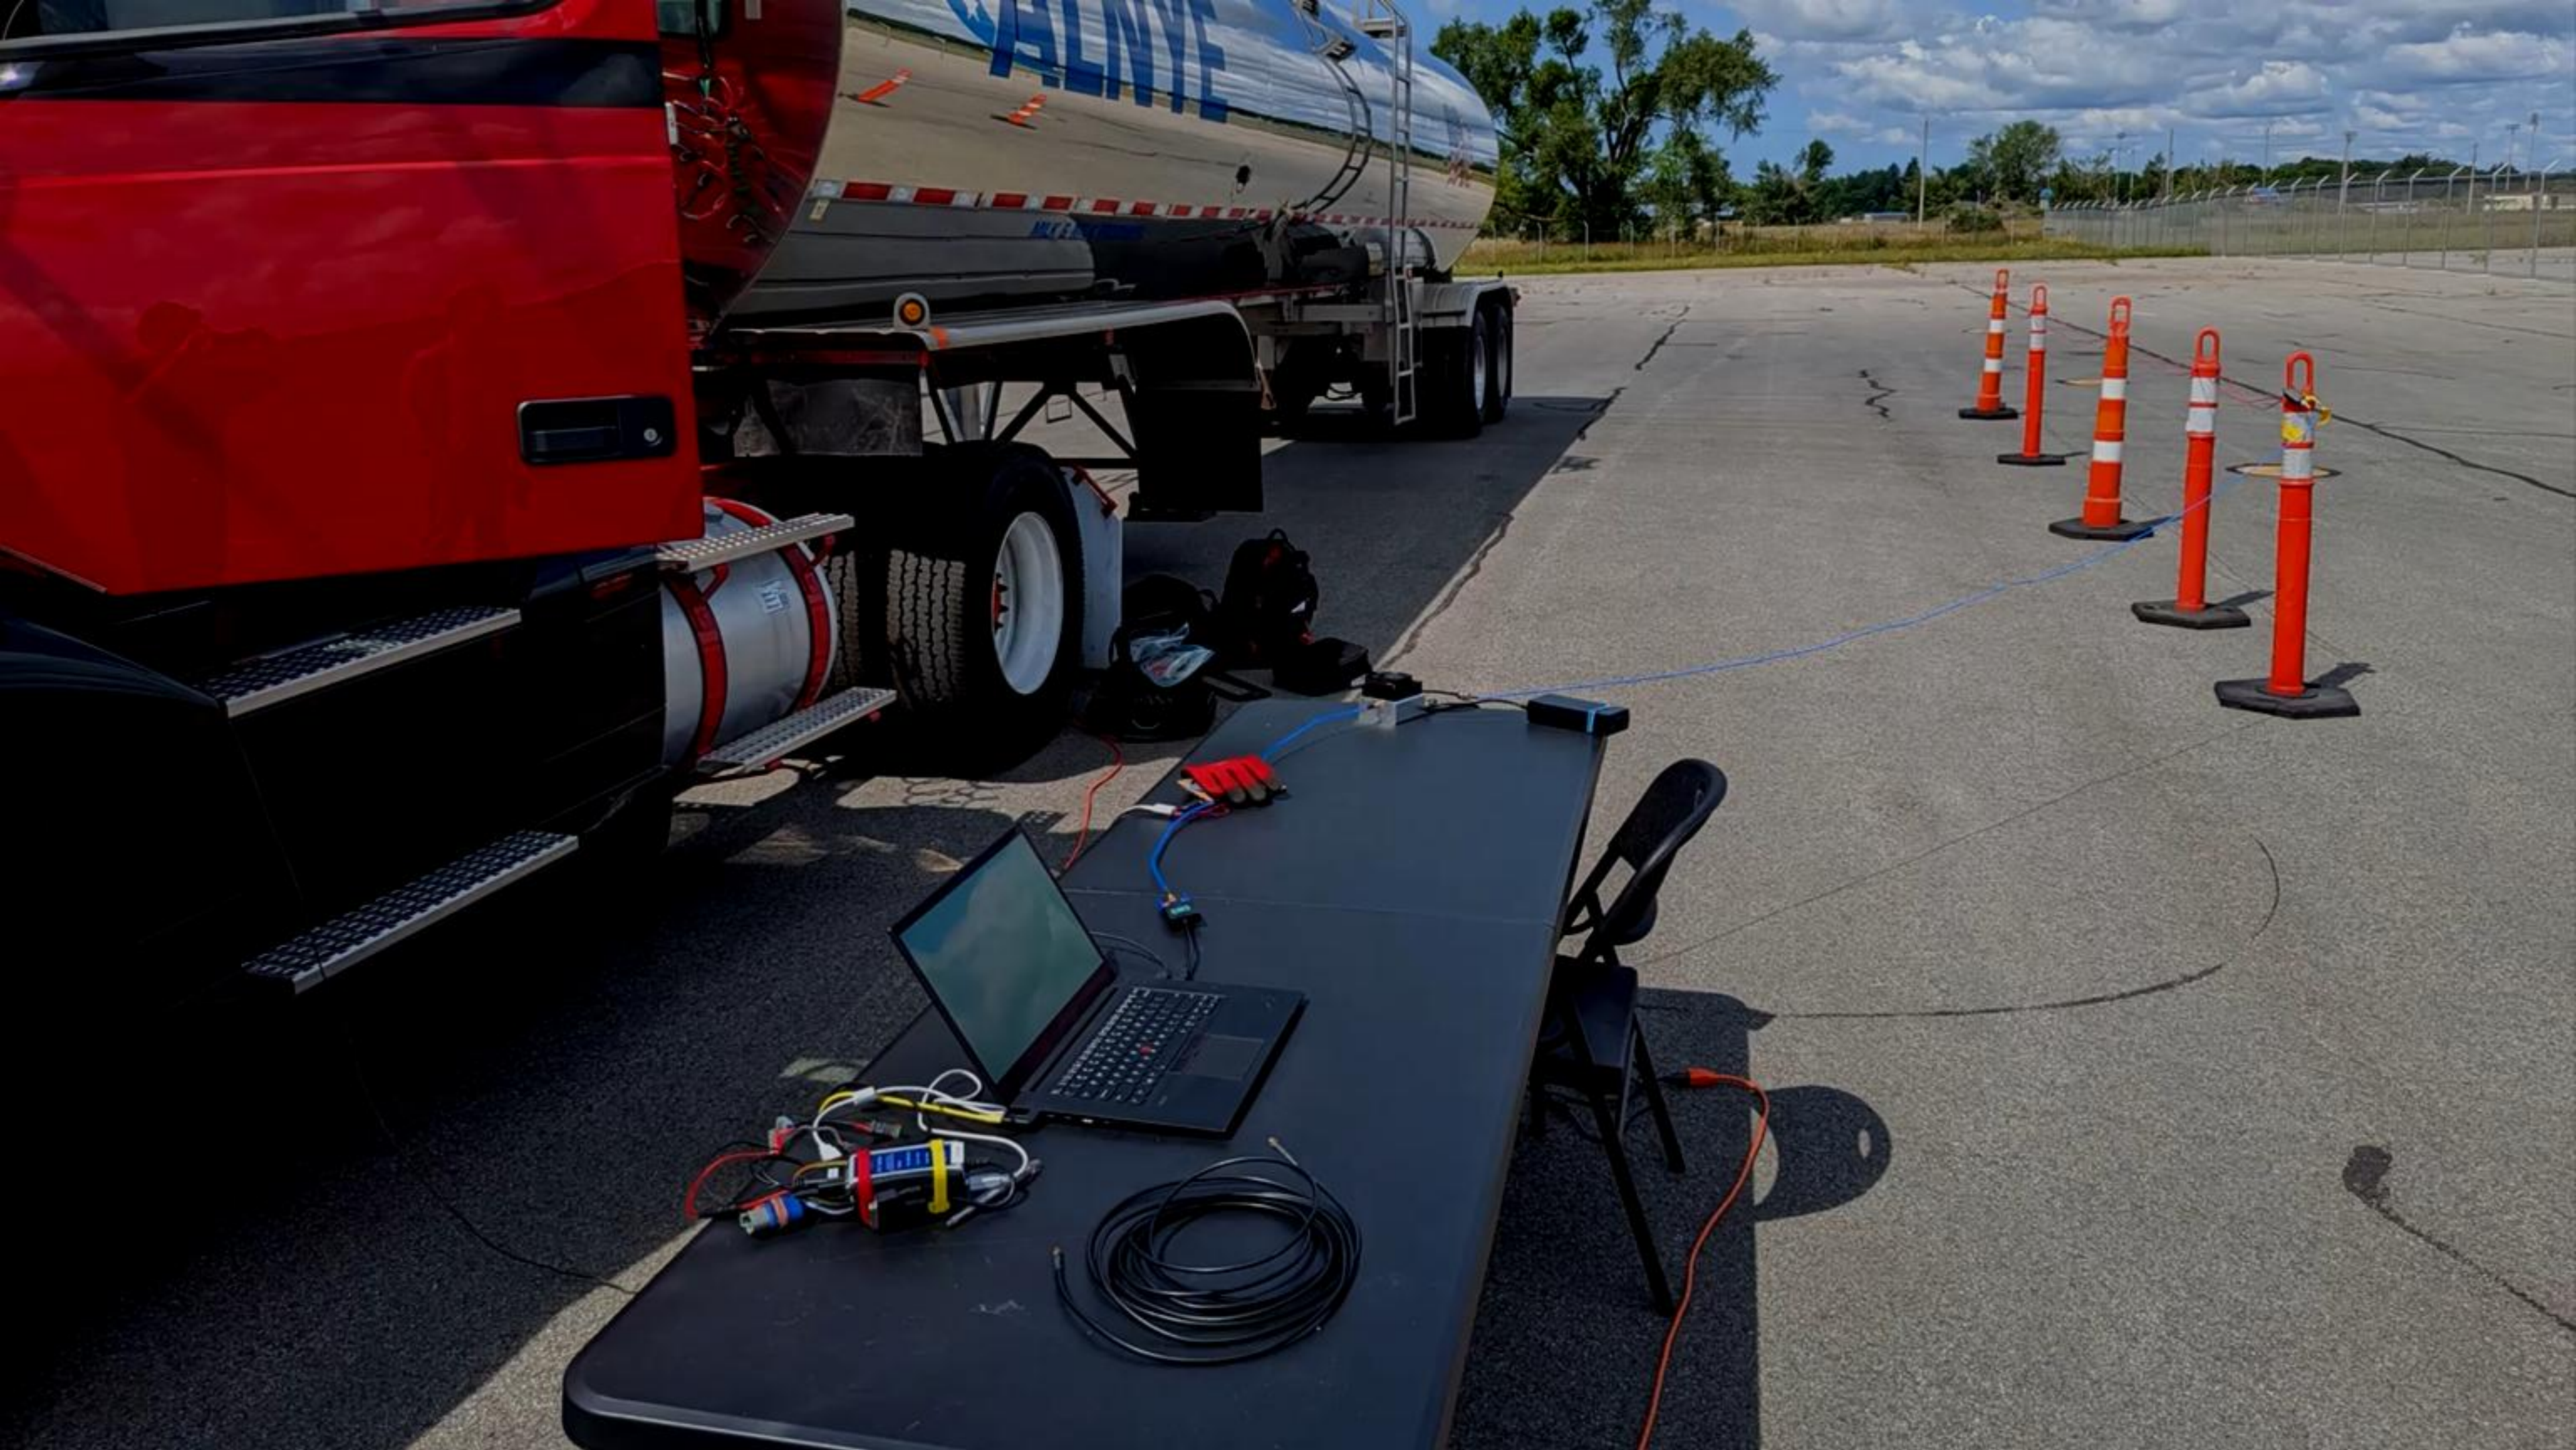
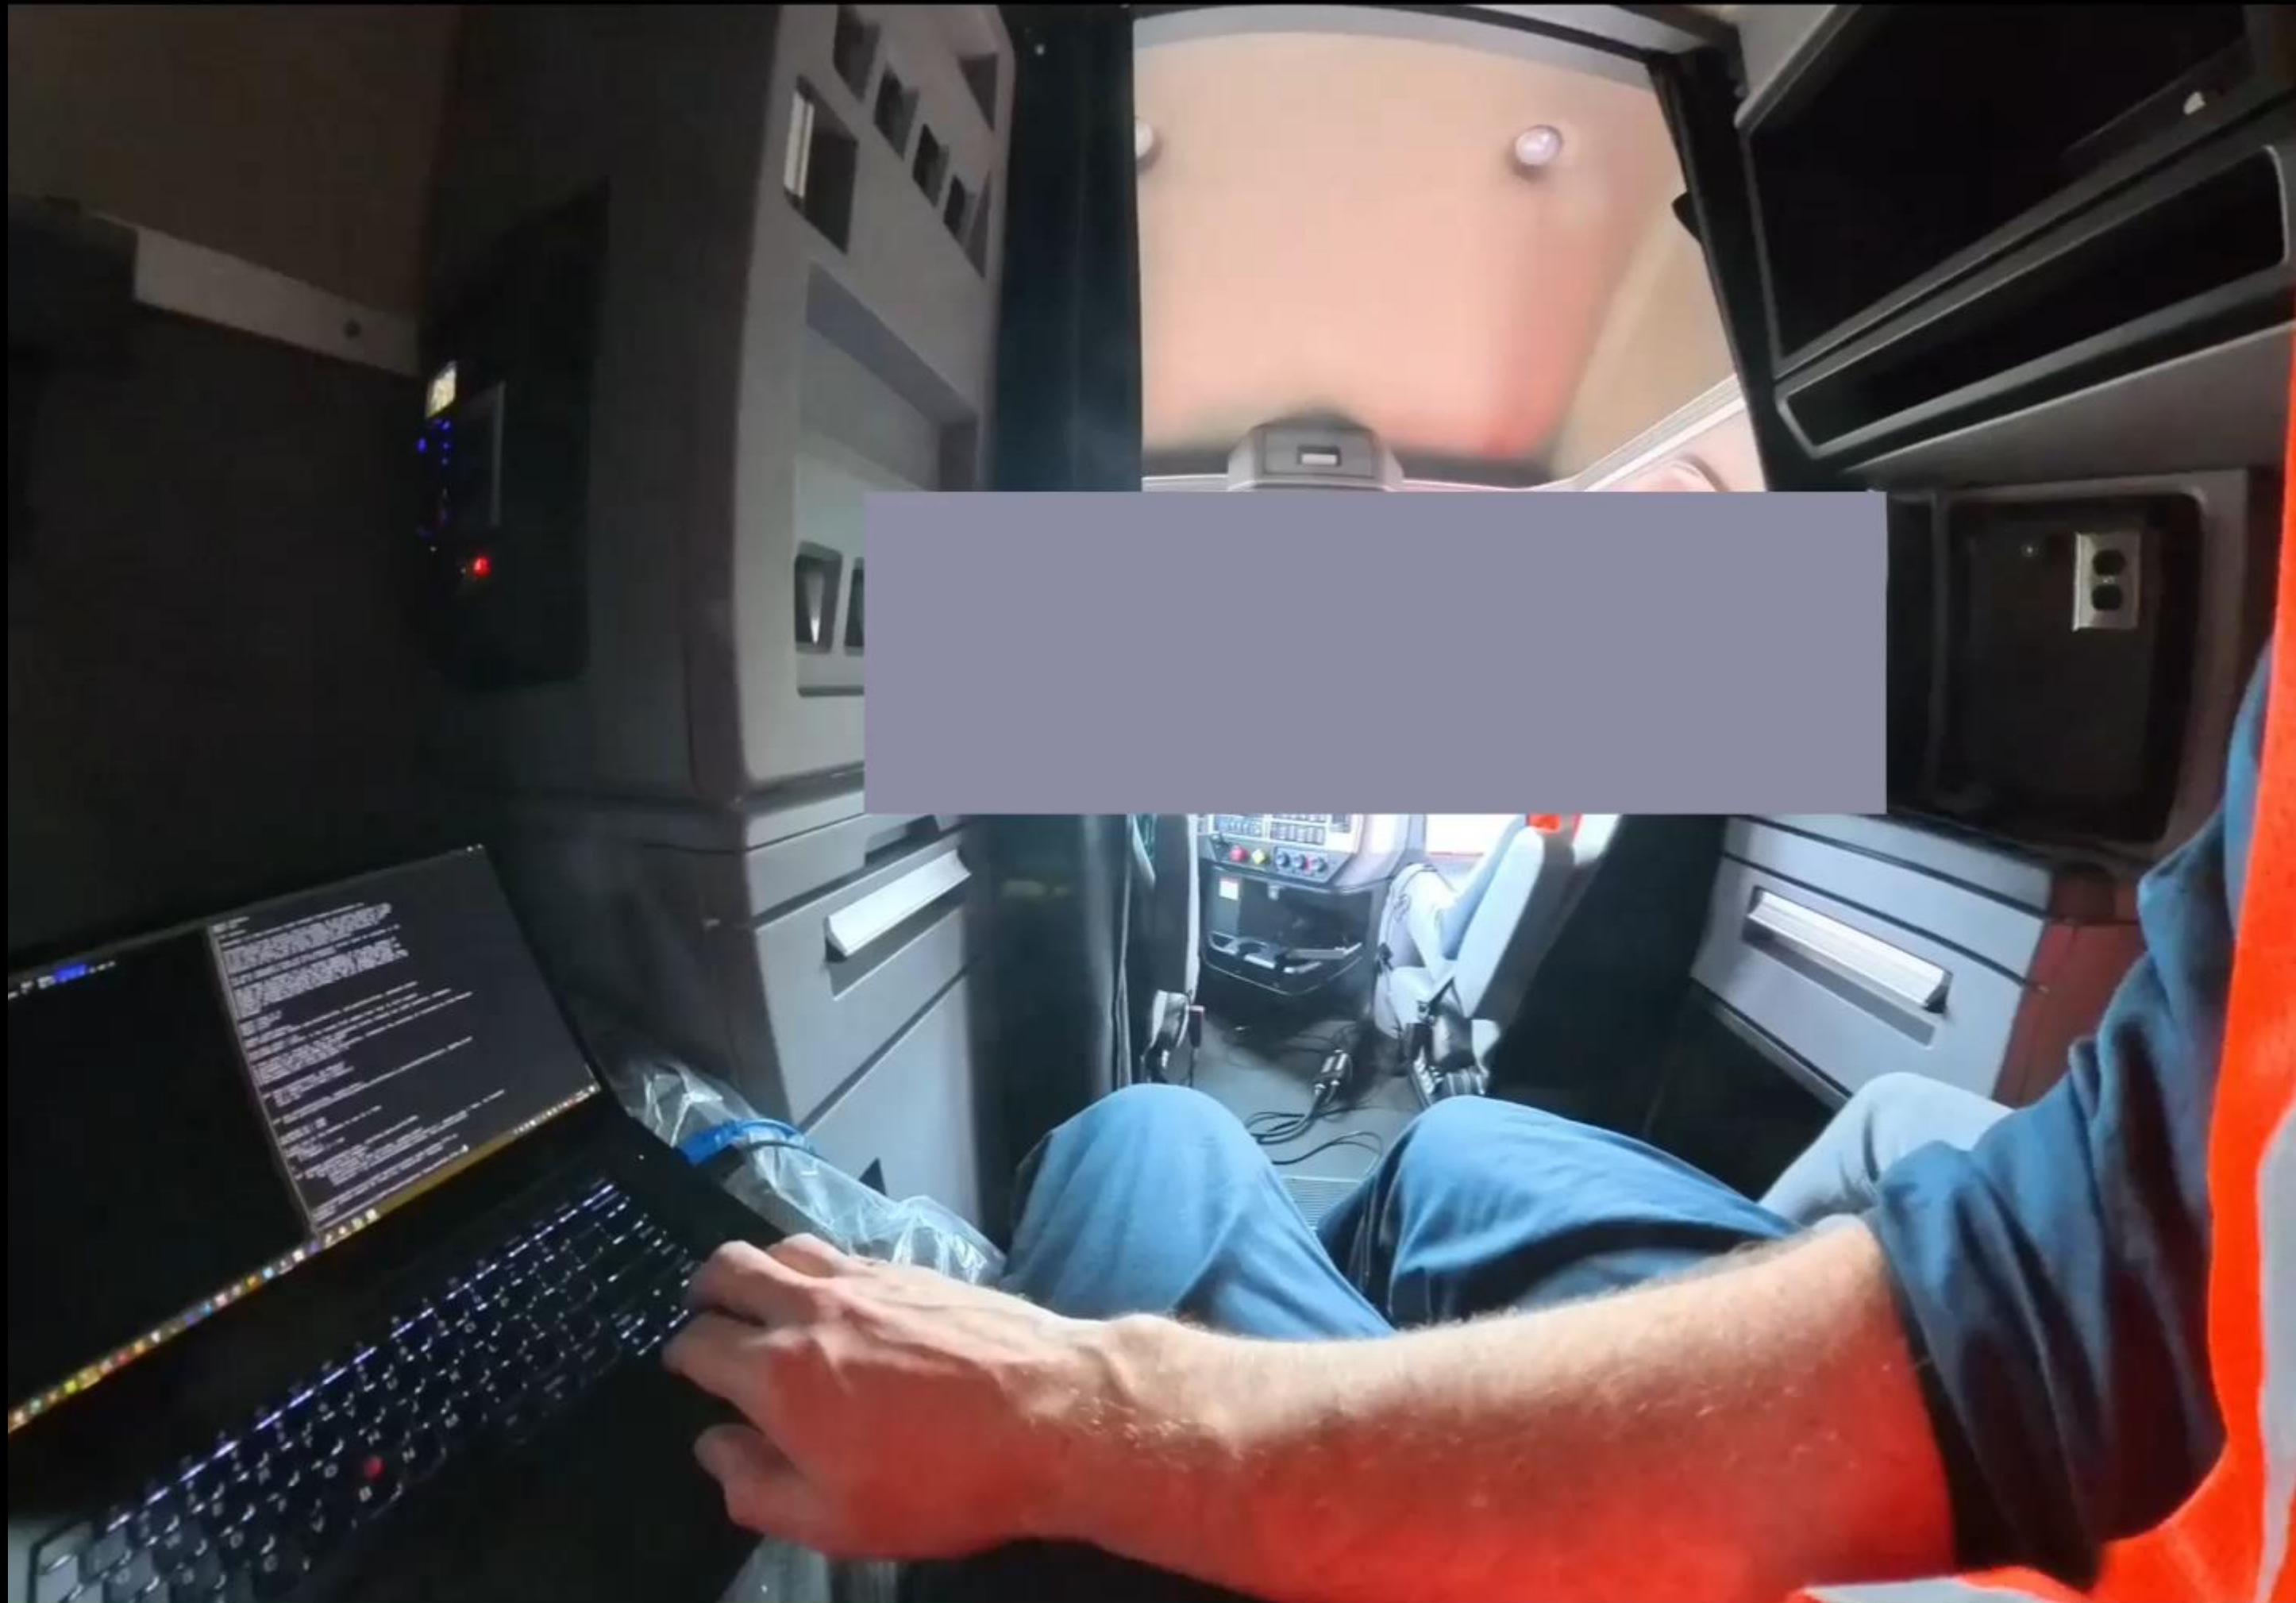
# Demos: DoS on the Track, RCE on the Bench

**Control: no attack signal**
