Master project in Civil Engineering

**Evaluation and retrofit of the
St. Lawrence Parish House in Petrinja
that was damaged during the 2020
earthquakes in Croatia**

Aline Florence Bönzli

Lausanne, EPFL 2024

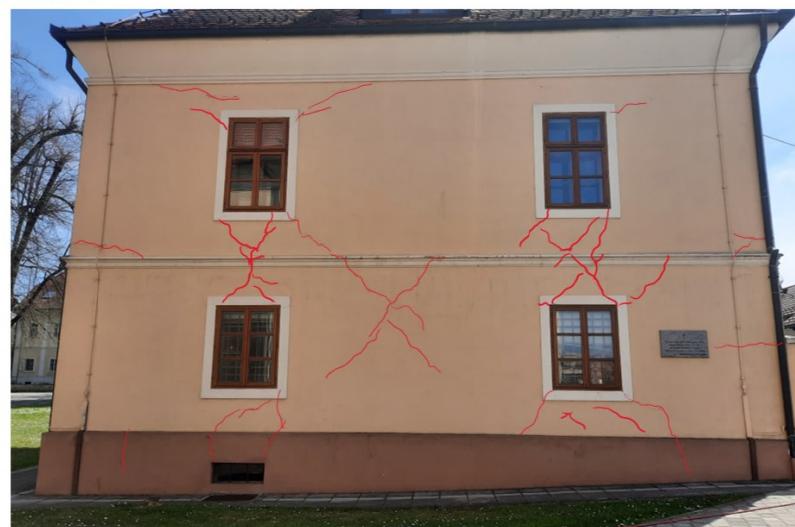
North Facade

Number	Description	Localization	Associated mechanism	Label	Connected cracks
1	Diagonal cracks	Starting from either top corner of the top east window	Cracking due to flexural mechanism with lifting off of the roof	NF1	FF7
2	Diagonal crack	Starting from the top west corner of the west top window and bottom east corner of top west window	Flexural crack due to force from south	NF2	FF21
3	Horizontal crack	Starting at the east extremity of the facade, at mid-height	Flexural crack from a global mechanism bending the whole facade or shear crack from a stress concentration in the corner of the building together with crack n° 11 on east facade	NF3	EF11
4	Diagonal spandrel cracks	Between the east side windows	Shear cracks / spandrel cracks	NF4	NF5 / NF6 / NF7
5	Diagonal cracks through the	Center of the facade	Shear crack in between the pier and node zone -> might be difficult to achieve in simulations?	NF5	NF4 / NF6 / NF7

6	Vertical/Diagonal cracks	Starting from the bottom corners of the top west window	Cracking due to a possible OOP mechanism in the spandrel below the top window. Due to the lower vertical load and no restraining slab on top this part of the wall is sensible to OOP bending.	NF6	NF4 / NF5 / NF7
7	Diagonal cracks	Above bottom west window	Shear crack in spandrel	NF7	NF4 / NF5 / NF6
8	Diagonal crack	Starting from the top west and bottom east corner of bottom west window	Flexural or shear crack due to seismic excitation towards the the east	NF8	
9	Horizontal crack	Starting at the west extremity of the facade, at mid-height	Flexural crack from a global mechanism bending the whole facade or shear crack from a stress concentration in the corner of the building together with crack n° 1 on west facade	NF9	WF1
10	Diagonal cracks	Between the corners of the bottom east window and the cellar window	Spandrel failure in shear	NF10

11	Diagonal cracks	Starting from the bottom corners of the bottom west window	Shear cracks in spandrel	NF11	
12	Horizontal crack	Starting at the west extremity of the facade, at quarter-height (middle of bottom storey wall)	Corner stress concentration, might be in relation with ground floor crack 13 to cope with the out of plane failures GF14, GF15, GF18, GF19	NF12	GF14 / GF15 / GF18 / GF19 / WF3 / WF4
