# **Sample Documentation**

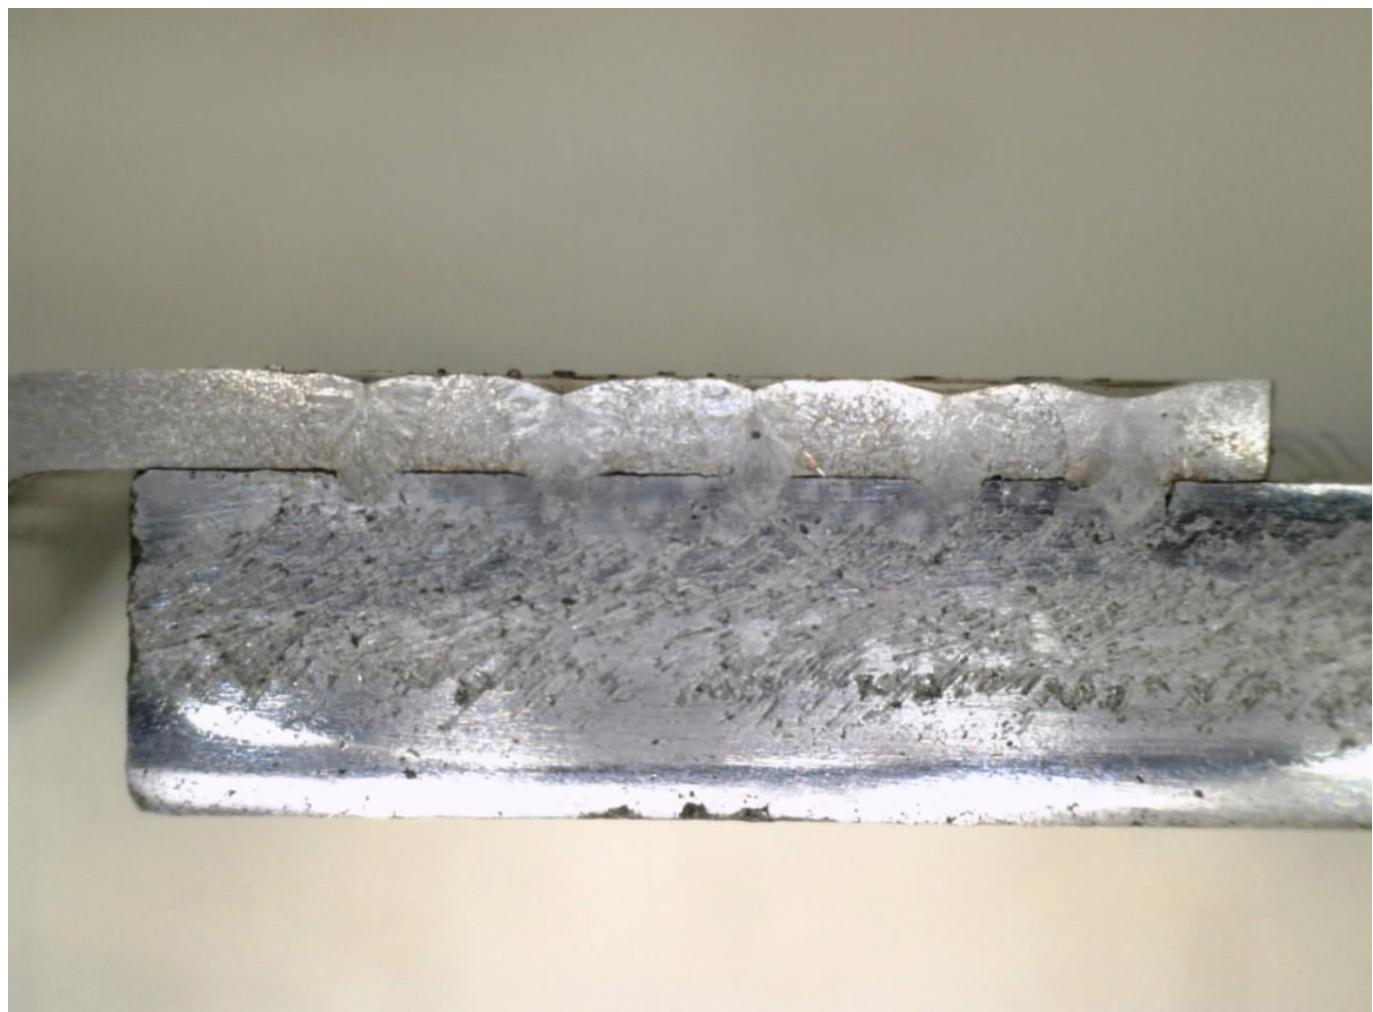
## Sample #2 Picture

This sample was welded the same as sample 1 except we went back and welded over the first row of spot welds in an attempt to nail the gap down further.

Results: Consistent Penetration throughout, but a gap of ~0.005 was noticed on the top of the weld where the beam initially punches into the material.

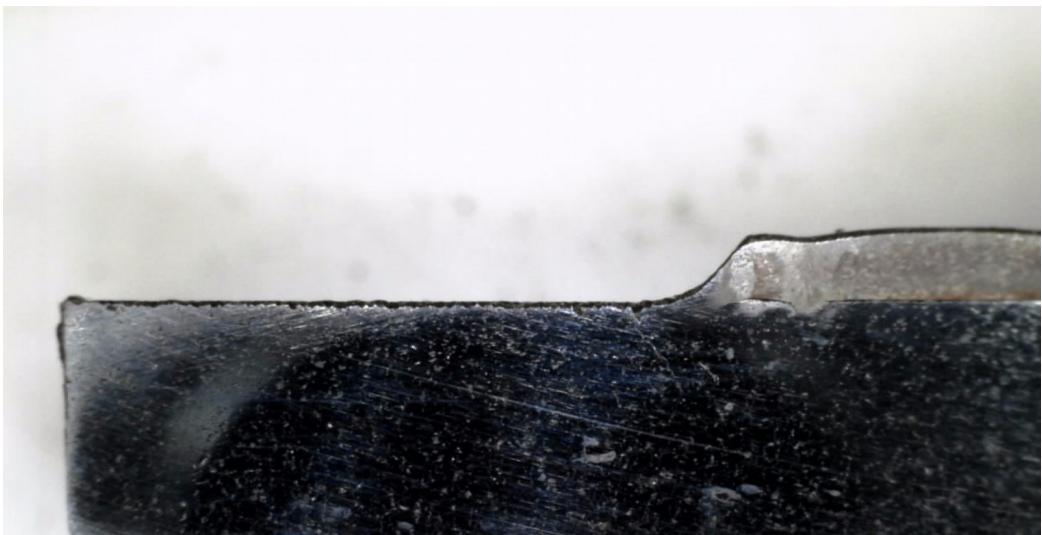
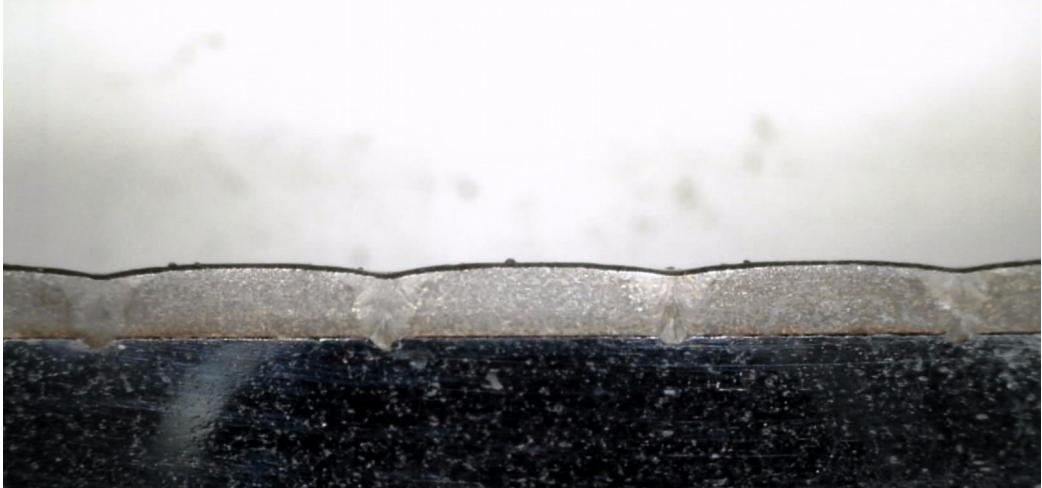
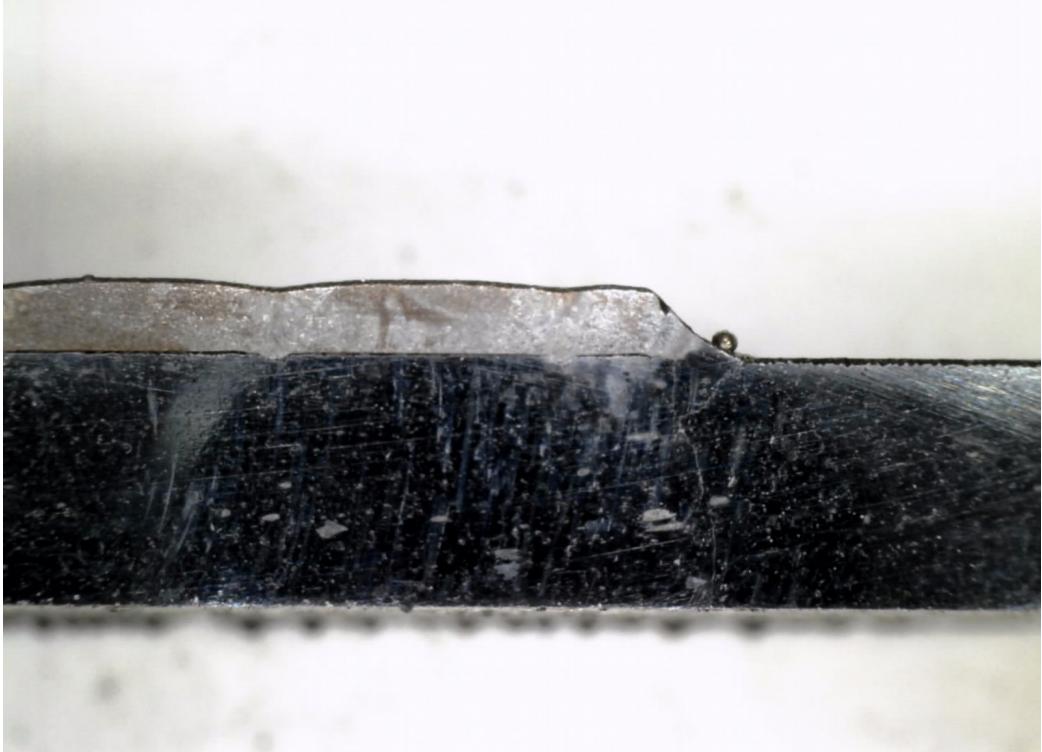
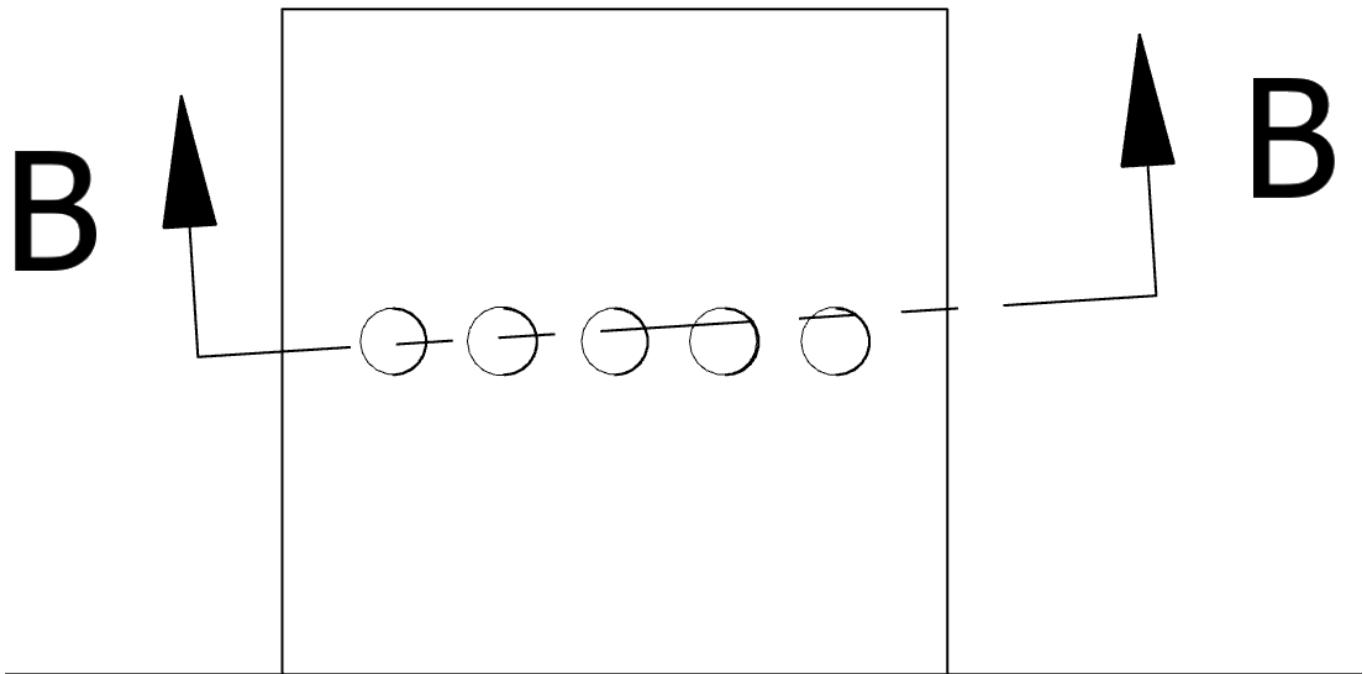
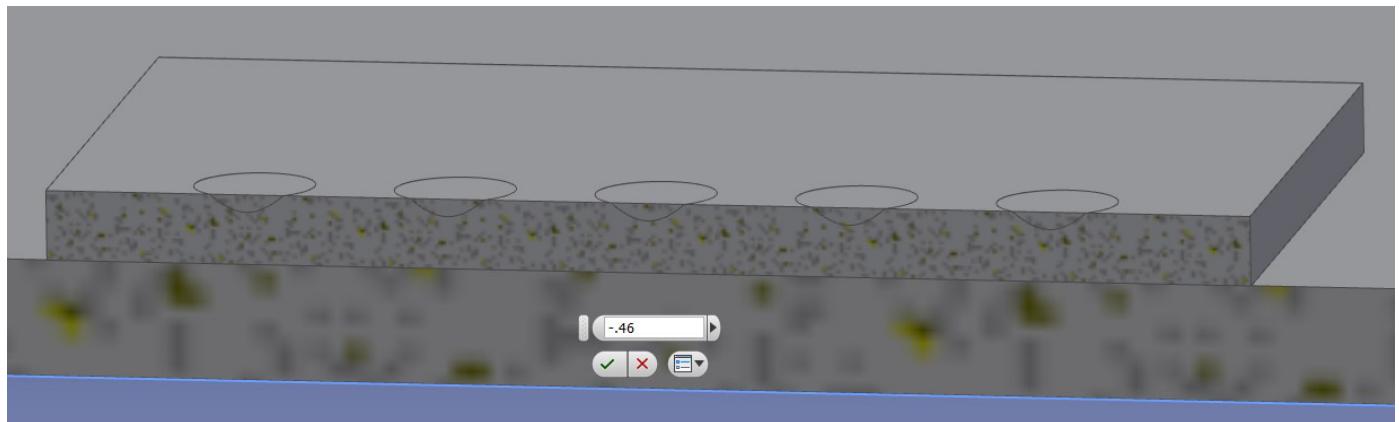
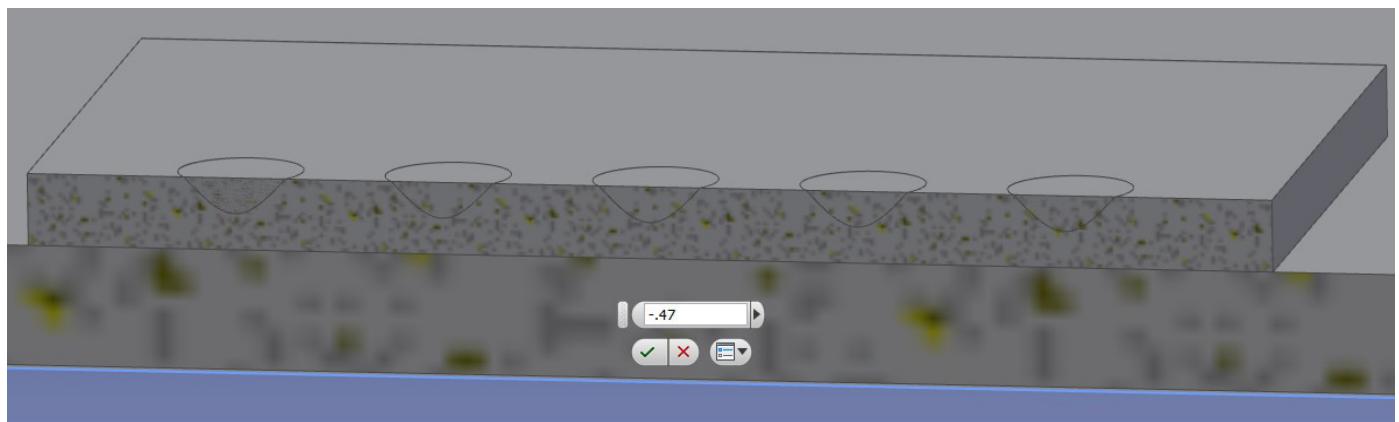
### Sample #3 Picture

This sample was welded in the traditional manner, clamping down on the bottom of the part rather than the mating surface (like previously welded in the beginning) We rolled the edges of the weld (fillet weld) on 4 corners, proceeded to tack the 35 spots, then did a full fillet weld pass on the 3 applicable sides of the shunt.

Results: Consistent Penetration throughout, but we noticed external cracking on the toe of the fillet welds, and internal cracking through the base metal.
