Report on C3-76-018726-1-A21-0044

04/23/2021

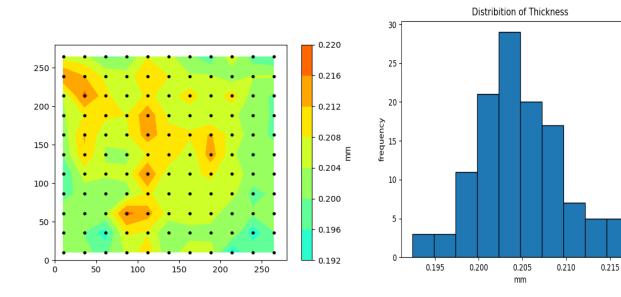
The plate was laid up and cured and post cured as per the manufacturer recommended procedure. It was then measured on a Hexagon coordinate measuring machine for the thickness measurements

Units in mm
