Report on C3-76-018726-1-A21-0047

04/23/2021

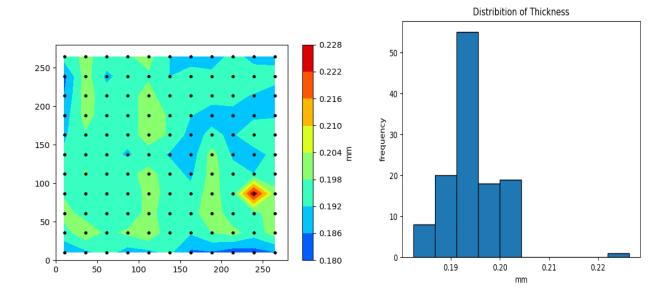
Units in mm

The plate was laid up and cured and post cured as per the manufacturer recommended procedure. It was then measured on a Hexagon coordinate measuring machine for the thickness measurements

Average Thickness:	0.194		
Thickness Standard Deviation:	0.005
