## Report on C3-76-018726-1-A21-0050

04/23/2021

The plate was laid up and cured and post cured as per the manufacturer recommended procedure. It was then measured on a Hexagon coordinate measuring machine for the thickness measurements

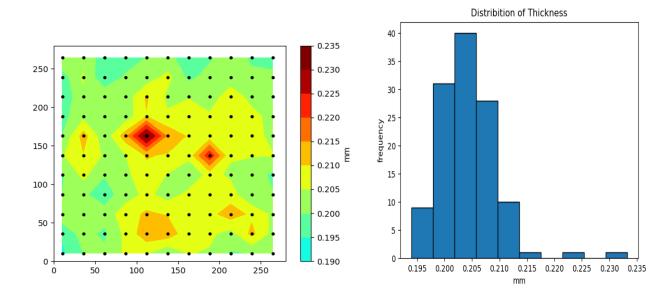
#### Units in mm

Average Thickness:	0.204		
Thickness Standard Deviation:	0.005
