Report on C3-76-018726-1-A21-0050

04/22/2021

Langdon Felter-CMSC

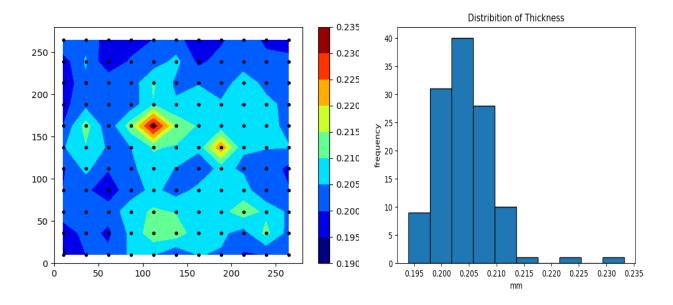
The plate was laid up and cured and post cured as per the manufacturer recommended procedure. It was then measured on a Hexagon coordinate measuring machine for the thickness measurements

Units in mm

Average Thickness:	0.204		
Thickness Standard Deviation:	0.005
