Report on C3-76-018726-1-A21-0046

04/22/2021

Langdon Felter-CMSC

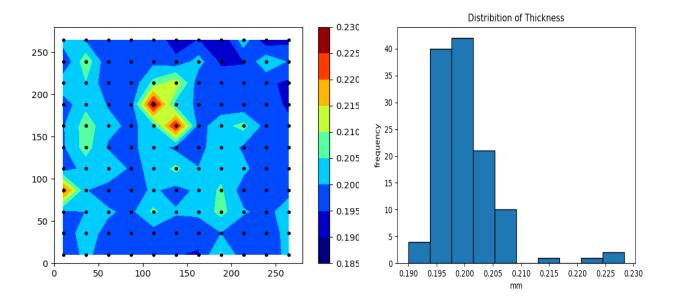
The plate was laid up and cured and post cured as per the manufacturer recommended procedure. It was then measured on a Hexagon coordinate measuring machine for the thickness measurements

Units in mm

Average Thickness:	0.200		
Thickness Standard Deviation:	0.006
