Report on C3-76-018726-1-A21-0049

04/22/2021

11x11 Thickness Measurements for C3-76-018726-1-A21-0049

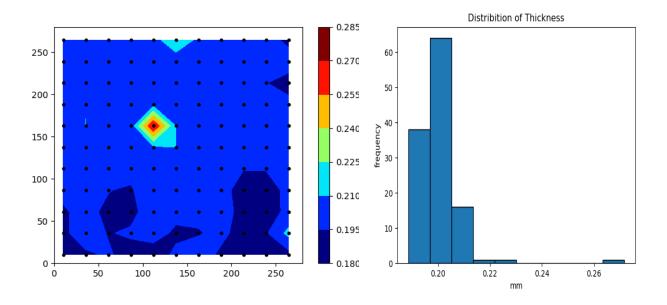
The plate was laid up and cured and post cured as per the manufacturer recommended procedure. It was then measured on a Hexagon coordinate measuring machine for the thickness measurements

Average Thickness:	0.200		
Thickness Standard Deviation:	0.009
