Report on C3-76-018726-1-A21-0044

04/22/2021

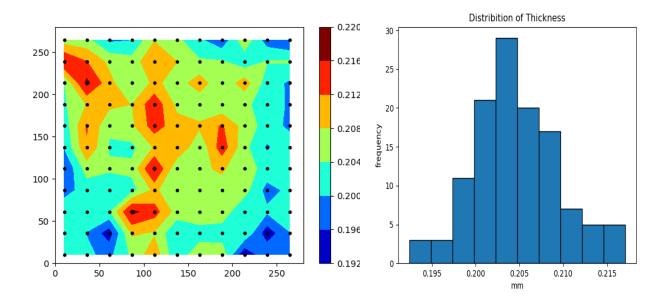
The plate was laid up and cured and post cured as per the manufacturer recommended procedure. It was then measured on a Hexagon coordinate measuring machine for the thickness measurements

Units in mm
