Report on C3-76-018726-1-A21-0045

04/22/2021

Langdon Felter-CMSC

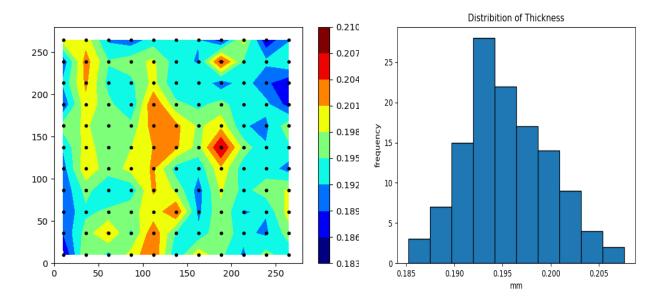
Units in mm

The plate was laid up and cured and post cured as per the manufacturer recommended procedure. It was then measured on a Hexagon coordinate measuring machine for the thickness measurements

Average Thickness:	0.195		
Thickness Standard Deviation:	0.004
