Report on C3-76-018726-1-A21-0043

04/23/2021

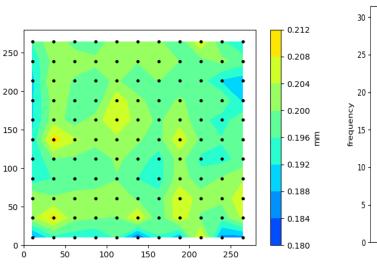
The plate was laid up and cured and post cured as per the manufacturer recommended procedure. It was then measured on a Hexagon coordinate measuring machine for the thickness measurements

Statistics

| Average Thickness: | 0.199 |
| Thickness Standard Deviation: | 0.005 |
