Report on C3-76-018726-1-A21-0043

04/22/2021

Langdon Felter-CMSC

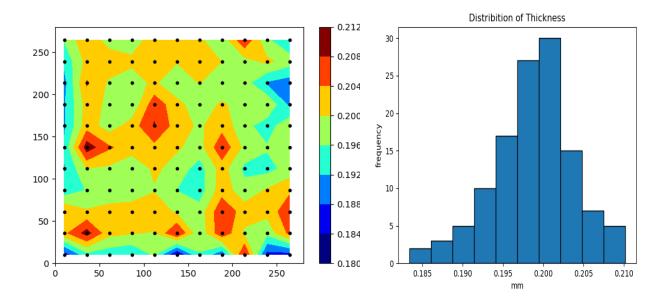
The plate was laid up and cured and post cured as per the manufacturer recommended procedure. It was then measured on a Hexagon coordinate measuring machine for the thickness measurements

Units in mm
