# **PRELIMINARY ENGINEERING REPORT**

## **CLEARWATER BEACH MARINA UTILITIES AND DRAINAGE IMPROVEMENTS CITY PROJECT NUMBER 14-005-MA**

**January 22, 2015**

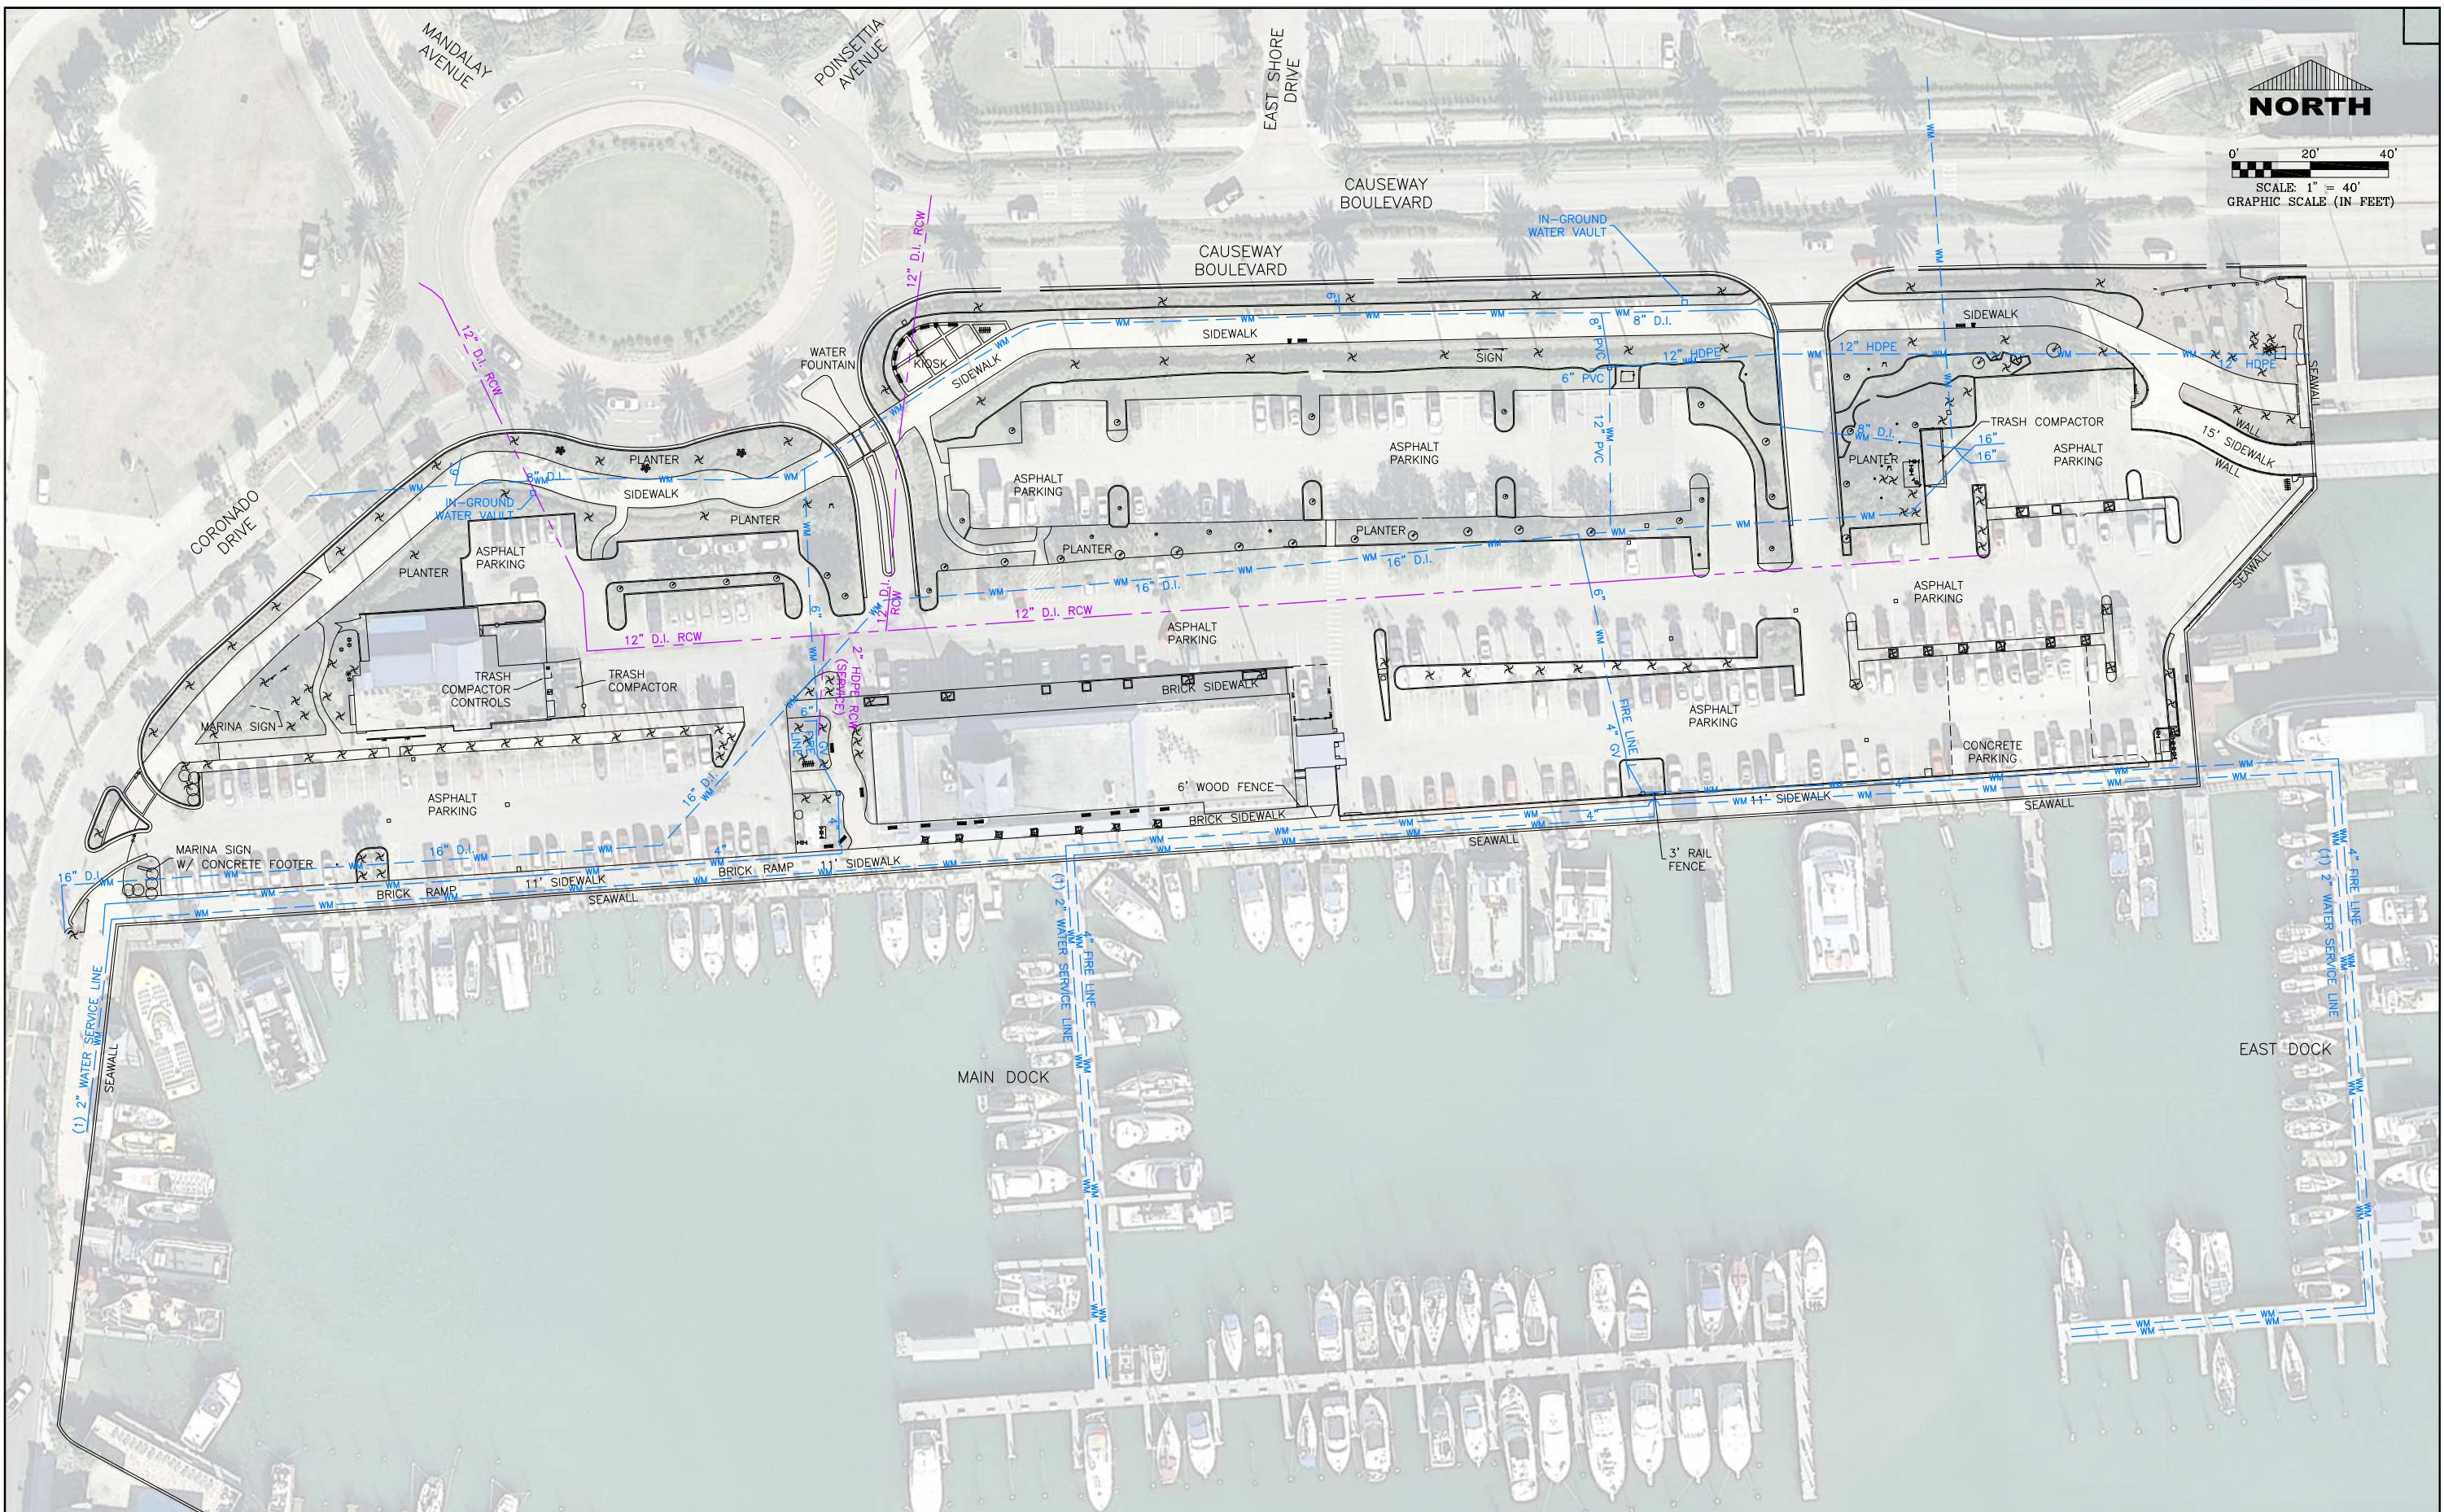
Clearwater Marina Parking Lot  
WATER & RECLAIMED WATER MAINS

The Beach Marina parking lot appears to have been part of various upgrades to Causeway Boulevard. The parking lot is utilized as a route for transmission of utilities, including an 8-inch line that becomes 12-inch water main on the north end of the parking lot going east-west which is adjacent to Causeway Boulevard. There is also a 16-inch water main running north-south on the eastern half of the parking lot and turning east-west near the eastern entrance to the Beach Marina. Additionally, there is a 12-inch reclaimed water main running primarily east-west through the parking lot approximately 40 feet north of the marina building. While the 8/12-inch water main and 12-inch reclaimed water main appear to stay north of the area of concern, the 16-inch water main turns south as it proceeds west and is installed approximately 10 feet north of the south curb line of the parking lot as it proceeds west of the Beach Marina's main building. **Figure 2** illustrates the existing water mains in the Beach Marina.

There are additional interconnections between the two water mains that apparently allow for better distribution and hydraulic conditions for the mains. However, the two water mains that appear to service the marina site are a 6-inch water main running north-south that is connected to the 16-inch water main on the east side of the marina building and an additional 6-inch water

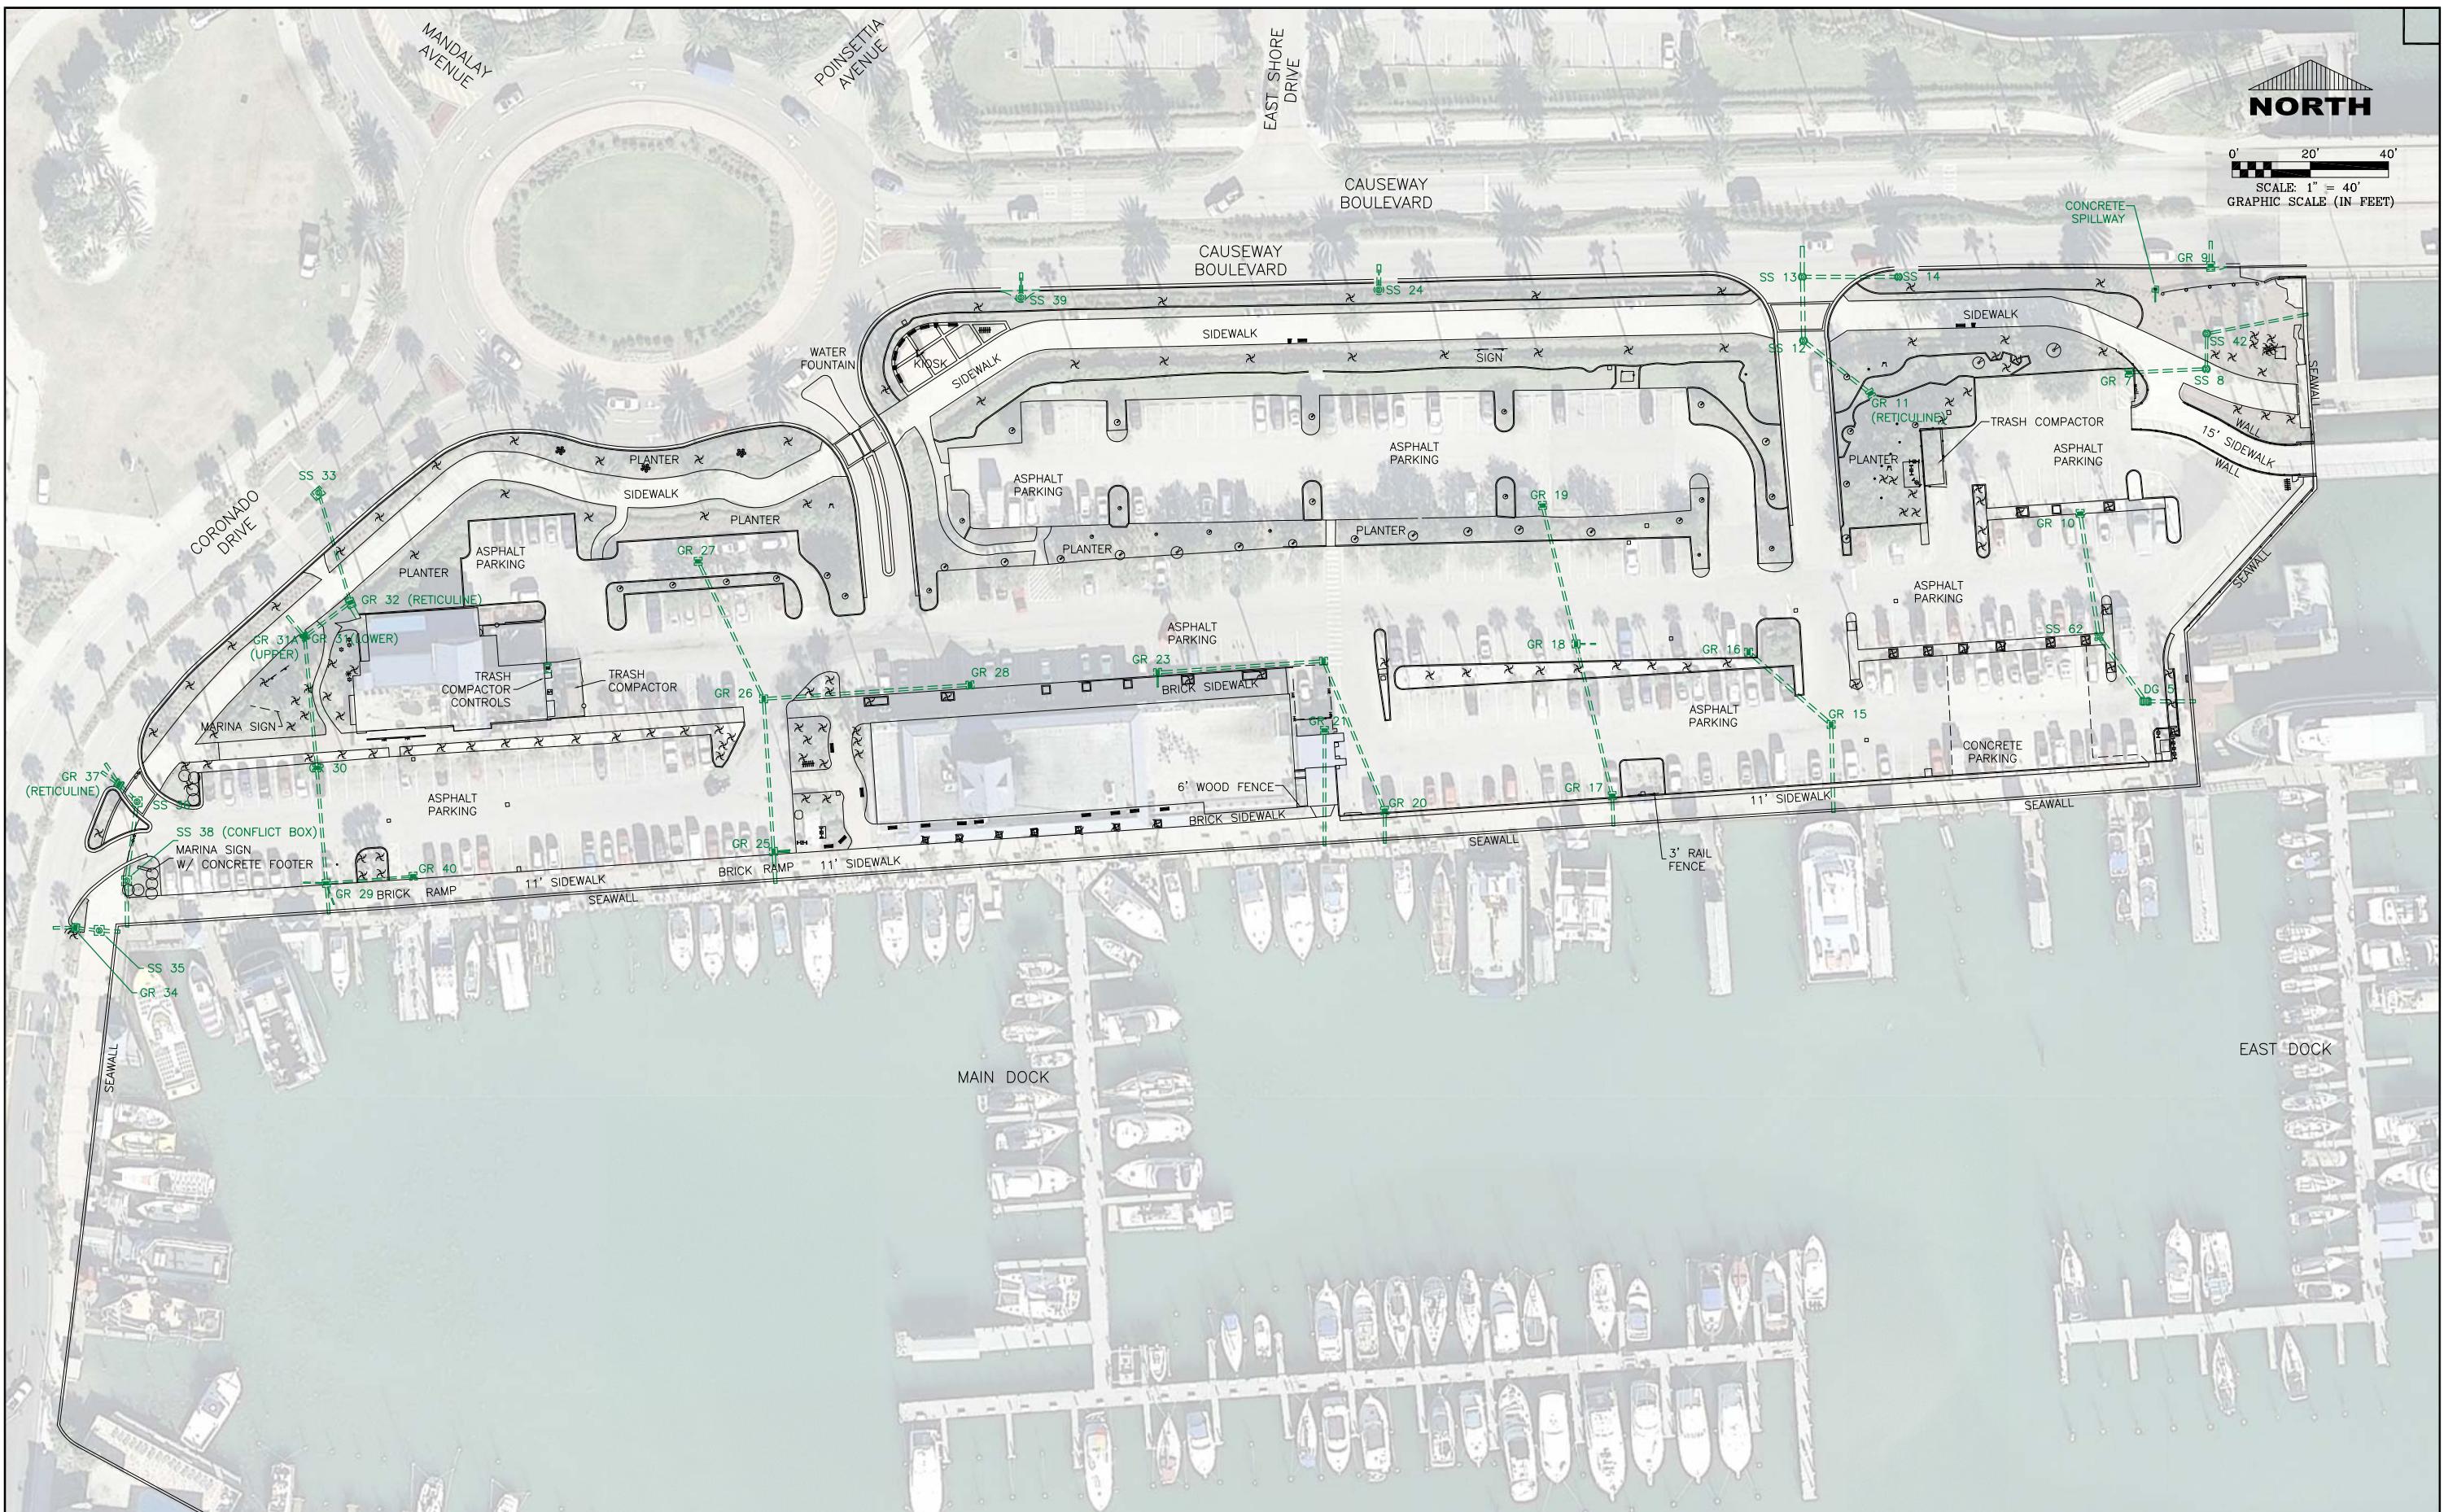
Clearwater Marina Parking Lot  
STORM WATER SYSTEM

The existing storm water system for the Beach Marina facility numerous storm water structures collecting storm water and conveying the water to waters of the marina, directly through the seawall. Approximately 11 storm water outlets were visible discharging storm water to individual seawall outfalls while 1 structure collected storm water and discharges the water to a drainage system in the Causeway Boulevard area. The storm water piping is typically 12 to 18-inch with one smaller 8-inch pipe that appears to have been added for additional collection east of the main marina building. The drainage appears to generally flow from north to south with some collection lines having more than one inlet and the eastern collection system including outlets to the east. It should be noted that all outfalls from the marina appeared to have inverts near or below sea level and the collection system does not include treatment. **Figure 3** illustrates the existing storm water collection system in the Beach Marina.

Due to cost considerations, storm water treatment is not recommended as part of this project. The Beach Marina elevation and existing storm water drainage would require either the entire site to be re-graded or a new large collection system and pump station to be constructed. To keep the existing boat slips in substantial use with limited interruption, a pump station would have to be constructed and a storm water pond would need to be constructed offsite. It is unclear where a pond could be constructed in close proximity (less than 1,000 feet) to the site, but the calculated rate of flow for storm water collection would be significant for a pump station application.

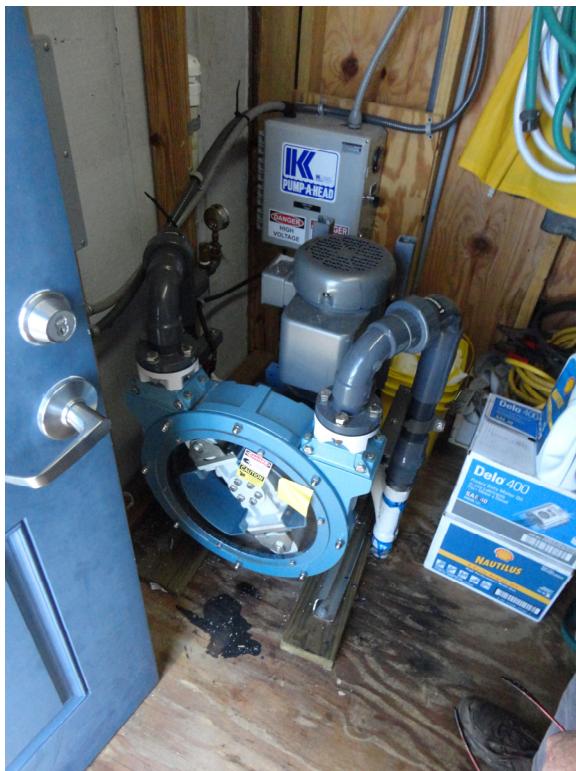
Pump out vacuum waste pump

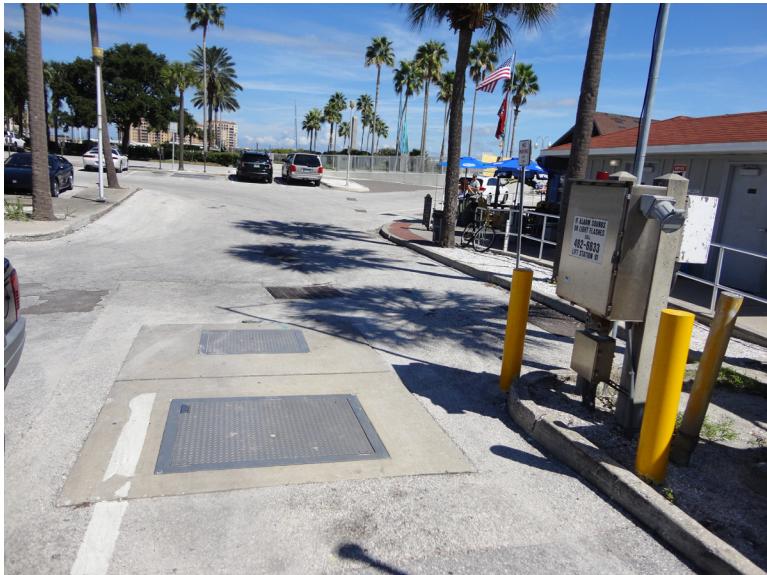
Existing Lift Station 81

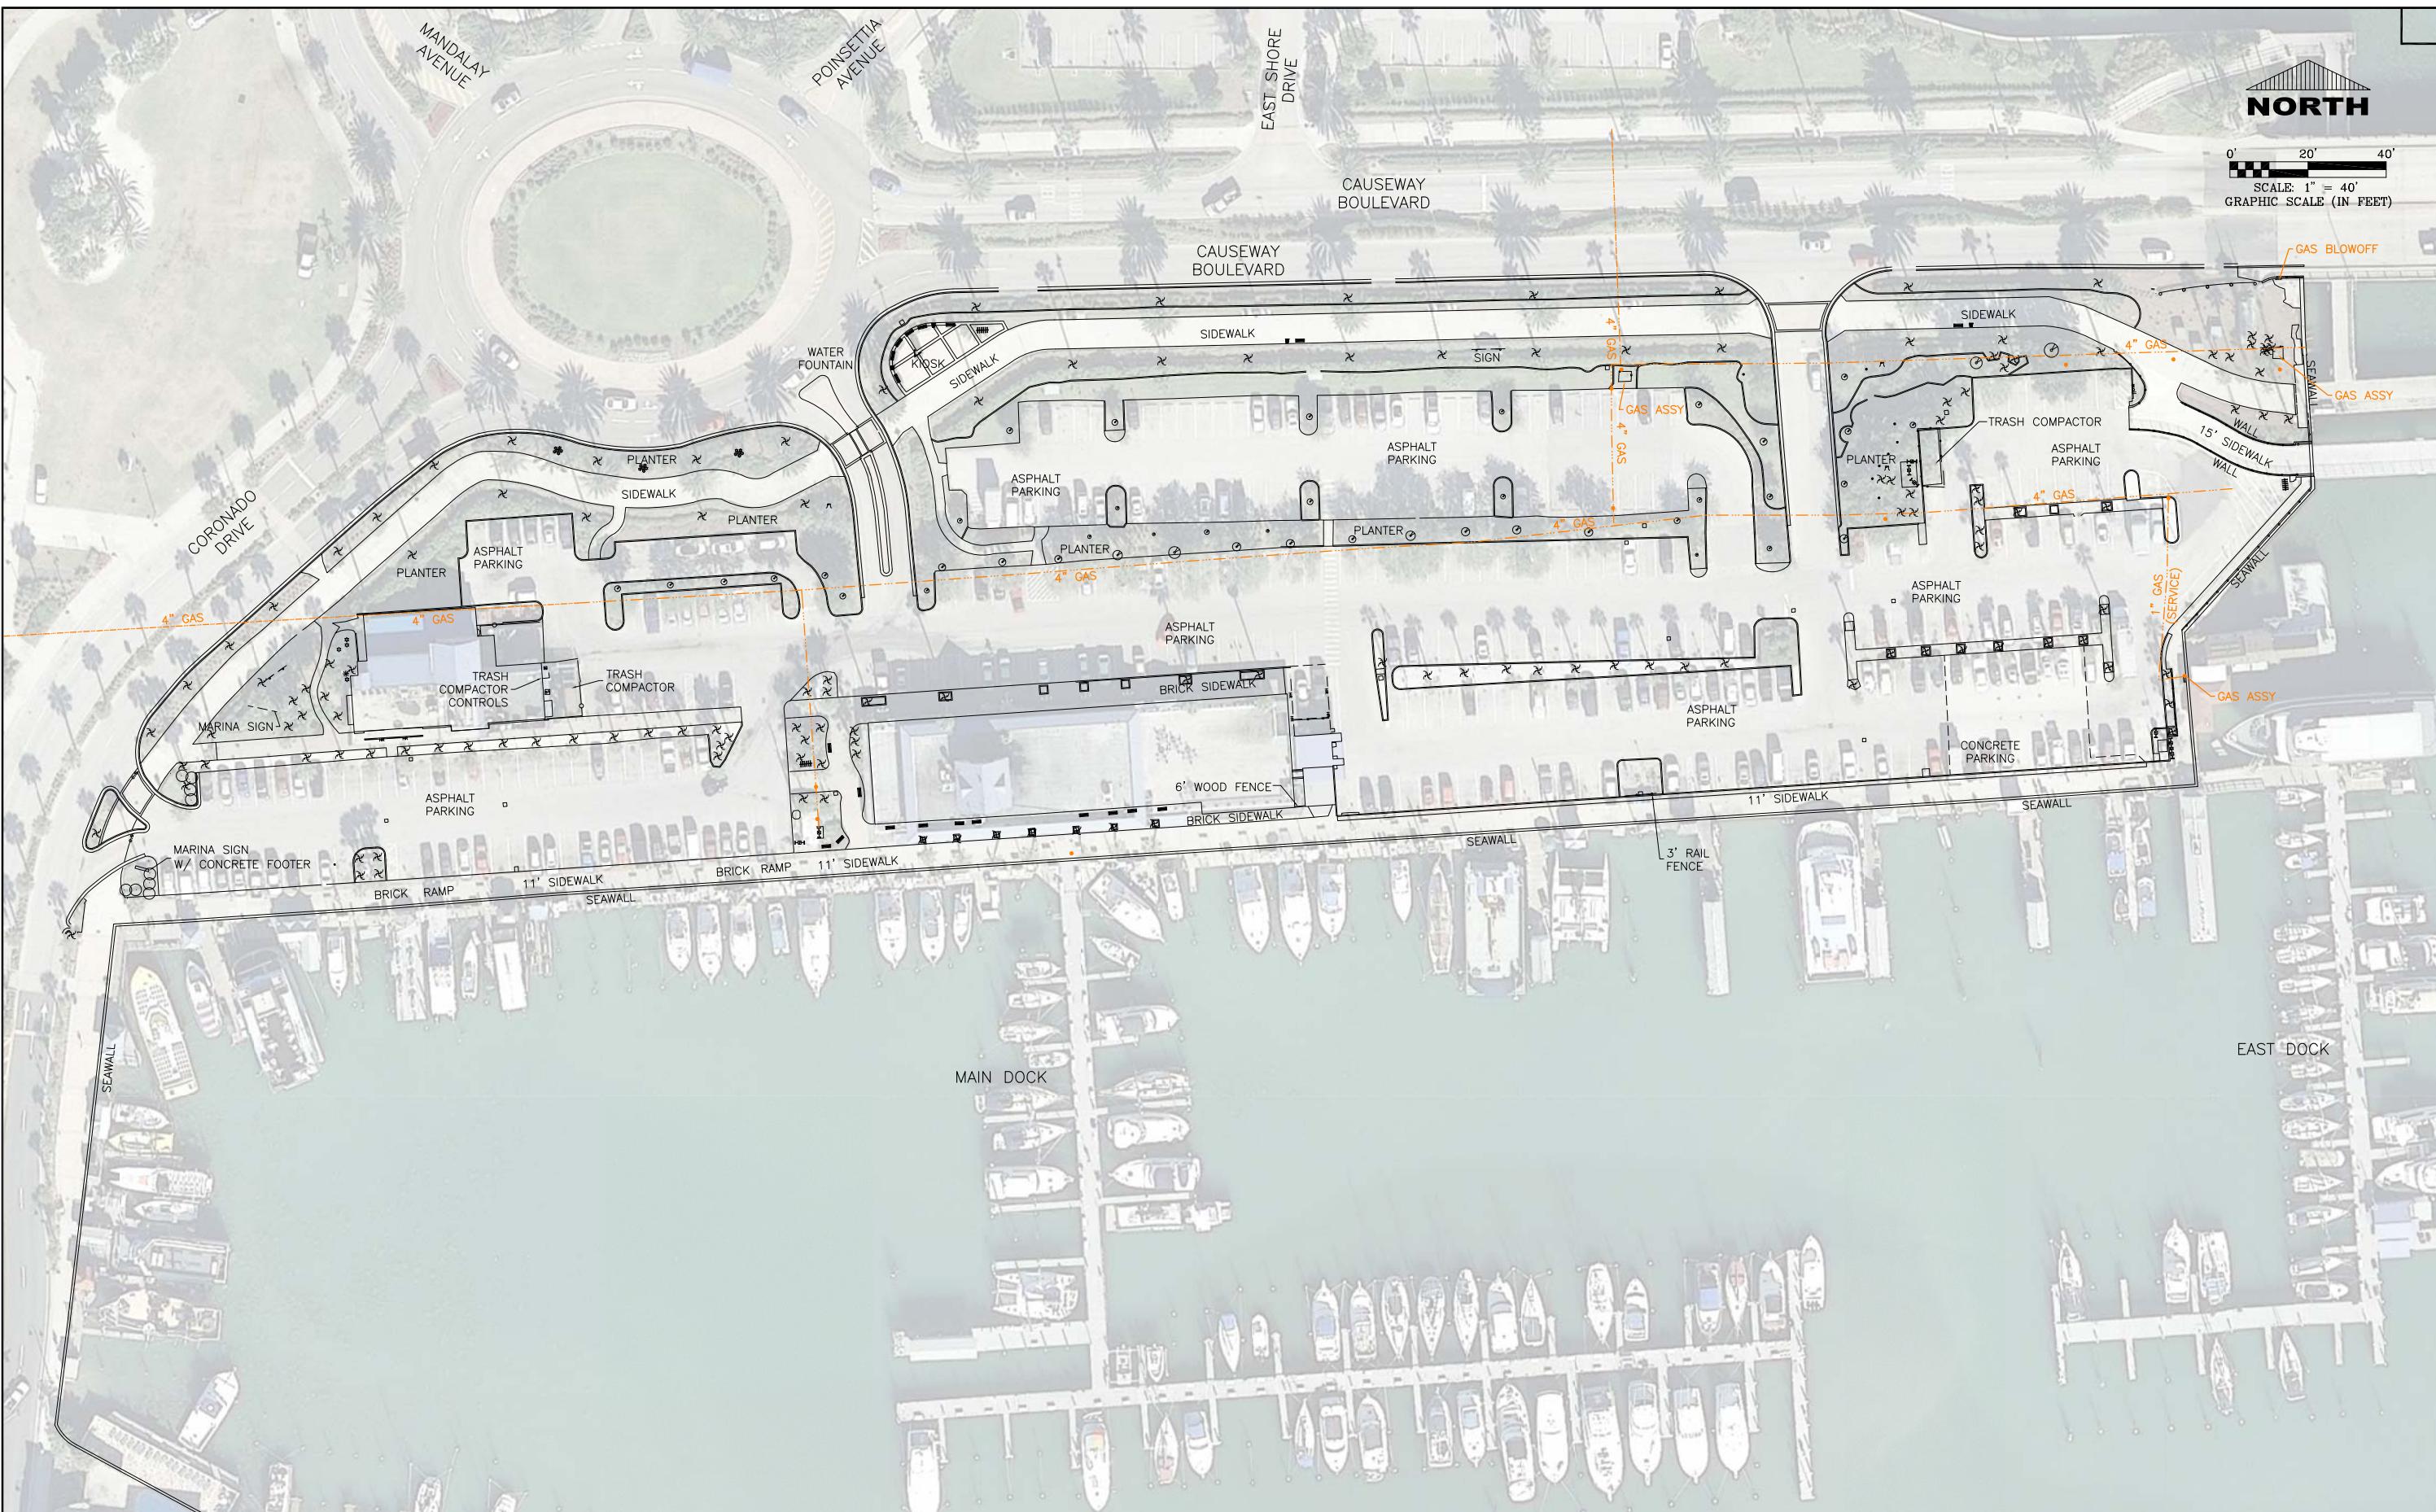
Clearwater Marina Parking Lot  
GAS LINES

The Beach Marina has an existing 4-inch natural gas distribution main that is installed east-west in the parking lot just to the north of the restaurant located at 37 Causeway Boulevard,

approximately 15 feet south of the gravity sewer lines. The main gas service is primarily for the restaurant located at 37 Causeway Boulevard and the restaurant being renovated in the main marina building. Discussions indicated that the docks do not typically utilize the gas service. **Figure 5** illustrates the existing natural gas distribution system in the Beach Marina.

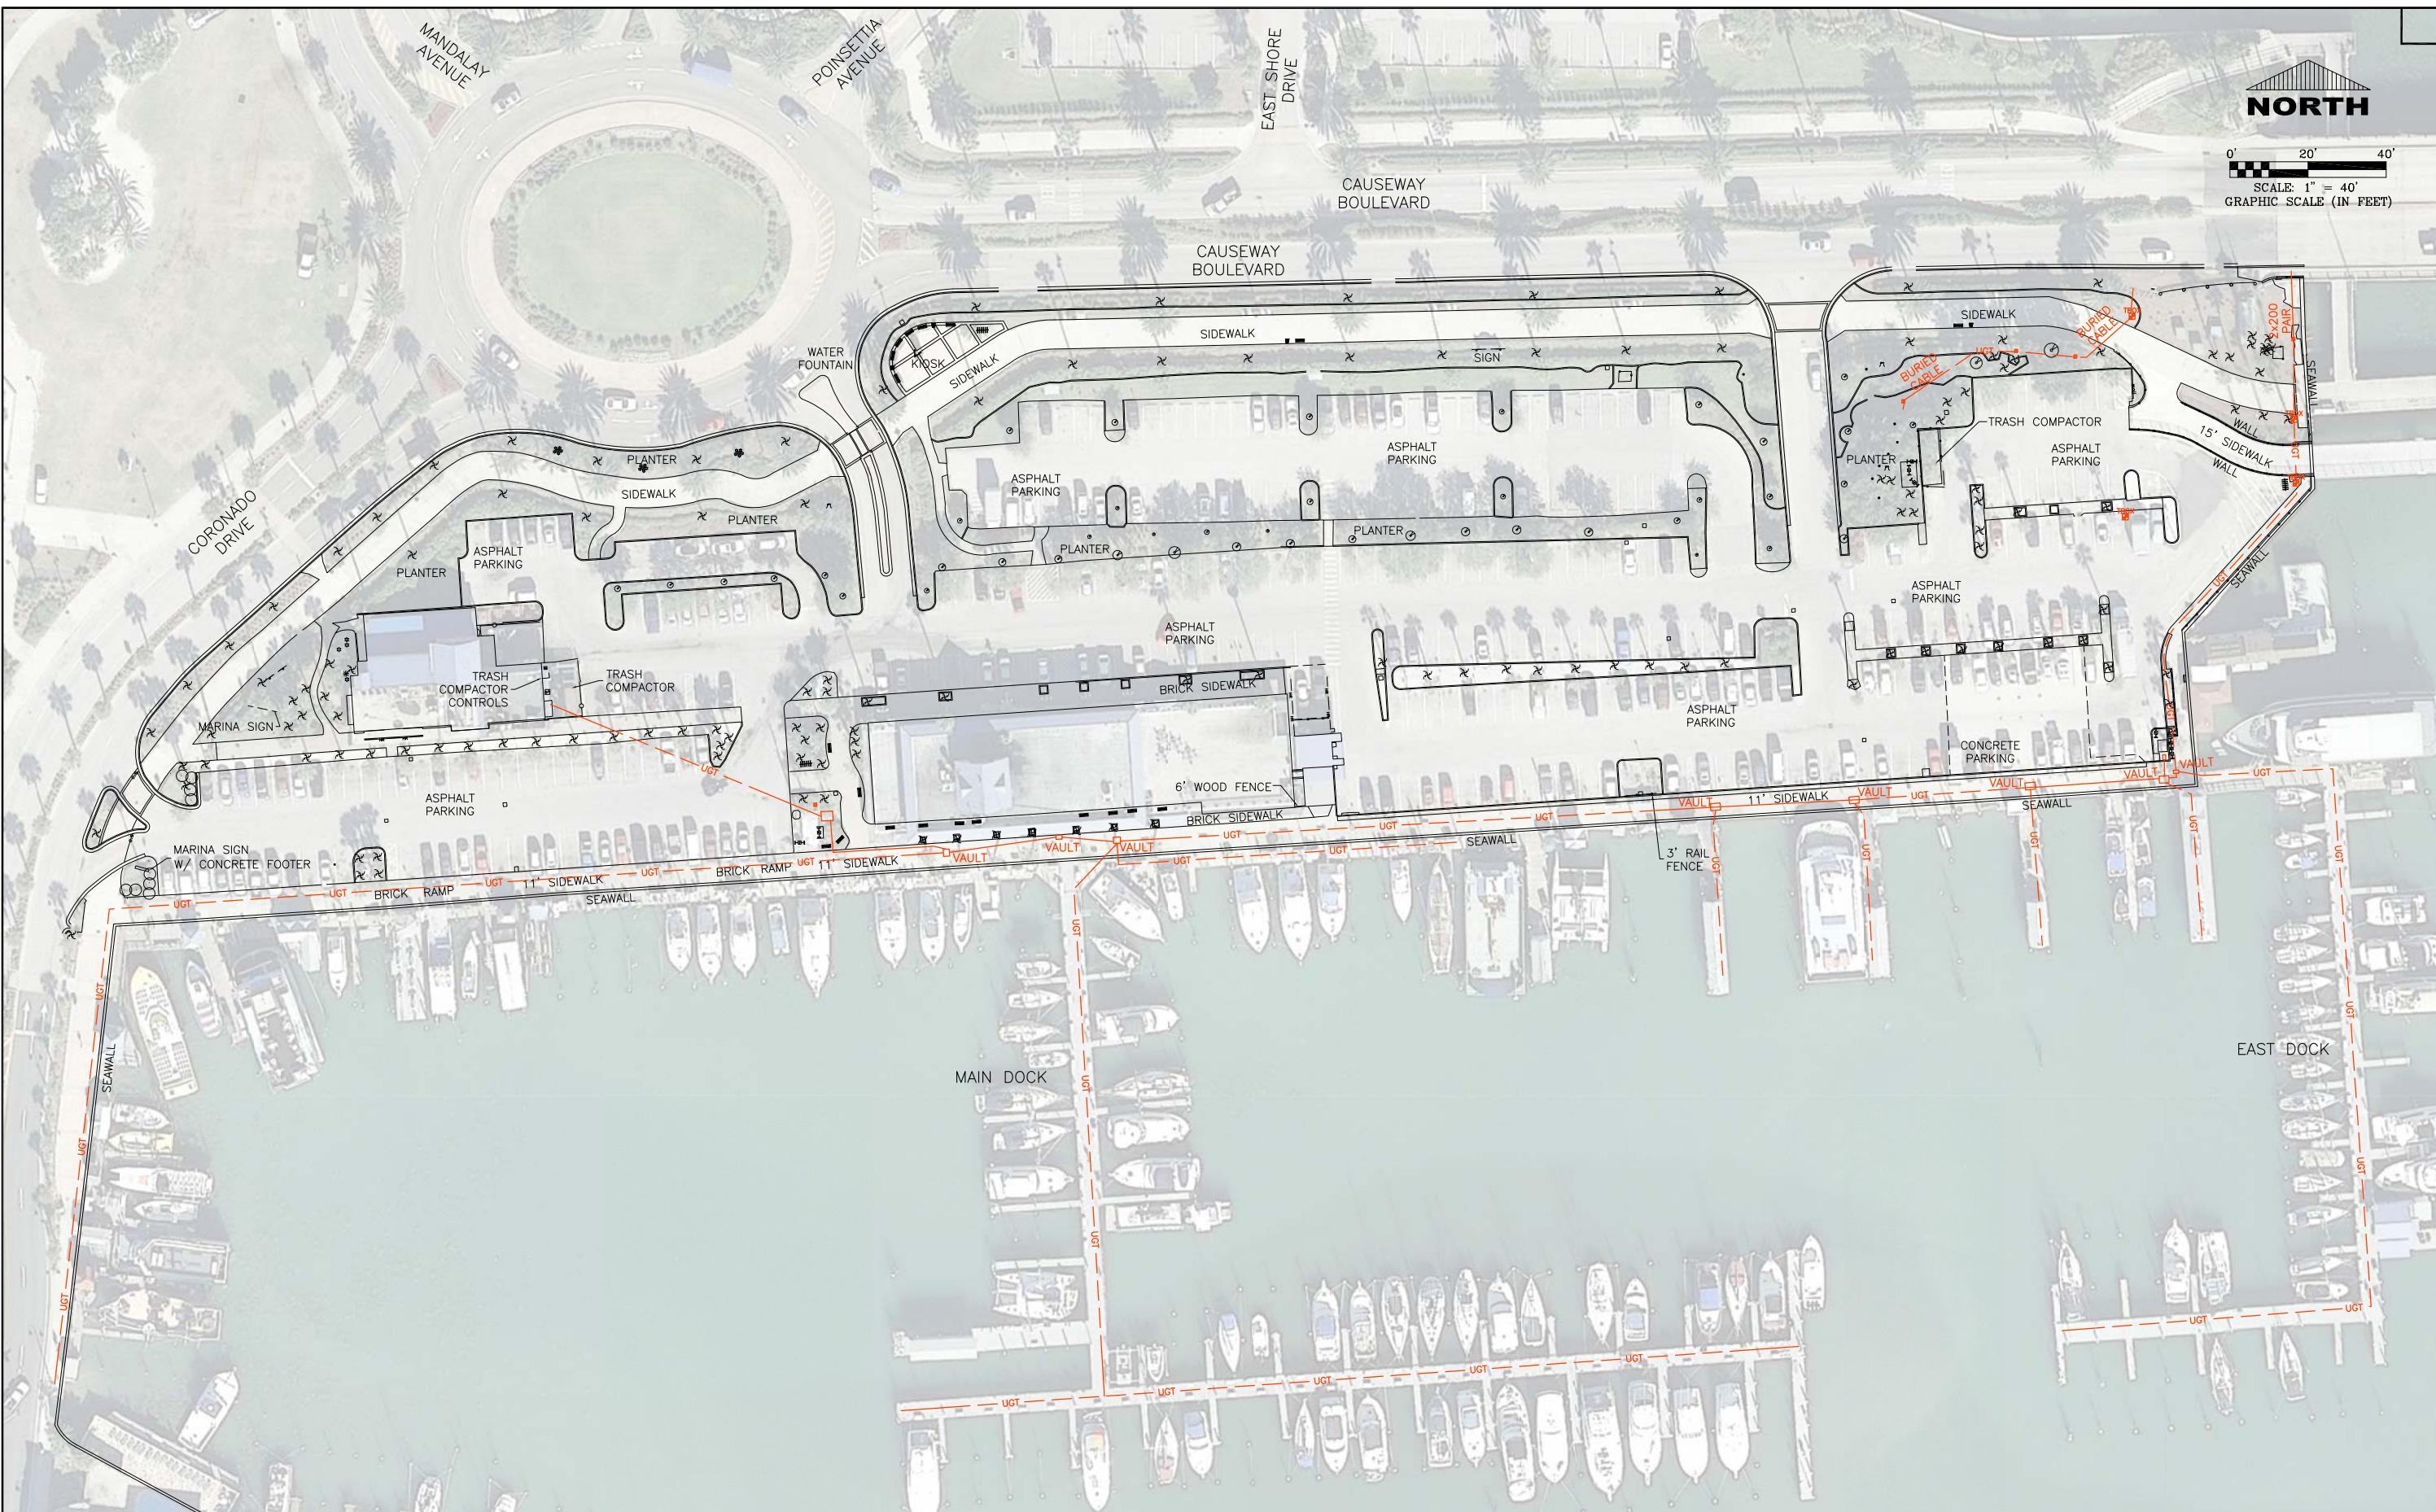
Clearwater Marina Parking Lot  
TELEPHONE LINES

While earlier technology necessitated the 400 pair of telephone wires, it was noted that less than 15% of the wires are now typically utilized. There are roughly 25 pair of wire going to the commercial docks, 12 pair to the restaurants, and 25 pair going to the marina that are typically utilized. Based on discussions with Verizon, there have been some recent issues with the wires on the western end of the marina and there have been issues during construction due to the number of telephone wires and their purpose.

Currently the Beach Marina offers telephone connection at each boat slip. However, it has been noted that they are rarely utilized and may no longer be needed. If the phone cables were to be relocated and replaced, Verizon would recommend decreasing the number of pairs present to allow for a more optimized network, decreased footprint, and decreased relocation price. **Figure 6** illustrates the existing telephone service lines in the Beach Marina.

It is recommended that the number of pairs of telephone service wires be closely reviewed with Verizon. The Beach Marina could then consider eliminating phone service to the majority of individual boat slips. The recommendation would still provide service to the commercial slips with vendors present, the marina, and the restaurants. It is preliminarily estimated that the number of pair of phone wires would reduce from 400 to roughly 100 and four main pull boxes may be able to be removed from the sidewalk area. The existing conduits and pull boxes

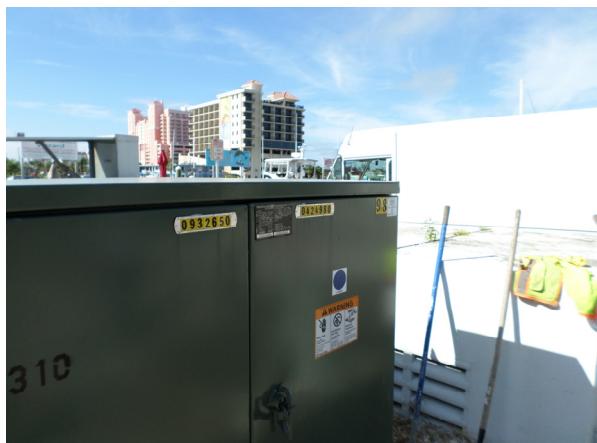
Adjacent to the west side of the marina building is a 300kVA 120/208V step down transformer that supplies power to the marina slips and docks. In addition, Duke Energy has installed a new

second utility transformer to service the marina building and out parcel restaurant. The transformers primary feeder is loop fed via a north-south easement through the parking area to the west of the marina office building from a vault on the north sidewalk. Adjacent to the transformer location is the original concrete transformer vault structure that is partially above ground. While the vault is no longer used to

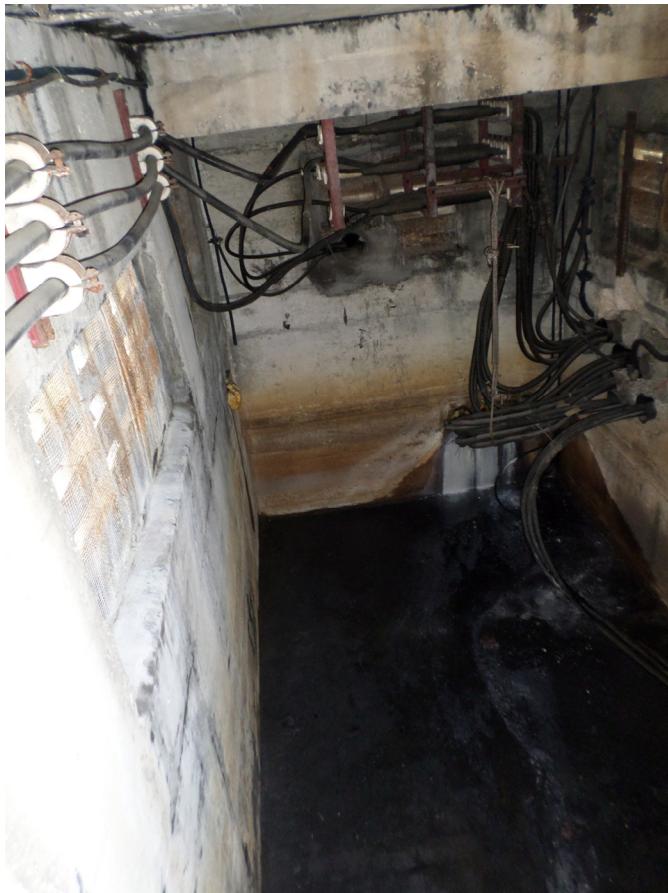
Interior view of the Duke Energy vault at the west service location

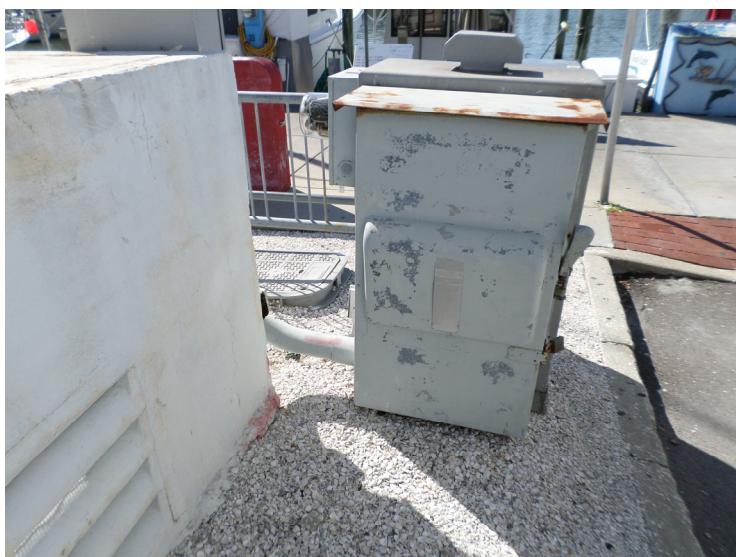
main dock. The power feeder on the load side of the 700 amp main disconnect is 2 sets of 4 #3/0 in a single 4-inch conduit. The feeder is routed under the side walk and penetrates the seawall at the connection to the main dock. This feeder is undersized for the over-current protection provided. In addition during discussions with the marina staff there is a significant voltage drop issue on the main dock depending on the number of downstream users. This service provides power to marina slips M1 through M63, M71 and M72.

The second electrical service at the west location is for the boat slips located along the seawall and consists of a 320 amp 3 phase meter and 400 amp main fused disconnect for the 120/208V 3

phase power. The main disconnect appears to provide power to a concrete in ground hand hole located next to the main disconnect. The hand hole is assumed to be a splice point for the feeders from seawall boat slip pedestals to the feeder from the main disconnect. There is no over-current protection, other than the main disconnect, on the feeders to the pedestals along the seawall. A cursory observation of the electrical supply system for the

pedestals indicates that a 200 amp 3 phase, 120/208 V feeder in 2-inch conduit is supplied under the sidewalk and then through the seawall to a group of 4 to 5 pedestals. After the raceway penetrates the seawall, the conduit is secured to the exposed side of the seawall and looped between four to five pedestals. This service appears to provide power to marina slips pedestals 1 through 47 along the seawall. An estimated total of twelve 2-inch conduits for power distribution would be expected under this section of sidewalk originating from this service point with half routed east from the service location and half routed west from the service location.

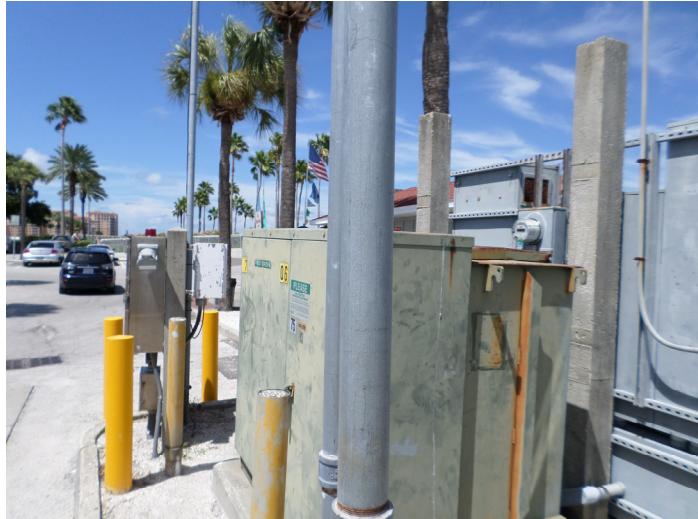
Along the east edge of the marina, there is a 75kVA 120/208V step down transformer that supplies power to the marina slips, east dock and the sanitary lift station.

The transformer primary feeder is loop fed via a north-south easement through the parking area to the west of the marina restroom building from a vault on the north sidewalk. Adjacent to the transformer location is a sanitary lift station structure. In addition, the underground marina fuel storage is in this vicinity of the parking field.

consists of one CT meter for the utility transformer. Metering for the individual boat slips is provided by private meters located at the slip power pedestals on the east dock. Metering for the large docks along the seawall is provided by a 1000 amp meter center with 13 private meters and main circuit breakers. At this location there are two electric services that supply the marina slips that are discussed further in this report. The first of these services is the power source for the east dock. The second service is the power source for the large slips located along the seawall.

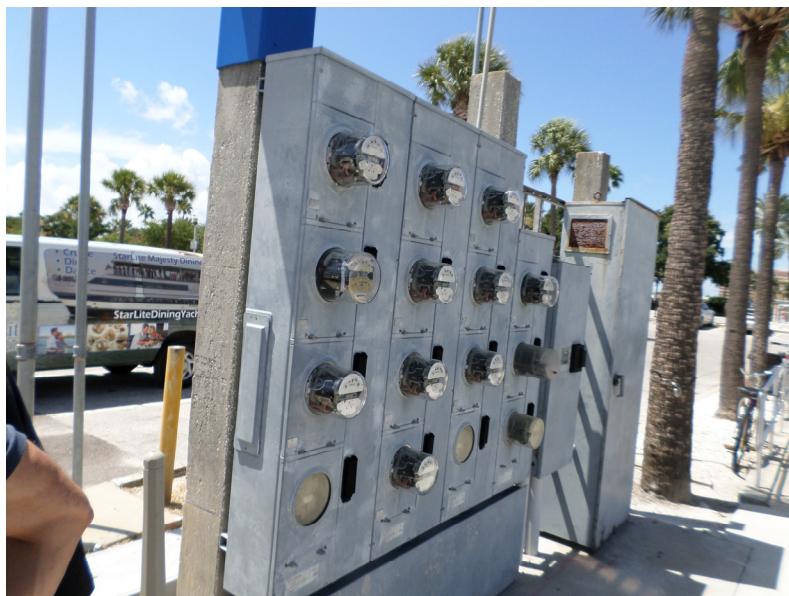
East electrical marina services 1 and 2.

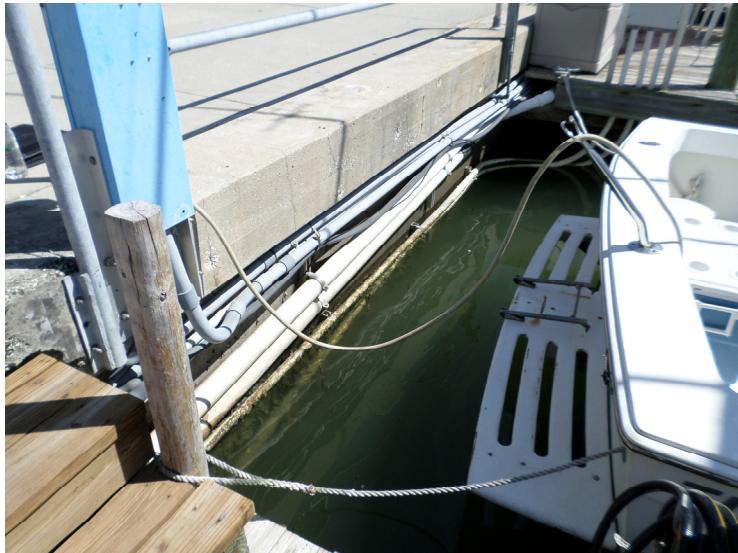
Power throughout the marina is provided by conduit and wire. Direct buried PVC conduit is located under the sidewalk. Based on conversations with the marina staff, the conduit systems are installed without utilizing a duct bank structure to organize the conduits making excavation for repairs difficult. In addition, numerous conduit systems are attached to the exposed side of the seawall. The exposed conduit is generally schedule 40 PVC with a mixture of stainless and galvanized supports. There are instances where the exposed conduits are broken or the supports have failed. In general the conduit systems are in need of maintenance but are in fair condition.

Typical conduit systems exposed on the seawall

- Maintain, repair and re-support existing electrical conduits located on the exposed side of the seawall and under the existing docks.
- To alleviate the underground conduit systems infra-structure conflicts under the sidewalk, replace the existing feeder system on both the east and west service locations with a duct bank of feeders located in a Trenwa system with removable covers along the entire sidewalk area.
- Replace the west electrical main disconnect servicing the main dock with a GFI protected main circuit breaker.
- Replace and upgrade the feeder to the main dock to improve the voltage drop condition and bring the conductor size and over-current protection into compliance with the NEC.

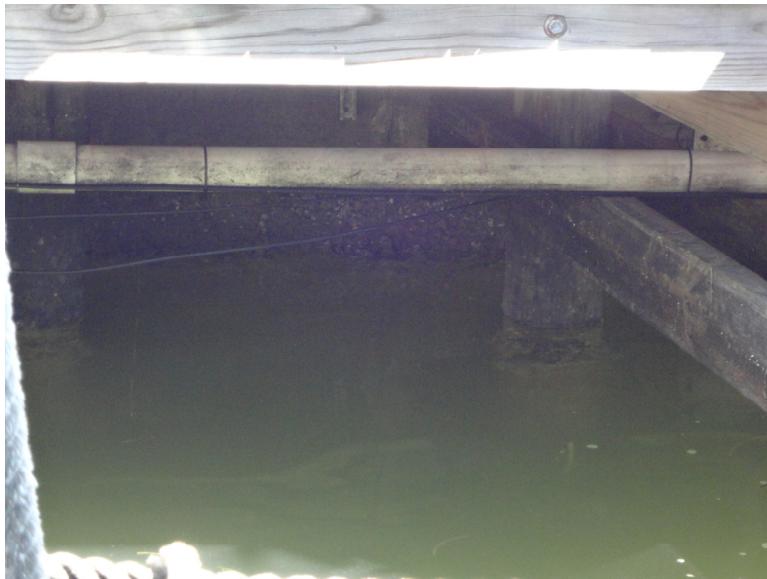
The cable lines are installed in parallel with the existing 208V power conduits and are terminated in similar locations at the utility pedestals. The cable line splits again at the Main Dock, again feeding each individual boat slip with the utility pedestal connection. It should be noted that there are several other cable drops to restaurants, the marina, and the commercial boat slips on the front of the docks. The existing cable appears to be loosely fastened to the underside of the existing docks on the front of the seawall. The photo below illustrates the typically condition of the cable wiring.

Existing cable wiring installed beneath dock near water, adjacent to apparent water service main
