STEVENSON CREEK WATERSHED MANAGEMENT PLAN

FINAL REPORT

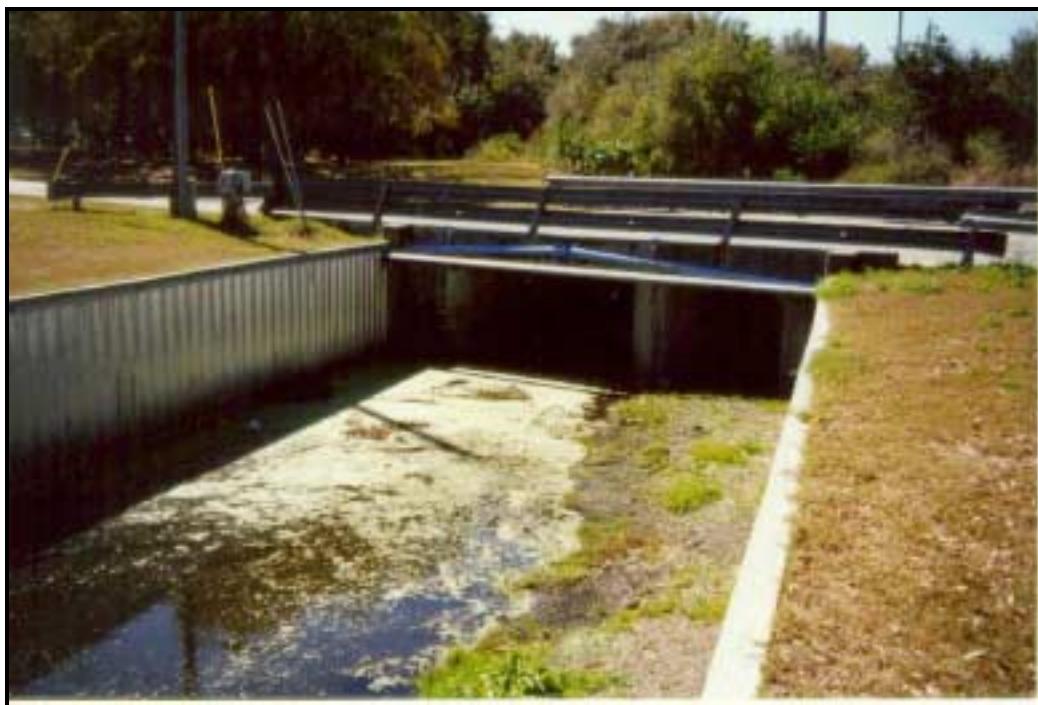
and flow conditions. No adjustments were made to the Manning's roughness in the vicinity of the Spring Branch at King's Highway station however, since within the range of the measurements, the flow appears to be controlled by the box culverts under King's Highway (refer to Figure 2.1-7). The simulated rating curve at this location provided a reasonable fit to the measured data without any adjustment to the Mannings "n" values.

Figure 2.1-7 Box Culverts Downstream of King's Highway Monitoring Station

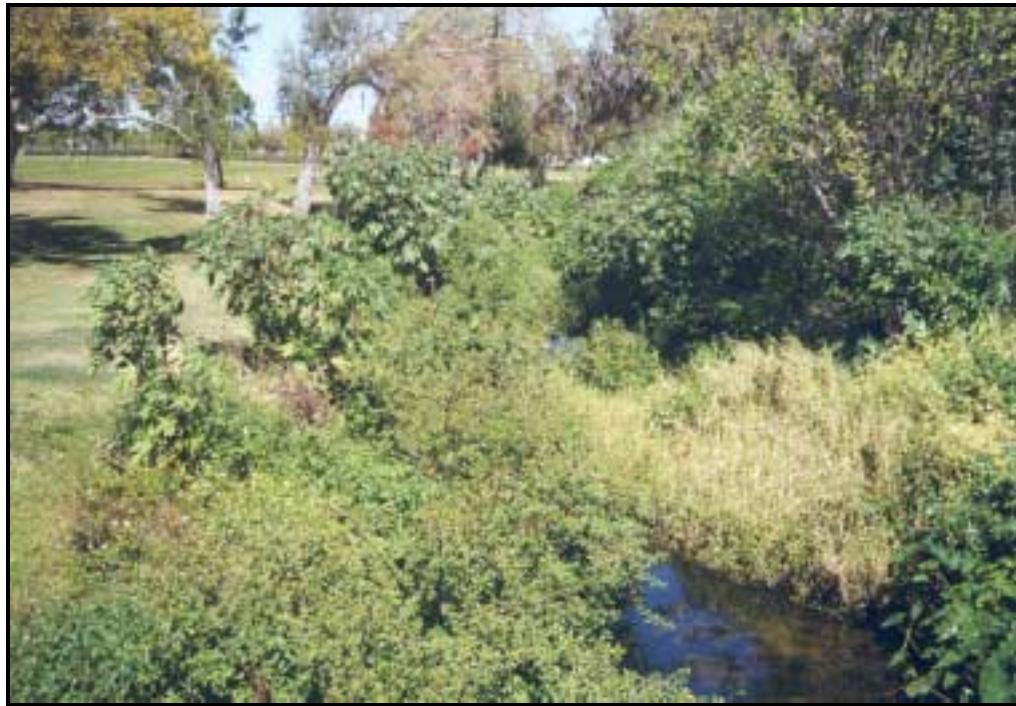
At the Drew Street gage in Stevenson Creek, it was necessary to increase the in-bank Mannings "n" from the initial estimate of 0.07, to 0.09 for the cross section immediately downstream of the gage in order to match the measured data. In a field visit in March of 2000, this section was observed to be heavily vegetated (refer to Figure 2.1-8), although the degree of vegetation in the channel generally decreased in the sections further downstream through the golf course. Of course, the degree of vegetation varies not only with location, but also with time of year and point in the maintenance cycle.

Figure 2.1-8 Vegetation in Channel Downstream of Drew Street Monitoring Station

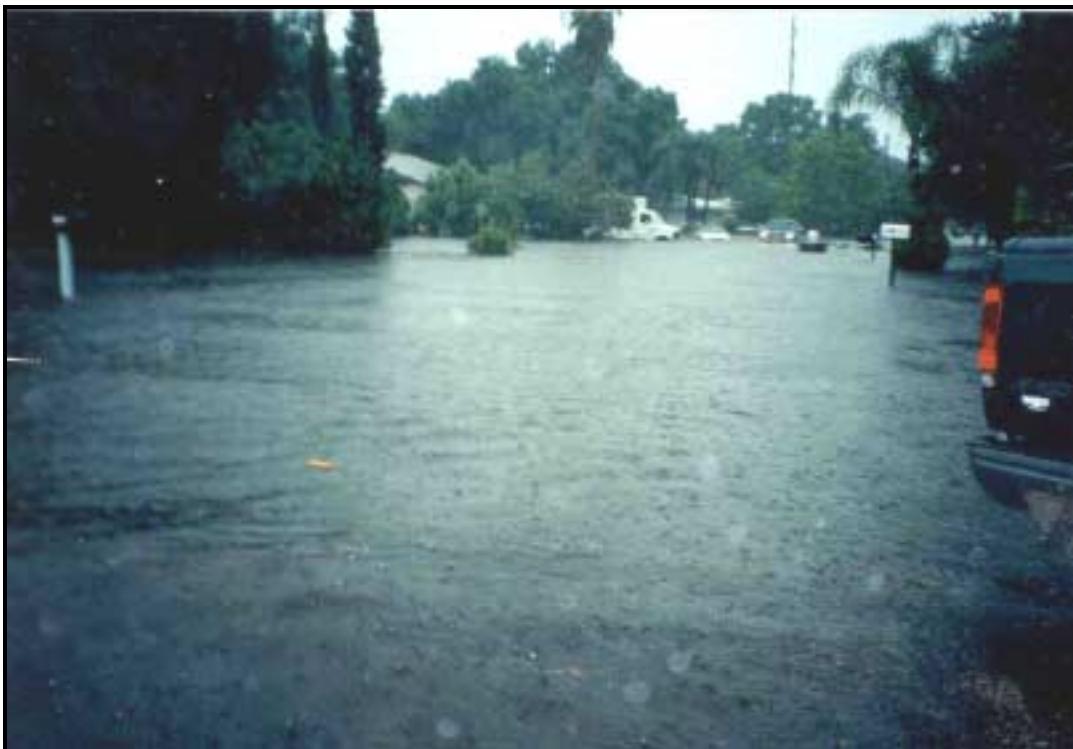
Upper Stevenson Creek encompasses the portion of the Creek targeted for conveyance improvements in Phase 3 of the 1988 W.K. Daugherty study. This phase was never constructed, primarily due to environmental concerns over the proposed improvement method of hardlining (paving) the channel with concrete. In the current analysis, the Upper Stevenson Creek subwatershed was found to contain 85 structure FPLOS deficiencies. All of these lie within the floodplain of the main channel of Stevenson Creek, with the largest concentration of them occurring on both sides of the Creek between Jeffords Street and Lakeview Avenue, and along Hillcrest Avenue south of Lakeview Road (see Figure 2.1-25).

**Figure 2.1-25 Flooding on Hillcrest Avenue, South of Lakeview Road
Storm of July 15 , 2000**

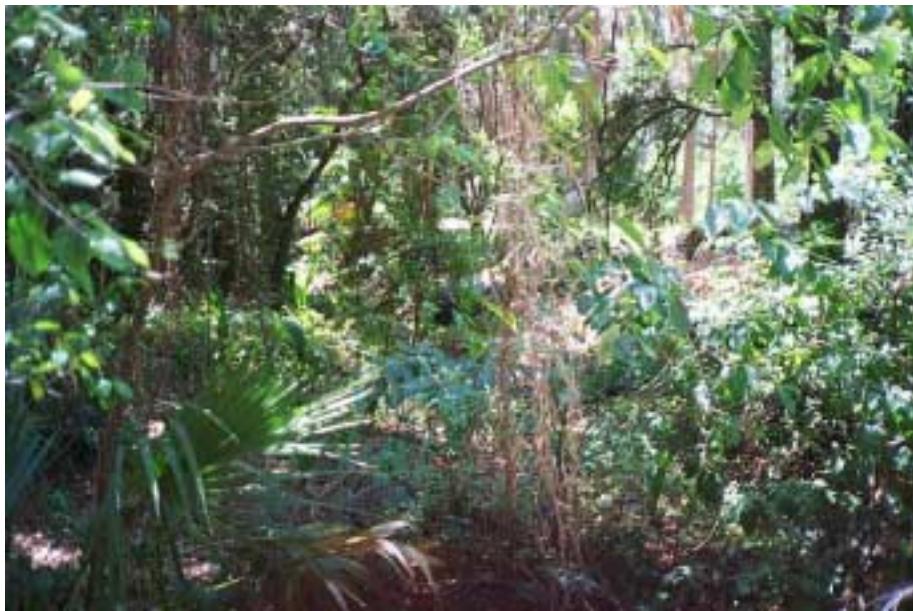
This photo was taken in the mesic forested area, in the southern part near State Street. The vegetation in this area includes slash pine, laurel oak, saw palmetto, and cabbage palm.

Despite the impacted condition of the parcel, it currently provides the only wildlife habitat of any substantial size within the watershed. Recent survey lines cut through the parcel indicate that it may be too late to preserve it, but it has the potential to become locally significant wildlife habitat, as well as a neighborhood recreational area.

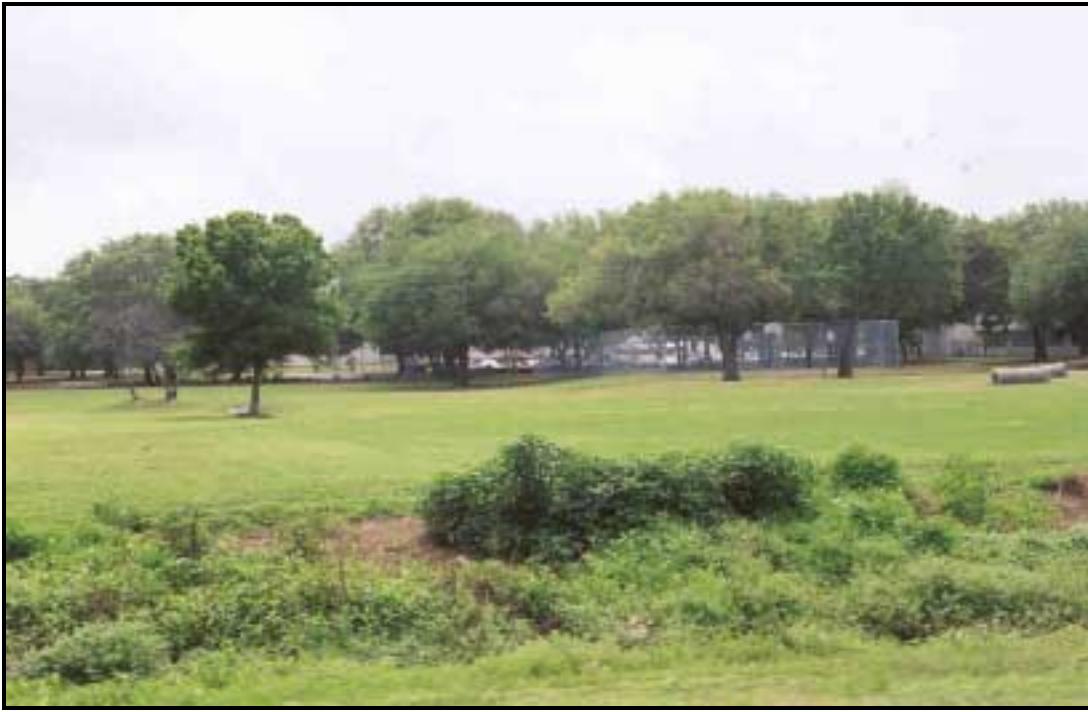
Figure 3.1-7. This photograph shows the area on the south side of Sunset Point Road that could be excavated to create the stormwater detention facility.

The majority of the created wetland will consist of a shallow littoral shelf that would be planted with pickerelweed, soft rush, arrowhead, water lily, and other wetland species. [Table 3.1-3](#) provides a list of suitable wetland species and their planting depths. A shallow channel would meander through the center of the wetland, as shown in [Figure 3.1-6](#). It is recommended that trees be planted around the perimeter of the wetlands to screen the area from adjacent land uses. Recommended trees are pond cypress, red maple, and pop ash in the wetland and laurel and live oak at the top of bank. The wetland vegetation would provide water quality treatment and wildlife habitat in a very depauperate area.

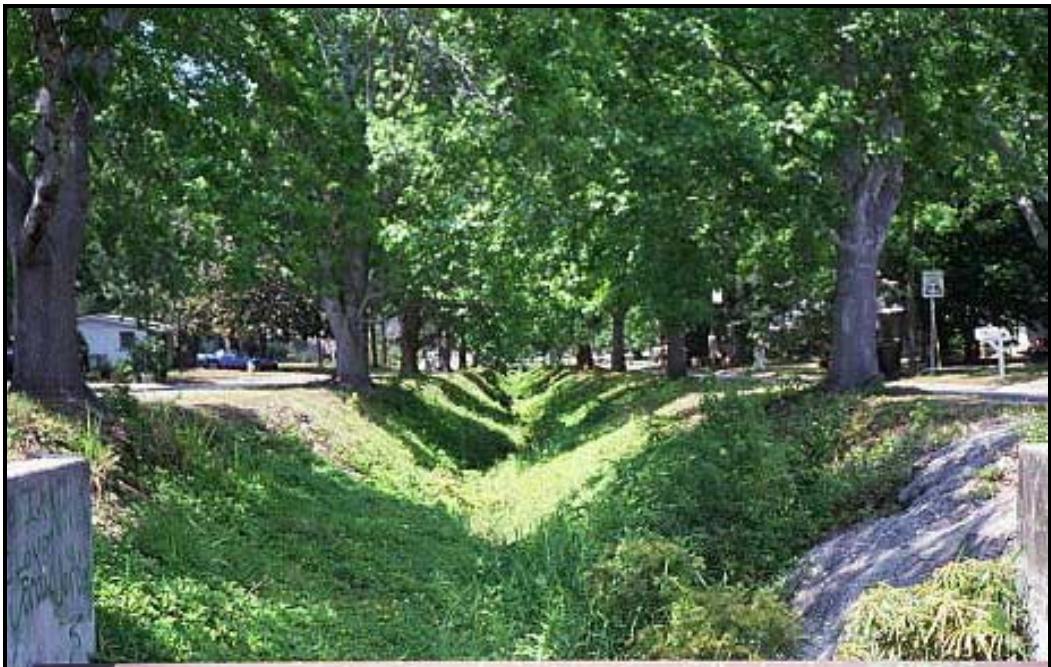
Figure 3.1-19. Stevenson Creek Channel and Trees Along Hillcrest Avenue, Between Jeffords Street and Browning Street (to remain)

This project also includes replacement of a failing retaining wall upstream of Browning Street, and removal of excess vegetation from the Creek downstream of the Lakeview Road Bridge. As can be seen in Figure 3.1-20, the majority of the vegetation to be removed is nuisance vegetation such as primrose willow (*Ludwigia peruviana*), melaleuca (*Melaleuca quinquenervia*), and Brazilian pepper (*Schinus terebinthifolius*). The City of Clearwater spends many precious man-hours and a significant part of the annual budget removing these noxious species from their waterways. The conceptual layout of Project 4A is depicted in [Figure 3.1-21](#).

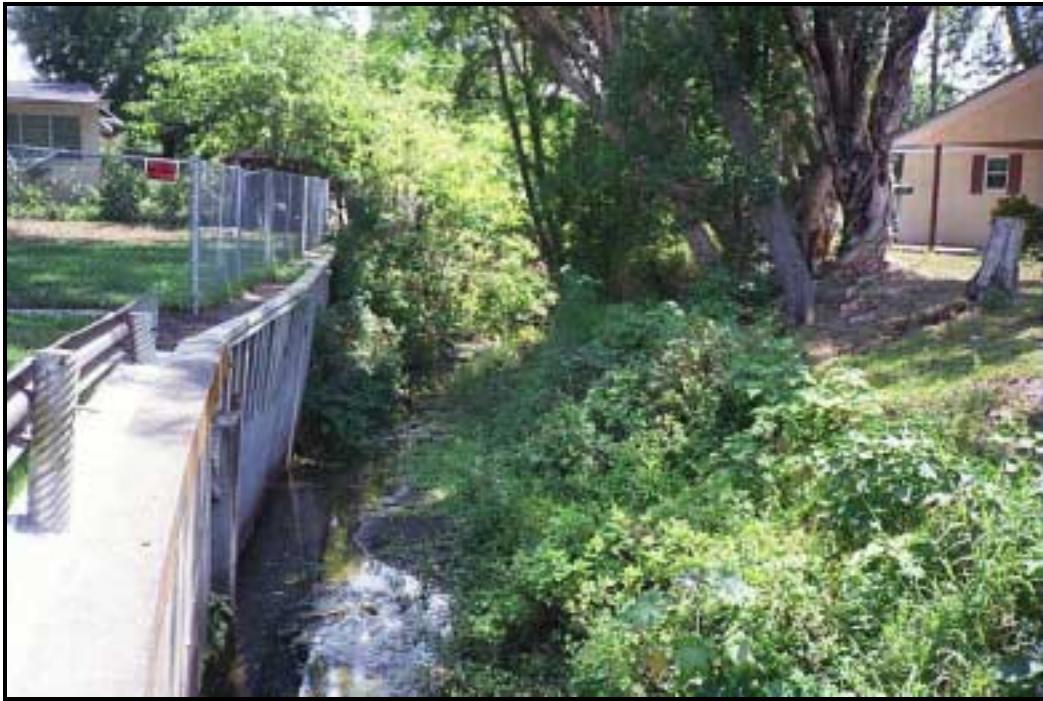
**Figure 3.1-20. Failing Retaining Wall Upstream of Browning Street,
to be Replaced and Exotic Vegetation to be Removed**

Project 4B. Upper Stevenson Creek Stabilization. Channel bank erosion is a major problem within Upper Stevenson Creek, in particular the section between Lakeview Road and Bellevue Boulevard, and to a lesser extent between Jeffords Street and Lakeview Road. As a partial remedy, various site-specific erosion repair measures could be implemented. These would consist of “spot” repairs of severely eroded areas using various methods such as gabion walls and geotextiles. These minor projects would target only those repairs necessary to protect public safety and private property from stream bank failures. However, this alternative would not stop the erosion from occurring, it would only repair the existing eroded areas. Additional repairs would have to be made periodically as problems occur. Another, more permanent alternative would be to reshape the channel cross section and install erosion control measures along entire lengths of channel, in particular between Lakeview Road and Bellevue Boulevard. Examples of erosion control measures would be low retaining walls along the toe of the channel banks, constructed of gabion baskets or “geoweb”-type retaining walls. These walls

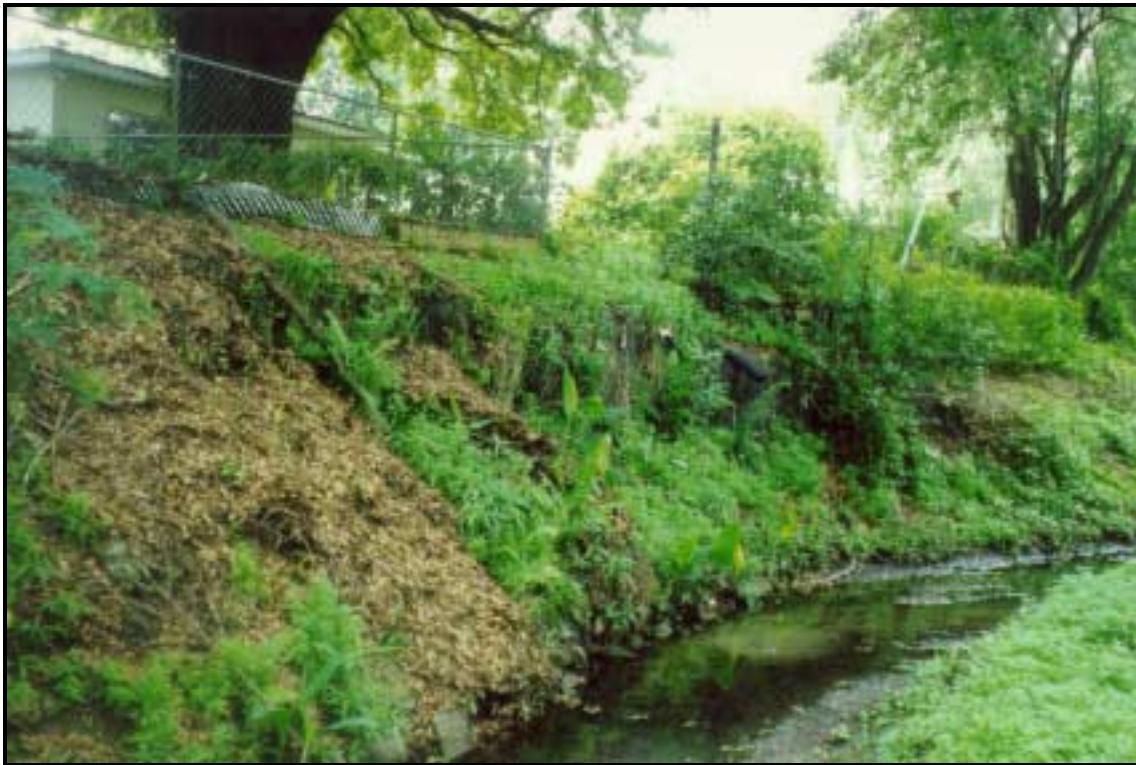
city's sewer or drainage system". Although these ordinances are interpreted to include lawn clippings, leaves, and fallen limbs, etc., such yard waste is not specifically mentioned in this portion of the Code. In order to facilitate the understanding and enforcement of this facet of the Code, it is recommended that "yard waste" be specifically included as a prohibited item.

Figure 3.6-1 Yard waste (Oak leaves) dumped by a resident on the banks of Upper Stevenson Creek.

The City Should actively seek to educate its residents on the negative effects of the dumping of yard waste into its creeks, ditches, and storm sewers. If necessary, these education efforts should be followed by active enforcement of the applicable ordinances.
