PRELIMINARY ENGINEERING REPORT

CLEARWATER BEACH MARINA UTILITIES AND DRAINAGE IMPROVEMENTS CITY PROJECT NUMBER 14-005-MA

**PRELIMINARY ENGINEERING REPORT
MARINA UTILITIES AND DRAINAGE**

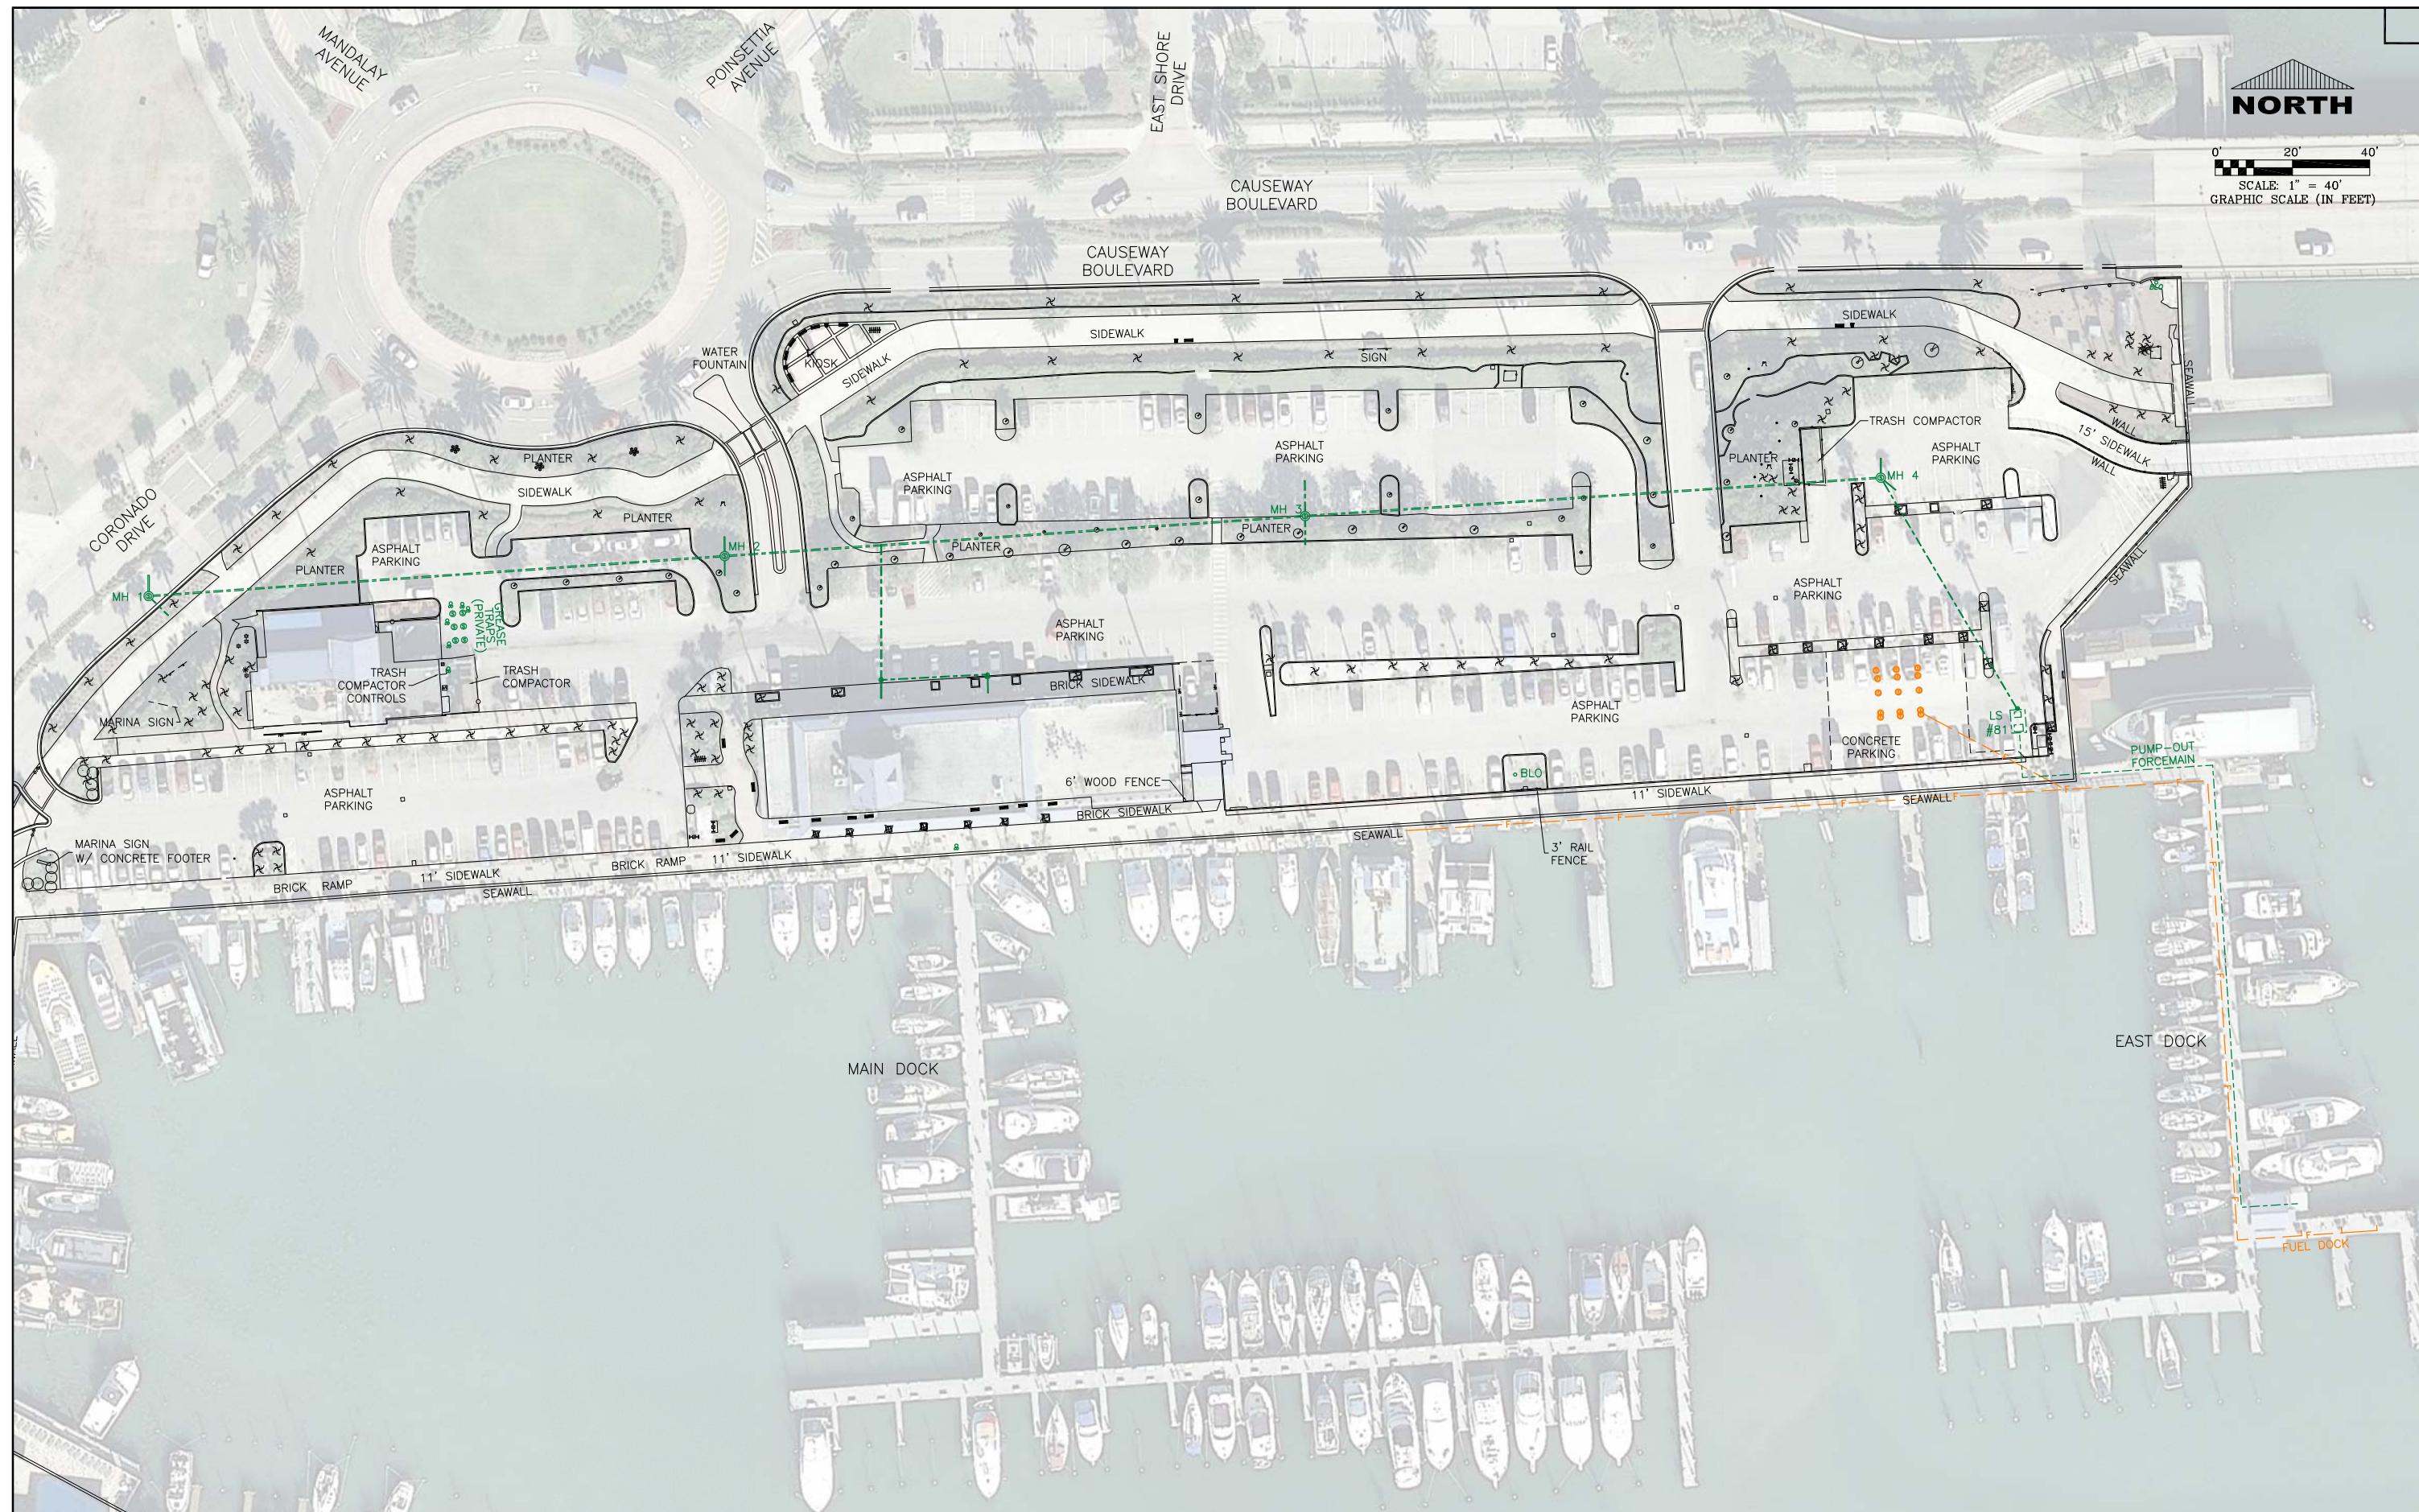
Clearwater Marina Parking Lot
WASTEWATER & FUEL LINE SYSTEMS

There is an east-west sanitary sewer collector that gathers waste flow and proceeds to the west. The sanitary collection system consists of four manholes that are installed approximately halfway between Causeway Boulevard and the waters of the marina. The first inlet is in manhole 4, as labeled in **Figure 4**, which includes a force main that is connected to an onsite pump station (Lift Station 81). There is an existing pump-out on the easternmost dock near transient boat slips. The pump-out allows emptying of wastewater holding tanks with a pump that was recently replaced. The pump-out conveys its waste directly to the onsite pump station, Lift Station 81, which conveys its flow to the eastern manhole described previously. **Figure 4** illustrates the existing wastewater collection system in the Beach Marina. The photos below are of the existing vacuum waste pump and of the existing Lift Station 81.

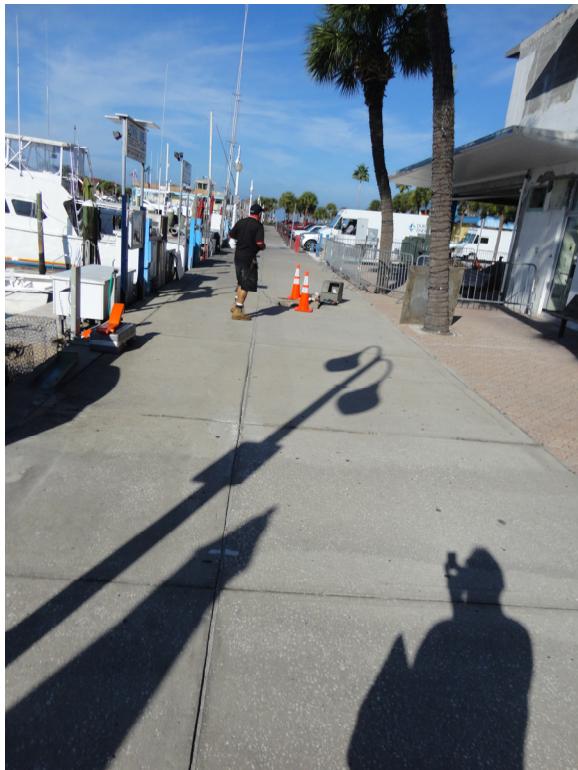
Verizon pull box in sidewalk

appeared to be in good condition and relatively orderly. If the number of locations where the phone services are terminated is reduced, the main lines could come in and at least three of the pull/junction boxes could be eliminated. Further, with the reduced number of pairs, the lines could be easier to service when there are problems. Because the phone lines are low voltage communication wires, they must be separated from any type of power line. It would be possible to locate the phone service lines that are post-Verizon trench as long as minimum separations are met. It would likely require shielded conduit upon leaving the trench if power service line are installed within the trench. Please see **Figure 9** for a depiction of the phone service utility with reduced service pairs.

It is recommended that the number of pairs of telephone service wires be closely reviewed with Verizon. The Beach Marina could then consider eliminating phone service to the majority of individual boat slips. The recommendation would still provide service to the commercial slips with vendors present, the marina, and the restaurants. It is preliminarily estimated that the number of pair of phone wires would reduce from 400 to roughly 100 and four main pull boxes may be able to be removed from the sidewalk area. The existing conduits and pull boxes

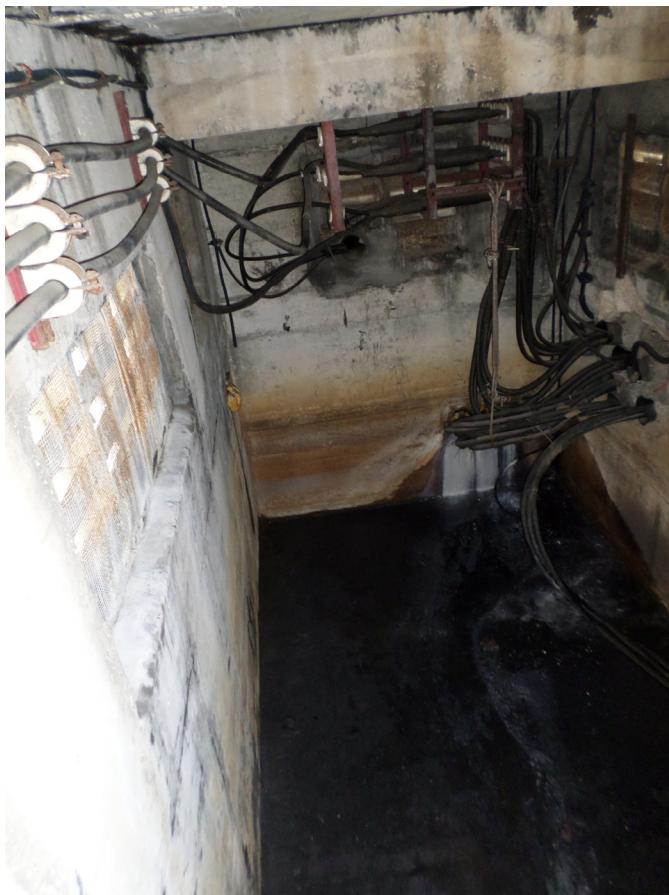
house transformers, it is being used as a manhole to route the secondary cables.

Interior view of the Duke Energy vault at the west service location

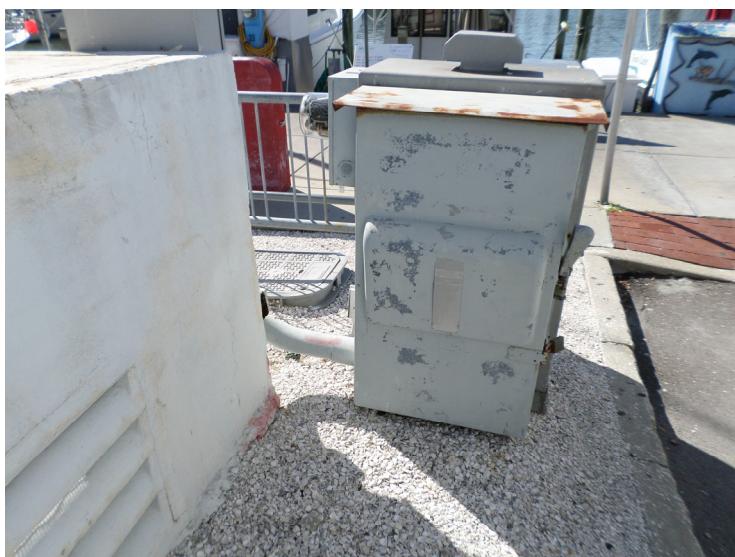
The second electrical service at the west location is for the boat slips located along the seawall and consists of a 320 amp 3 phase meter and 400 amp main fused disconnect for the 120/208V 3

phase power. The main disconnect appears to provide power to a concrete in ground hand hole located next to the main disconnect. The hand hole is assumed to be a splice point for the feeders from seawall boat slip pedestals to the feeder from the main disconnect. There is no over-current protection, other than the main disconnect, on the feeders to the pedestals along the seawall. A cursory observation of the electrical supply system for the

pedestals indicates that a 200 amp 3 phase, 120/208 V feeder in 2-inch conduit is supplied under the sidewalk and then through the seawall to a group of 4 to 5 pedestals. After the raceway penetrates the seawall, the conduit is secured to the exposed side of the seawall and looped between four to five pedestals. This service appears to provide power to marina slips pedestals 1 through 47 along the seawall. An estimated total of twelve 2-inch conduits for power distribution would be expected under this section of sidewalk originating from this service point with half routed east from the service location and half routed west from the service location.
