**CLEARWATER BEACH MARINA  
ELECTRICAL DISTRIBUTION EVALUATION  
& FEASIBILITY STUDY  
A/E #17039**

**25 CAUSEWAY BLVD  
CLEARWATER BEACH, FLORIDA 33765**

**CITY OF CLEARWATER  
CLEARWATER, FLORIDA**

**DRAFT REPORT  
SEPTEMBER 18, 2018**

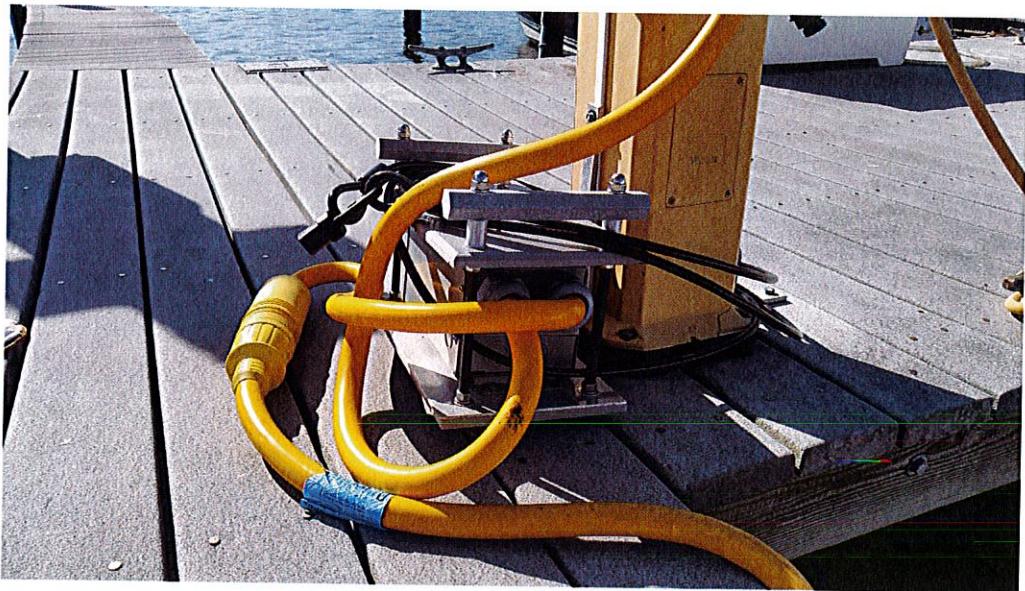
PHOTO 1- Shore Power Voltage Step-up Transformer

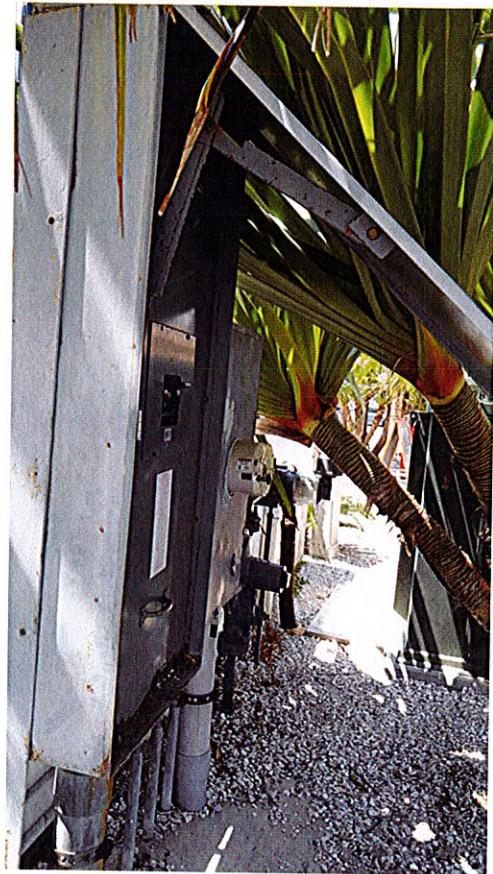
Electrical service disconnects are not properly labeled per NEC Article 230.3 (E), power distribution equipment is not labeled per NEC 110.22 and most equipment does not have Code compliant arc flash labels per NEC 110.21. Electrical panels with exposed live buss bars that are accessible from holes in bottom of electrical panels and cabinets (some enclosures have rusted-out bottoms).

PHOTO 2- Service Panel "MSP1" with bottom of cabinet rusted-out.

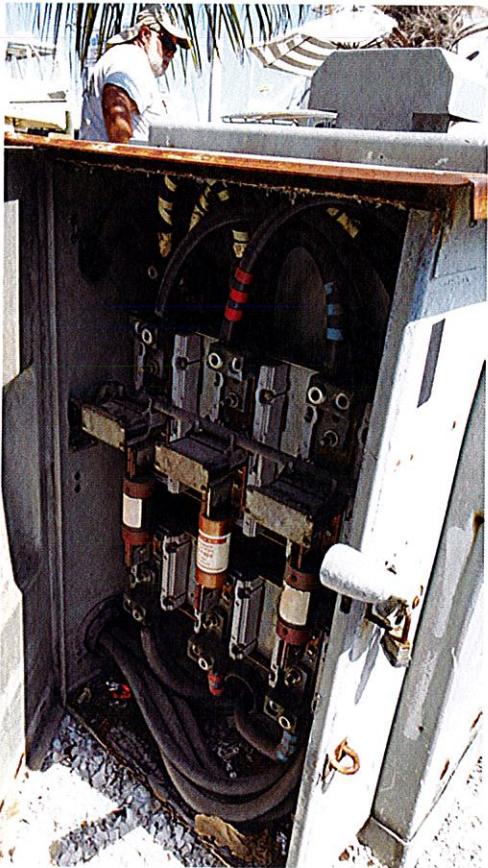
**PHOTO 3-** Service Switch "MSP2" with rusted-out bottom of enclosure

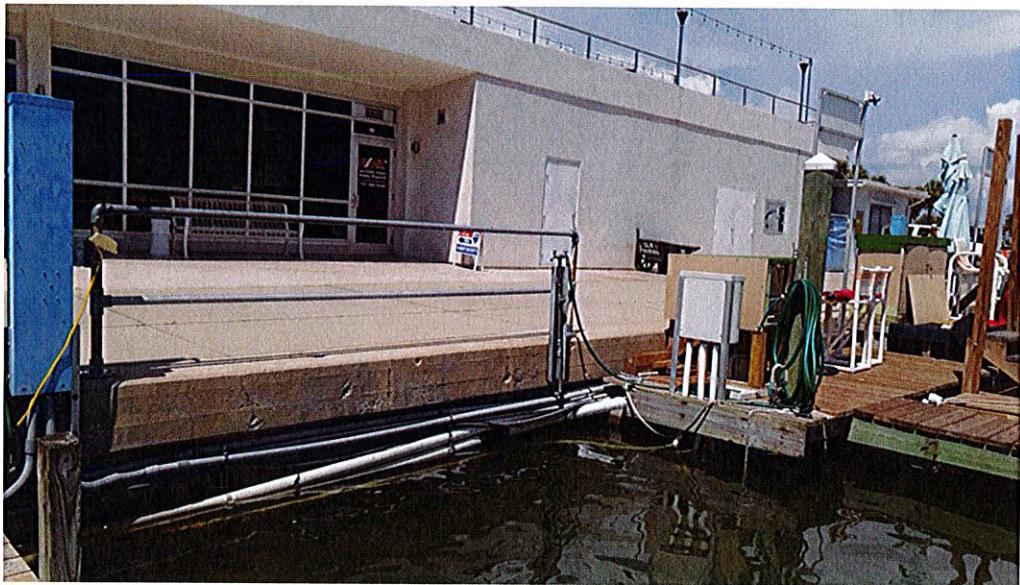
**PHOTO 4-** Feeder Conduits Not Supported

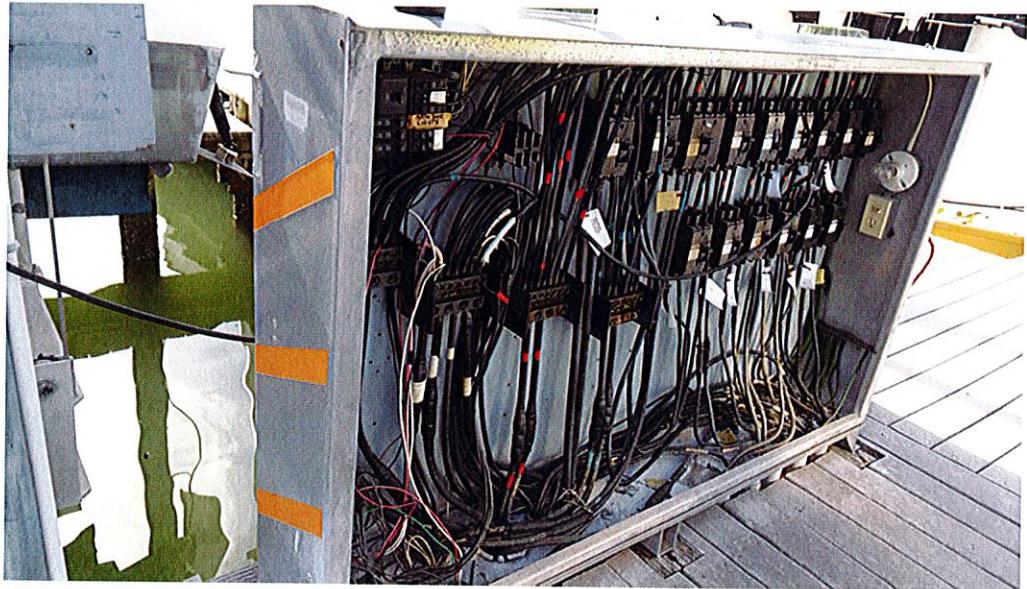
The existing service entrance panelboards and subpanels do not have a TVSS (transient voltage surge suppressor) or SPD (surge protective device) units. Most of the existing power distribution system equipment is in extremely poor condition and no longer serviceable. The existing power distribution service panels, panelboards, panelboard directory cards, meter centers, tap boxes, disconnects, slip power pedestals, and power distribution equipment are not labeled and Arc flash labels are not provided in accordance with NEC requirements. Electronic circuit breakers should be field tested and calibration verified. Thermography of circuit breakers and terminations is recommended. All abandoned equipment, wire and conduits shall be removed from distribution panels, tap boxes and cabinets. All feeder and branch circuit breakers in Tap boxes shall be labeled. Many panels are not rated for marine environment applications and have severe rust and are not safe. Reference pictures in Appendix A: pic #2 – Service panel "MSP1" and pic #3 – Service breaker "MSP2". Conduit Supports for many feeder conduits are missing and conduit is not adequately supported, reference pictures in Appendix A, pic #4. Feeder tap boxes had numerous taps, some illegal taps, not adequate conductor bending space and breaker labels missing, reference Appendix A, pic #5 and #6.

PHOTO 6- Feeder Tap Box "FT1" without feeder ground fault protection

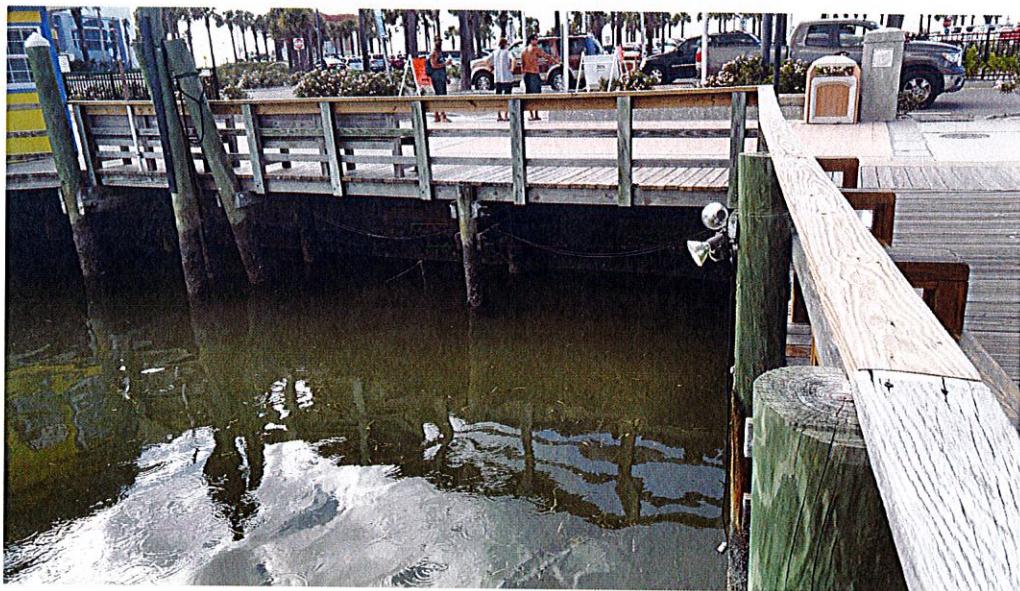
PHOTO 8- Cables not Supported

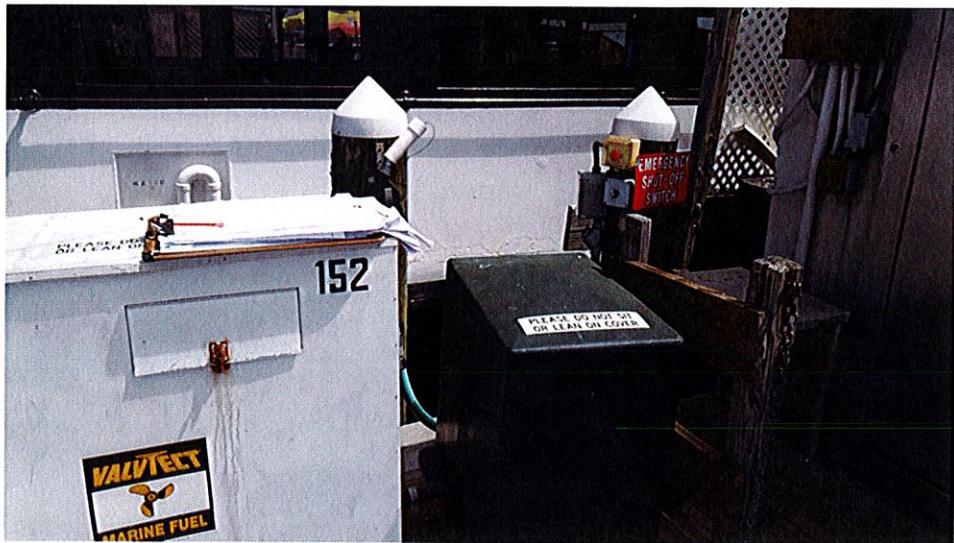
PHOTO 9- Fuel EPO Shut-Off PB Less than 20' from fuel dispenser

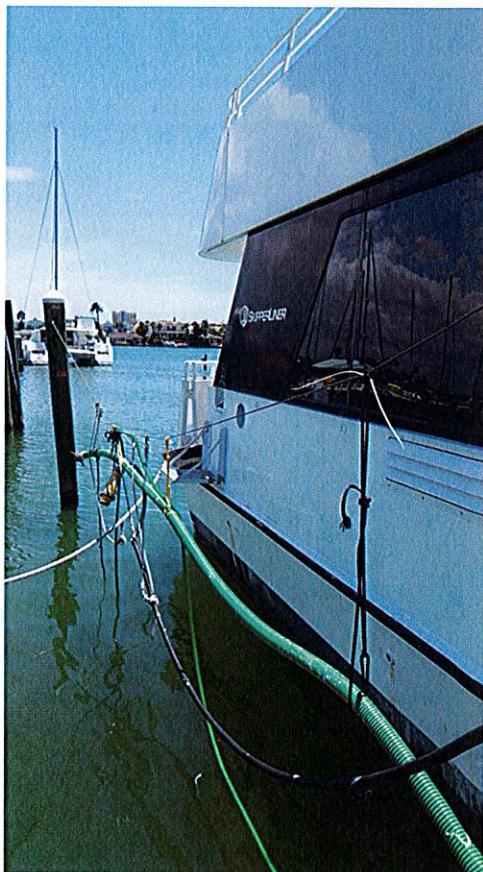
PHOTO 10- Improper Support of Power Cord

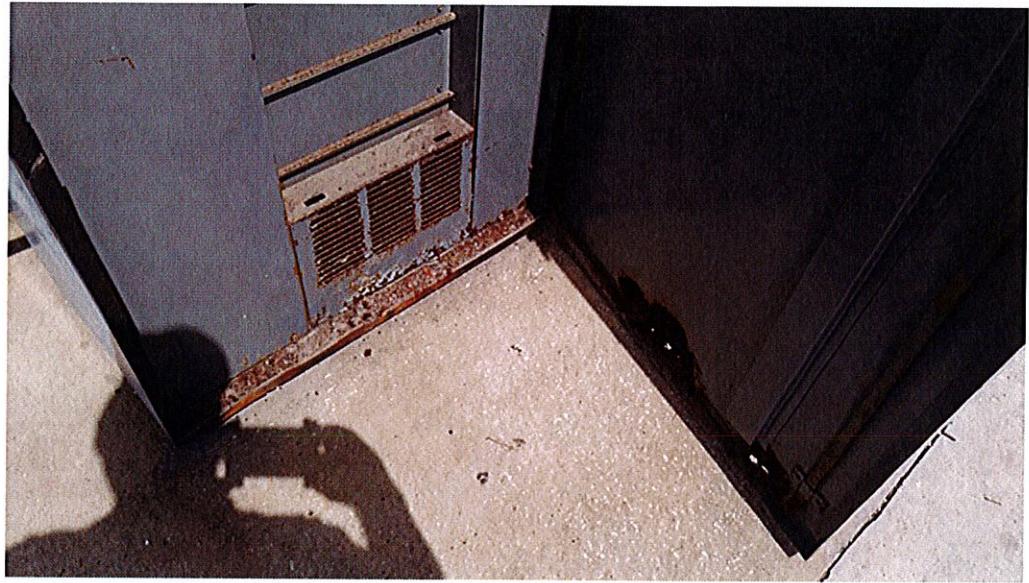
**PHOTO 11-** Service Panel MSP3 Rusted-Out Bottom

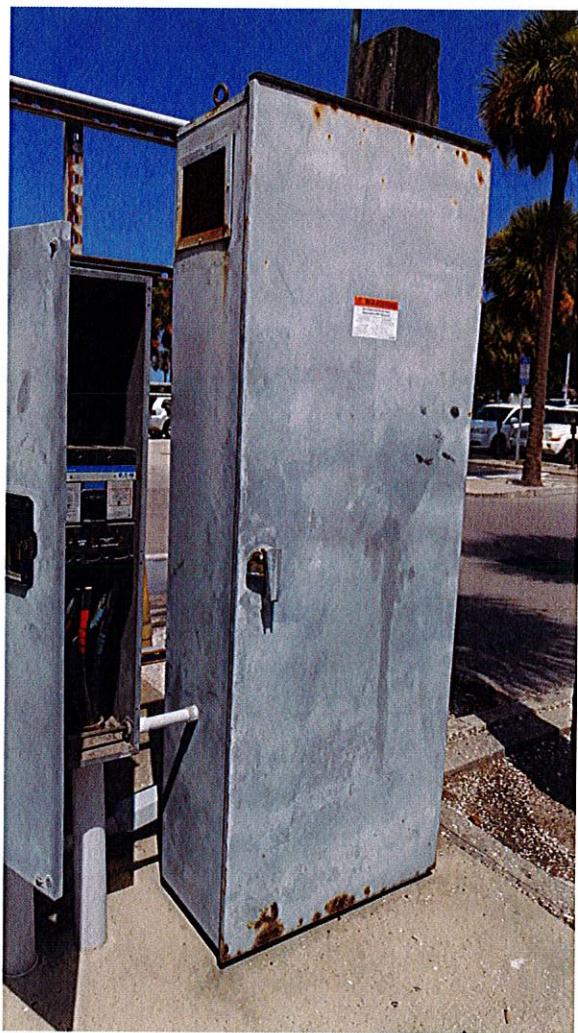
PHOTO 12- Service Panel "MSP3" and service switch "MSP4"

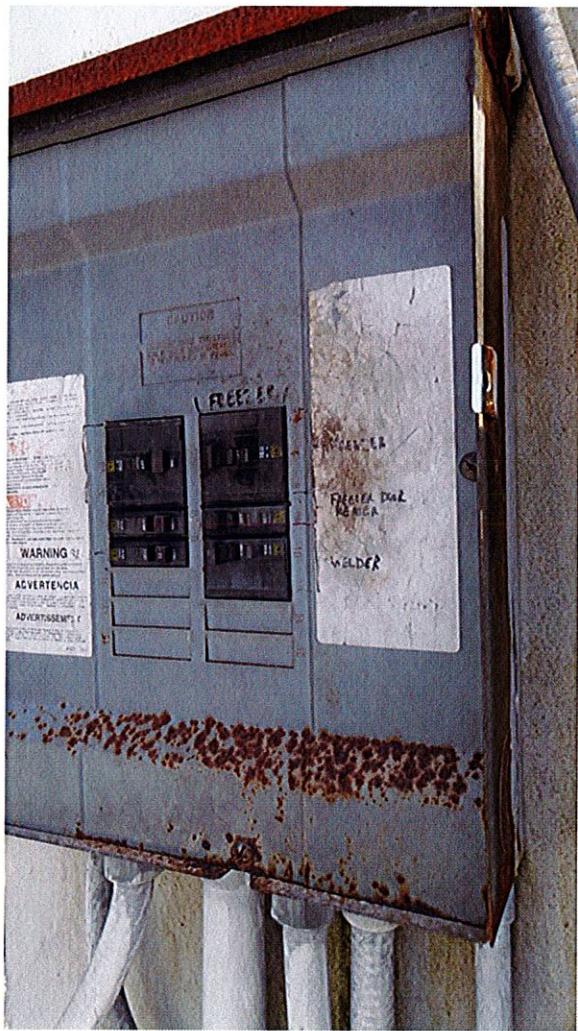
PHOTO 13- Panel With Significant Rust

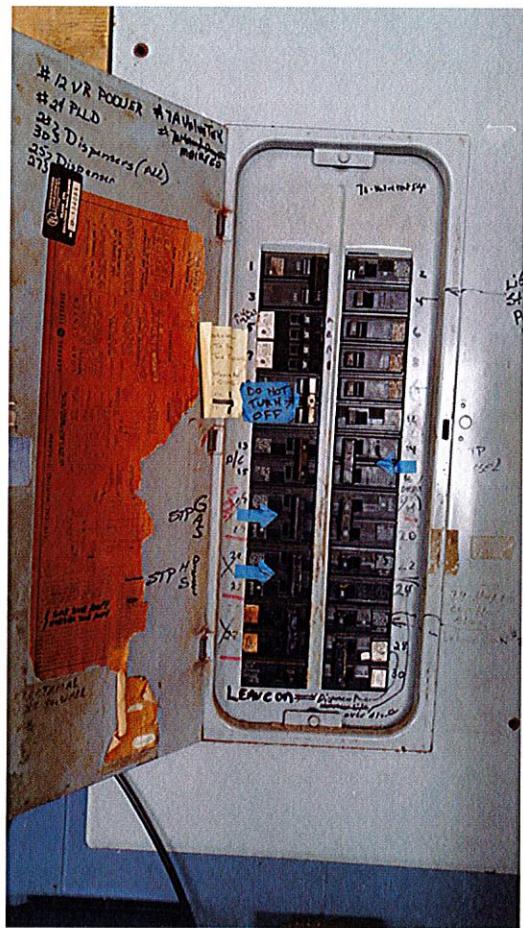
PHOTO 14- Fuel Dock House Sub-Panel- Panel and Branch Circuits Not Labeled Properly

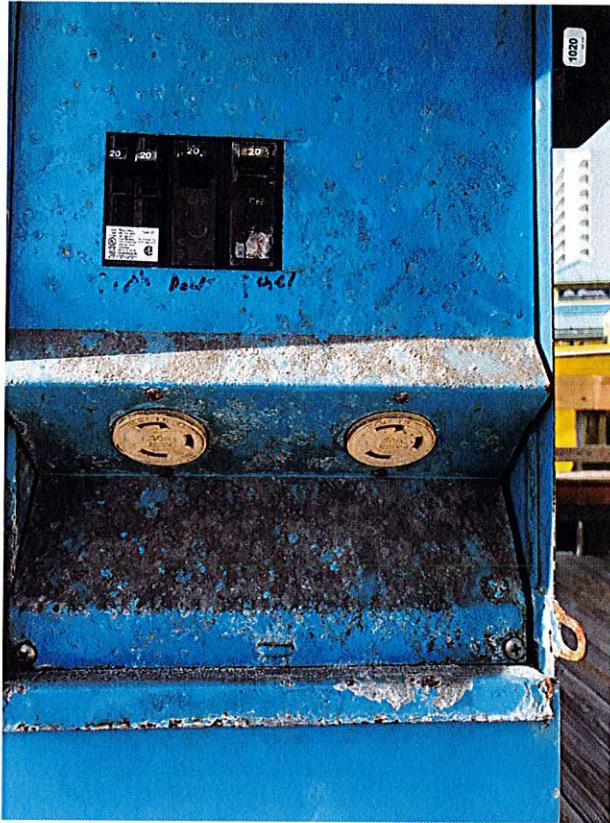
PHOTO 17- Power Pedestal with Excessive Corrosion

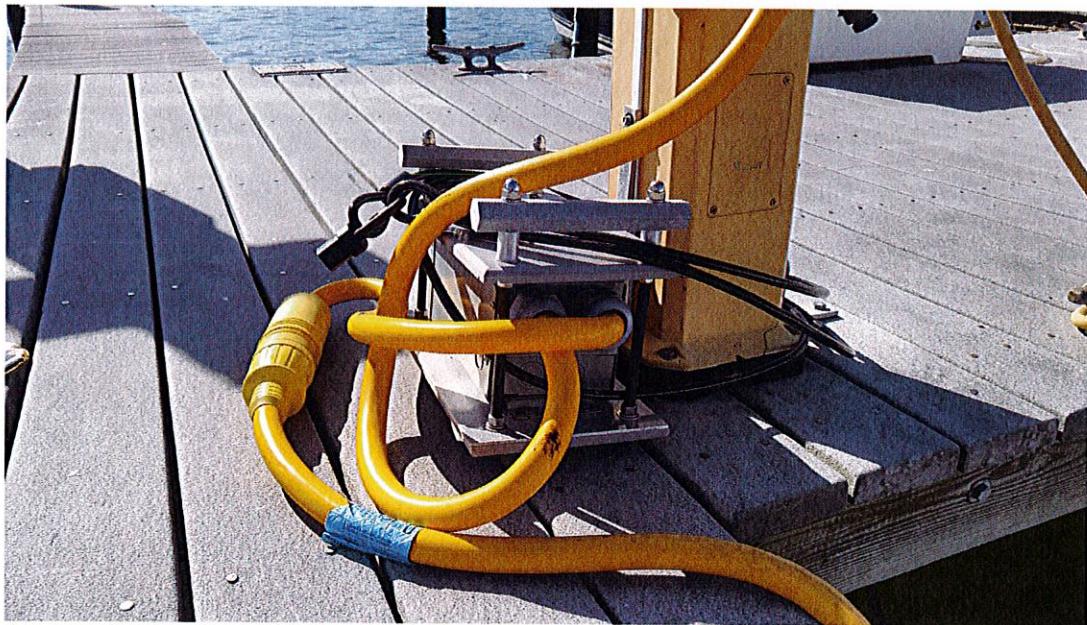
PHOTO 18- Voltage Booster Transformer

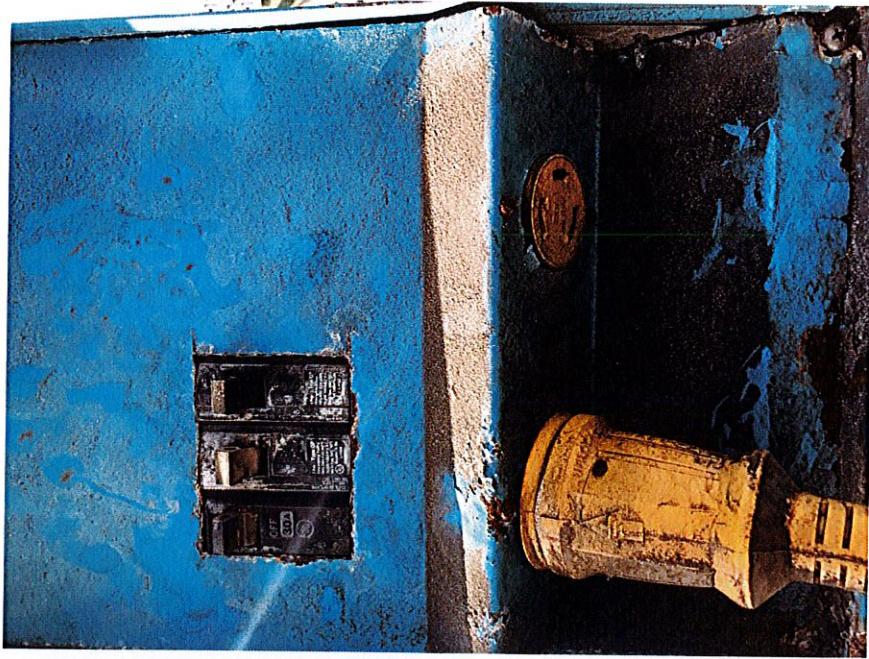
PHOTO 19- Power Pedestal with Significant Deterioration

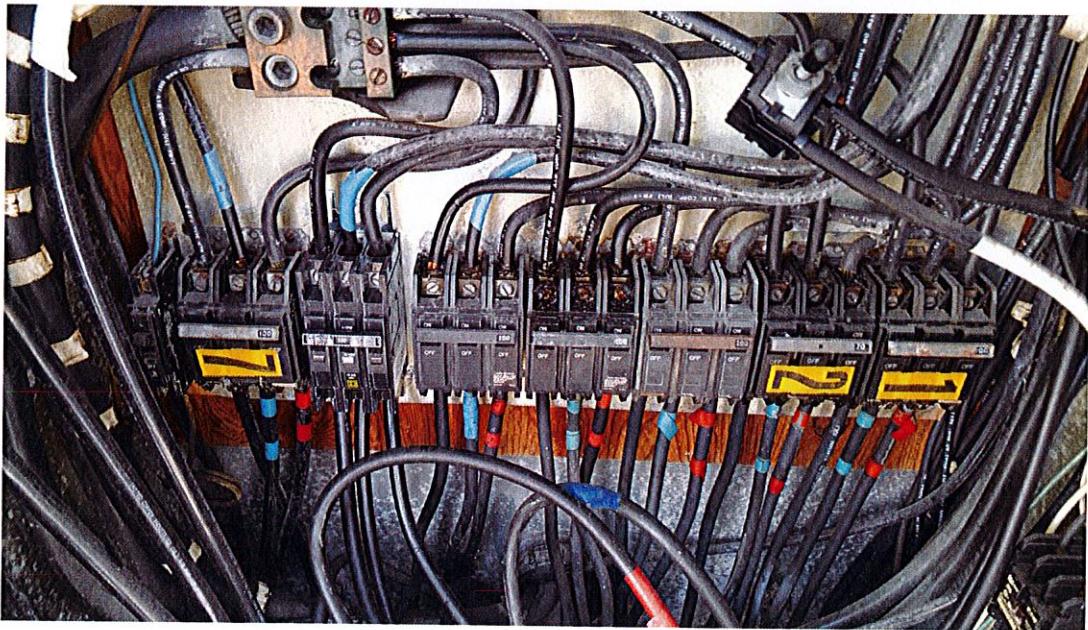
PHOTO 20- Feeder Tap Box "FT2" Without Feeder Circuit Ground Fault Protection

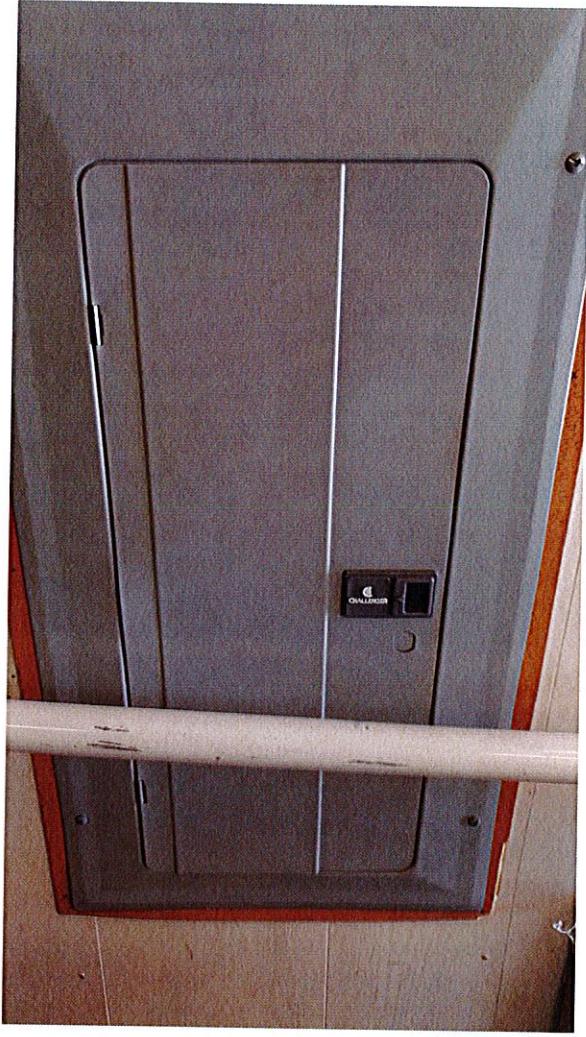
**PHOTO 21-** Starship II Rental Office Handrail Routed Over Panelboard Cover

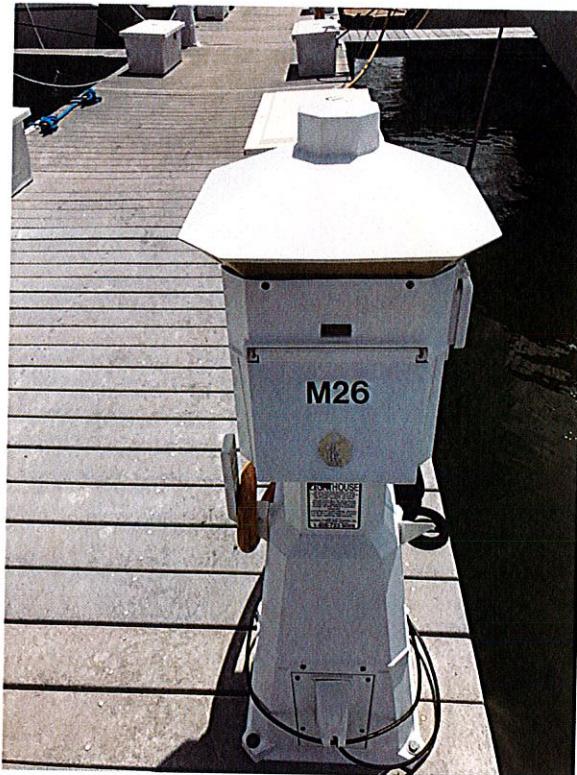
PHOTO 22- Shore Power Pedestal

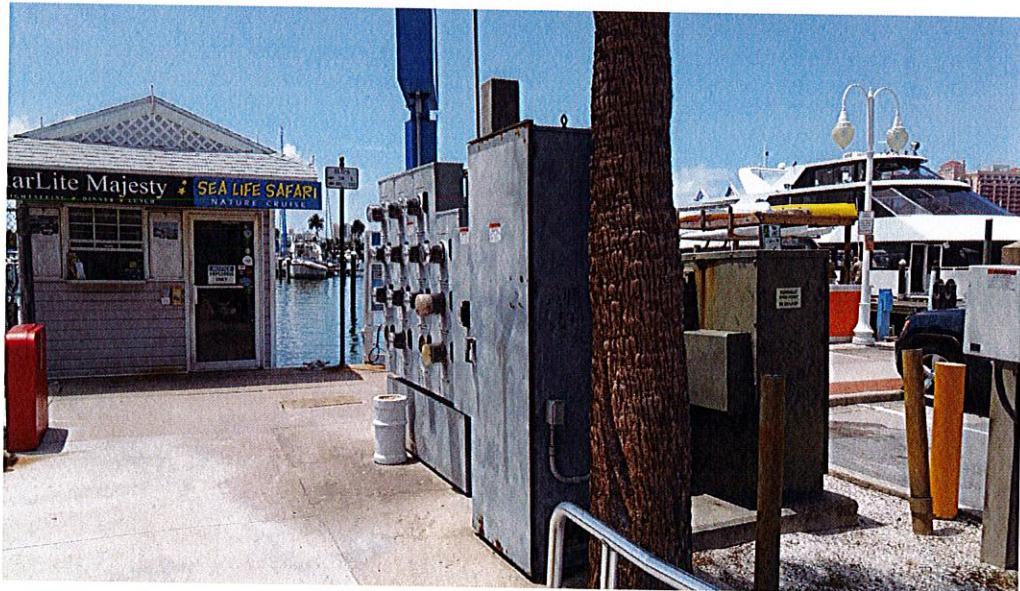
PHOTO 23- Service Panel "MSP3" and Meter Center "MC"
