**ADDENDUM NO. 1**  
**For**  
**18-0057-UT MS WRF Blend Tank Mixer**

**ADDENDUM #01 - Responses to Bidder Questions      09/28/2020**

Re: Structural Evaluation  
Marshall Street WRF Blend Tank  
City of Clearwater, Florida

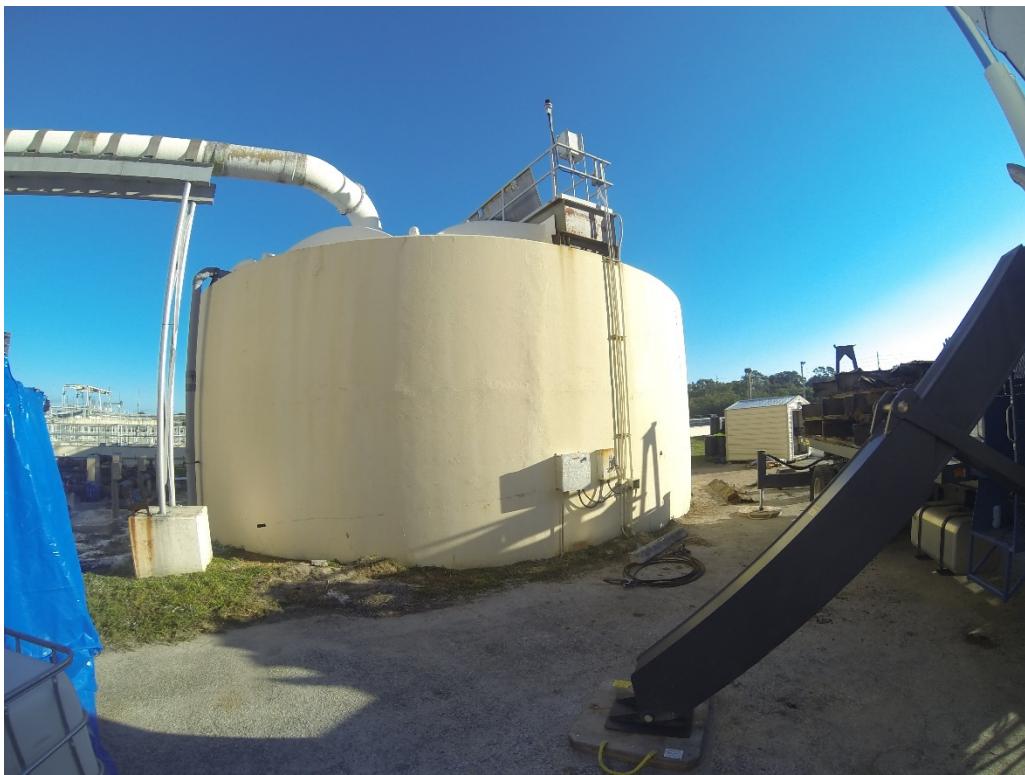
**Photo No. 1: Exterior View of Blend Tank**

- The exterior of the tank was observed to be in good to fair condition with minor cracking. No signs of active leaks or weeping was observed. (**Photo 1**)
- Only minor cracking was observed at the interior surfaces of the walls and floor slab. No spalling or exposed reinforcement was observed. There was no coating system visible at interior wall surfaces. (**Photo 3 & 4**)
- The access stairs and landings were taped-off. The treads on the stairs appear to be have experienced some degradation. The upper stair stringers had a noticeable horizontal lean. (**Photo 5**)
- Major corrosion of structural members was observed throughout the steel platform. Substantial to entire section loss was observed in the structural members. (**Photo 7-10**)

The overall condition of the concrete portions of the blend tank (walls and base slab) is in good to fair condition given the tanks age. Wekiva has also performed a cursory review of the structural record drawings that were prepared by Briley, Wild & Associates. After performing the site visit and reviewing the record drawings there are no structural concerns for the concrete portions of the tank to remain in service. During the visit, a portion of tank steel baffle walls were being cut and removed. It is recommended that any remaining steel within the tank be grinded below the concrete surfaces approximately 1" and provided with a corrosion inhibitor/bonding agent such as Sika Armatech 110 and then repaired flush with a Sikatop 123 repair mortar.
