**CLEARWATER BEACH MARINA  
ELECTRICAL DISTRIBUTION EVALUATION  
& FEASIBILITY STUDY  
A/E #17039**

**25 CAUSEWAY BLVD  
CLEARWATER BEACH, FLORIDA 33765**

**CITY OF CLEARWATER  
CLEARWATER, FLORIDA**

**DRAFT REPORT  
SEPTEMBER 18, 2018**

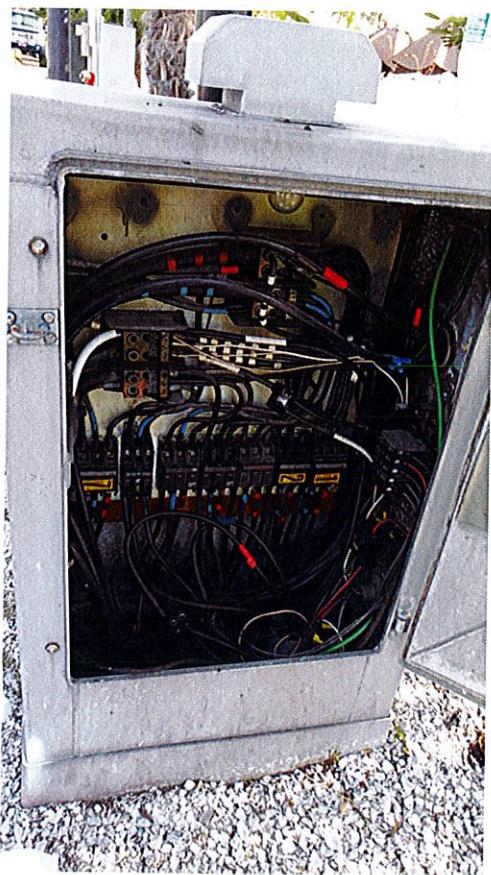
The existing service entrance panelboards and subpanels do not have a TVSS (transient voltage surge suppressor) or SPD (surge protective device) units. Most of the existing power distribution system equipment is in extremely poor condition and no longer serviceable. The existing power distribution service panels, panelboards, panelboard directory cards, meter centers, tap boxes, disconnects, slip power pedestals, and power distribution equipment are not labeled and Arc flash labels are not provided in accordance with NEC requirements. Electronic circuit breakers should be field tested and calibration verified. Thermography of circuit breakers and terminations is recommended. All abandoned equipment, wire and conduits shall be removed from distribution panels, tap boxes and cabinets. All feeder and branch circuit breakers in Tap boxes shall be labeled. Many panels are not rated for marine environment applications and have severe rust and are not safe. Reference pictures in Appendix A: pic #2 – Service panel "MSP1" and pic #3 – Service breaker "MSP2". Conduit Supports for many feeder conduits are missing and conduit is not adequately supported, reference pictures in Appendix A, pic #4. Feeder tap boxes had numerous taps, some illegal taps, not adequate conductor bending space and breaker labels missing, reference Appendix A, pic #5 and #6.

PHOTO 5- Feeder Tap Box "FT2"

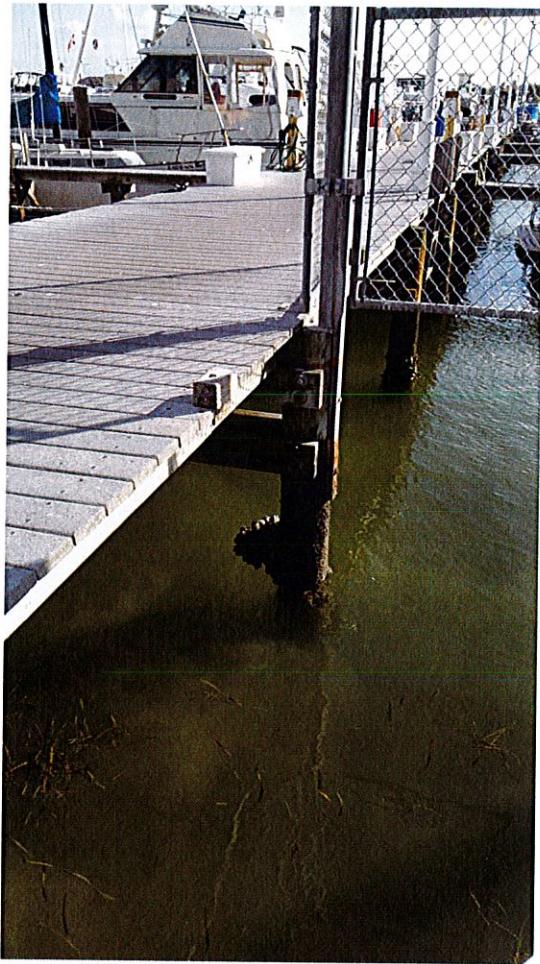
PHOTO 7- Electrical Datum Line Markings on Piling (one for west main docks and the other for east docks)

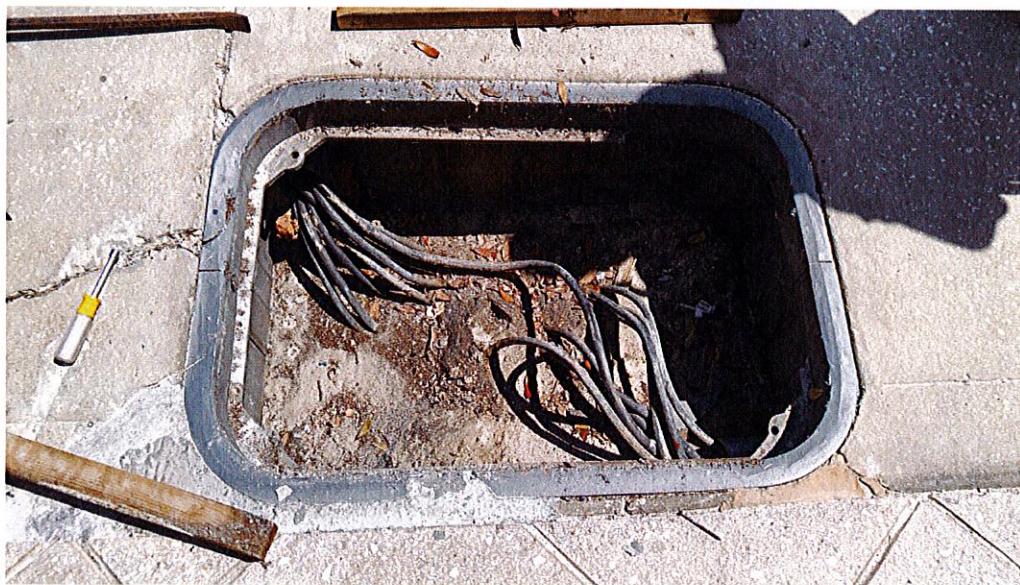
PHOTO 15- Feeder Circuit Handhole in Front of Main Dock

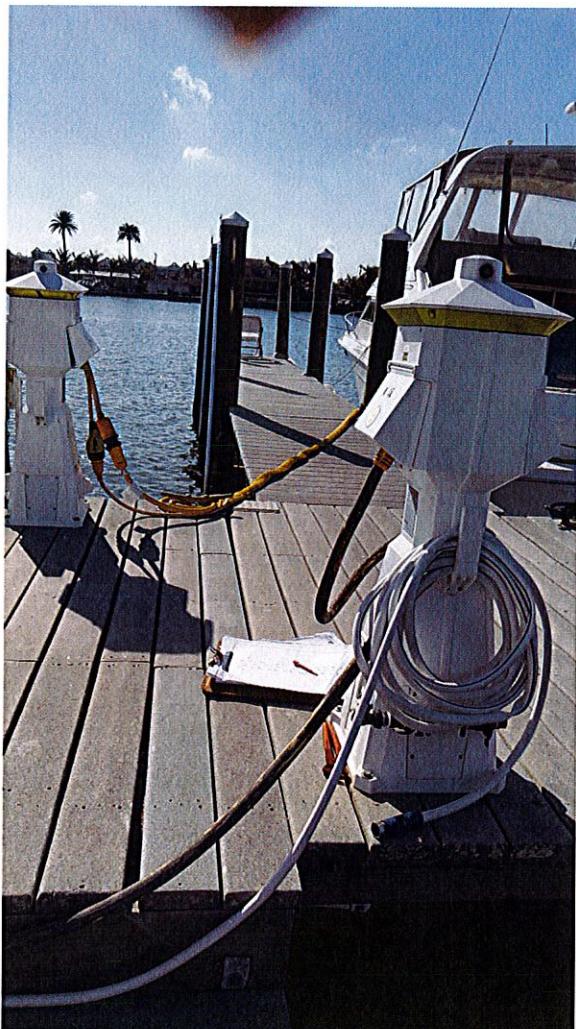
**PHOTO 16-** Power Cord "Y" Adapter Required For Larger Vessels With Larger Than 50A/2P Service And To Reduce Voltage Drop
