CITY PROJECT NO. 20-0036-EN-A

ISSUED FOR
BIDDING
06/30/21

BAYCARE BALL PARK
601 N OLD COACHMAN ROAD
CLEARWATER, FLORIDA 33765

STRUCTURAL
REPAIRS
(2021)

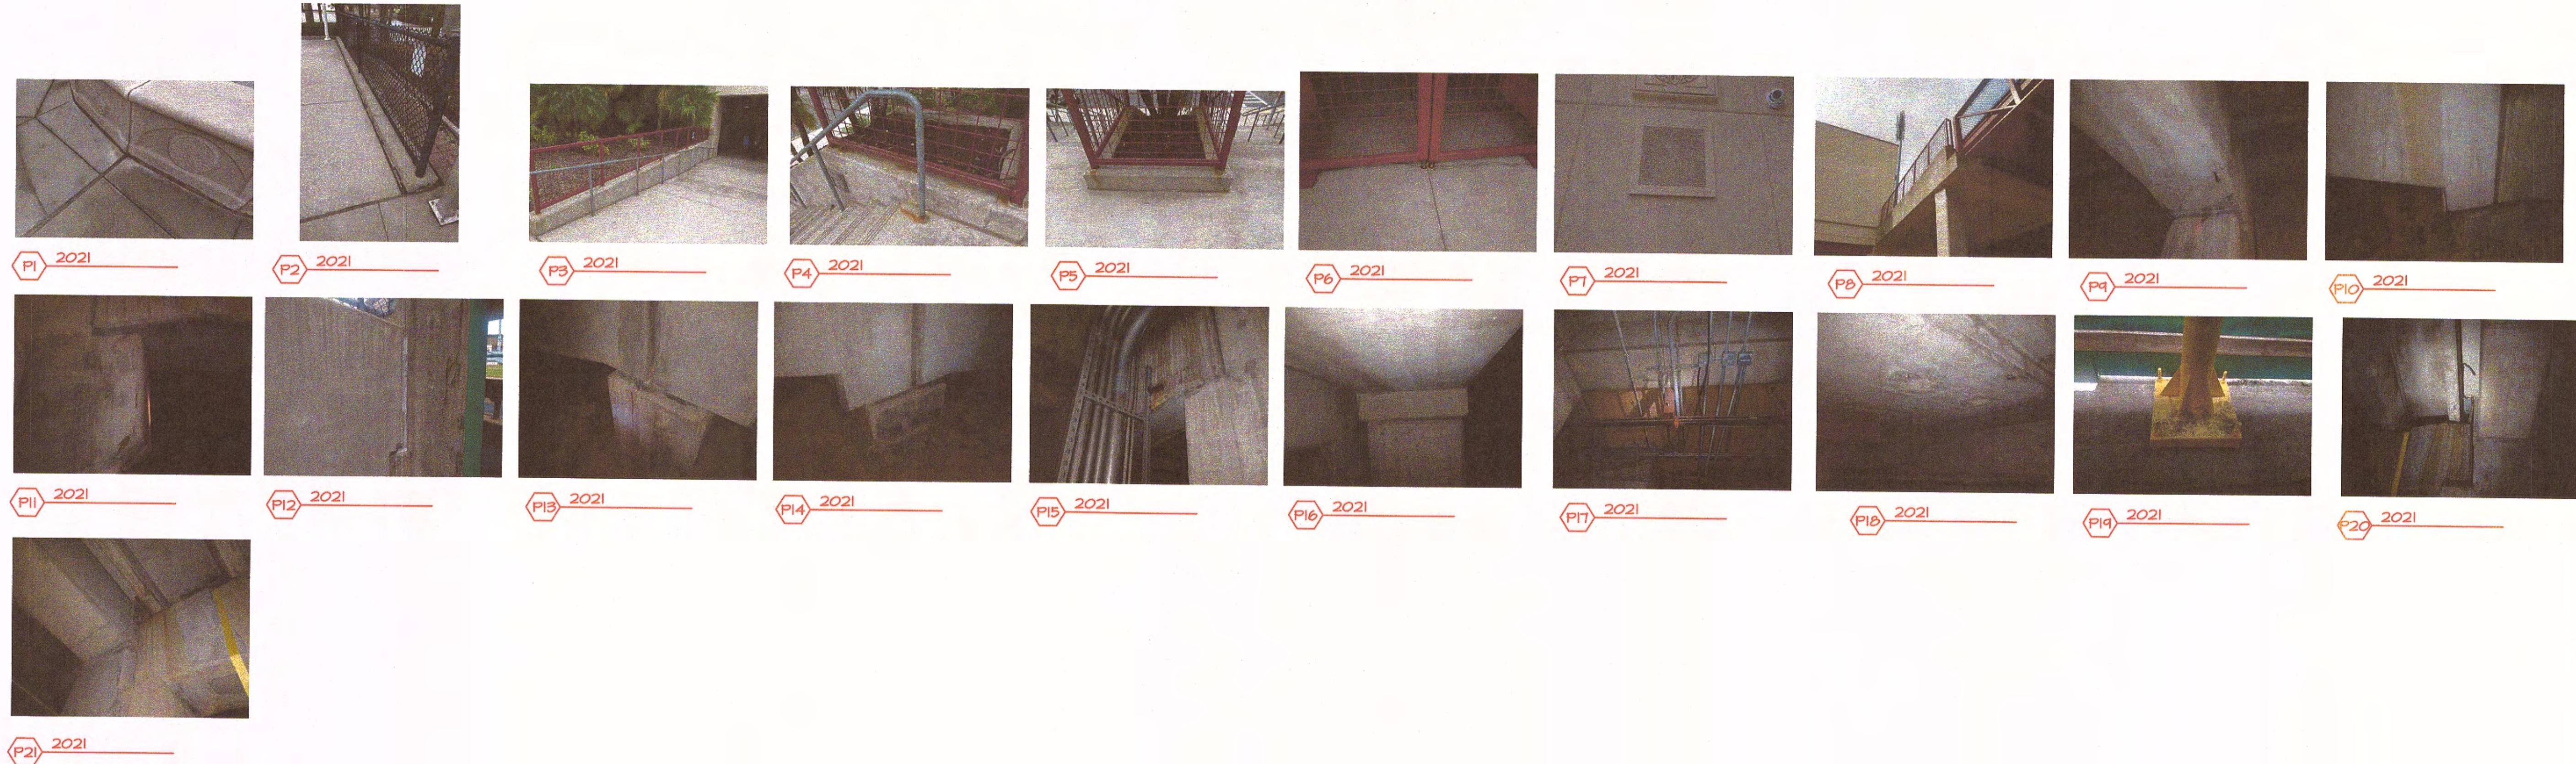
2021 SURVEY PHOTOS LOWER LEVEL

- P1: Damaged Sealant Joint
- P2: Bad Fence
- P3: Rusted Post Pocket
- P4: Rusted Steel
- P5: Rusted Post Pocket, Concrete Spall
- P6: Rusted Post Pocket
- P7: Damaged Speaker
- P8: Rusted Steel, Concrete Crack
- P9: Exposed Rebar
- P10: Concrete Crack
- P11: Concrete Crack
- P12: Failed Sealant Joint
- P13: Concrete Crack
- P14: Concrete Crack
- P15: Rusted Anchor
- P16: Concrete Spall
- P17: Rusted Steel Tubing
- P18: Concrete Spall
- P19: Repaint Baseplate
- P20: Sheet Metal Box
- P21: Sheet Metal Box

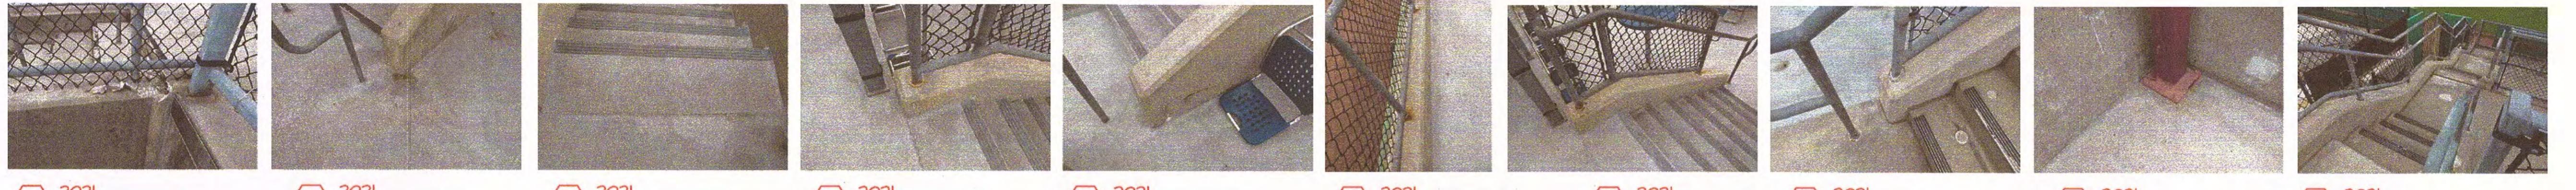
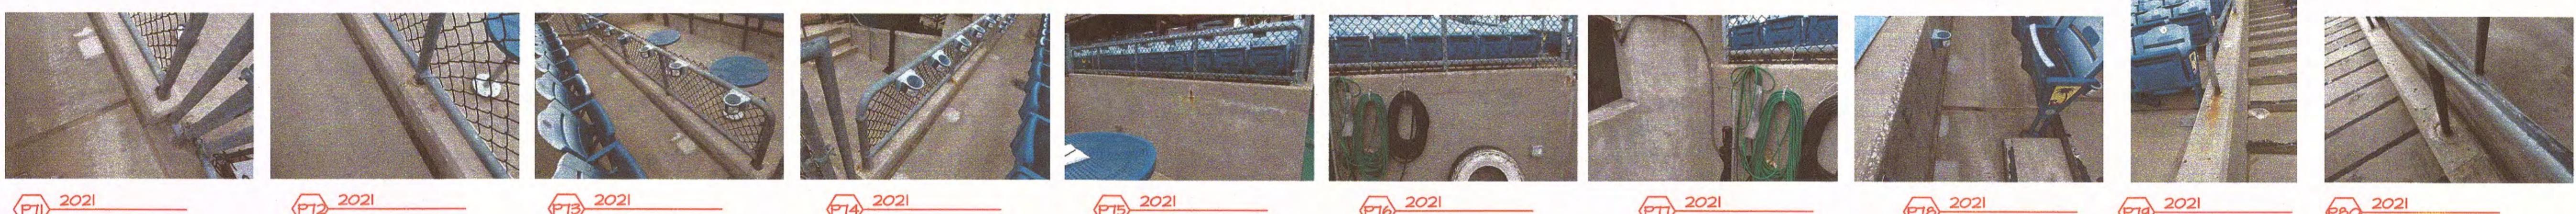
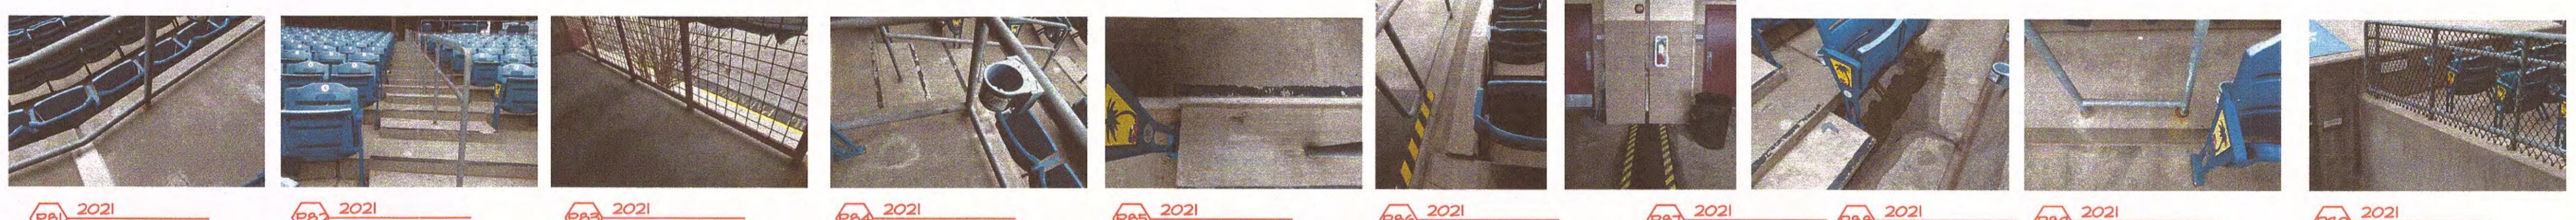
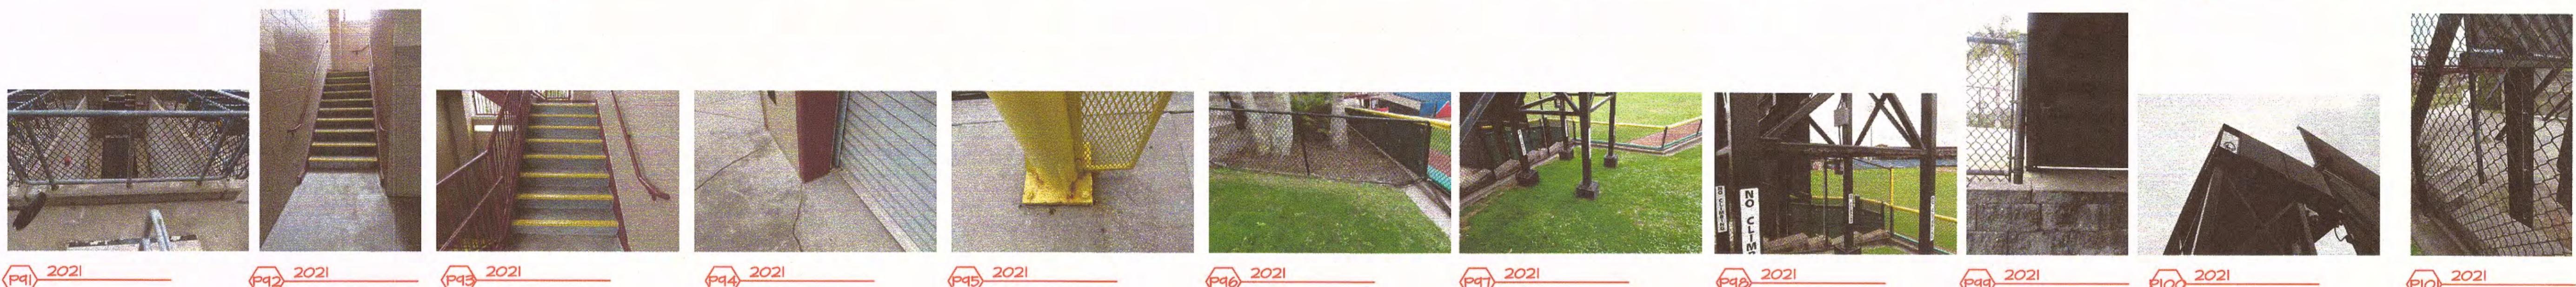
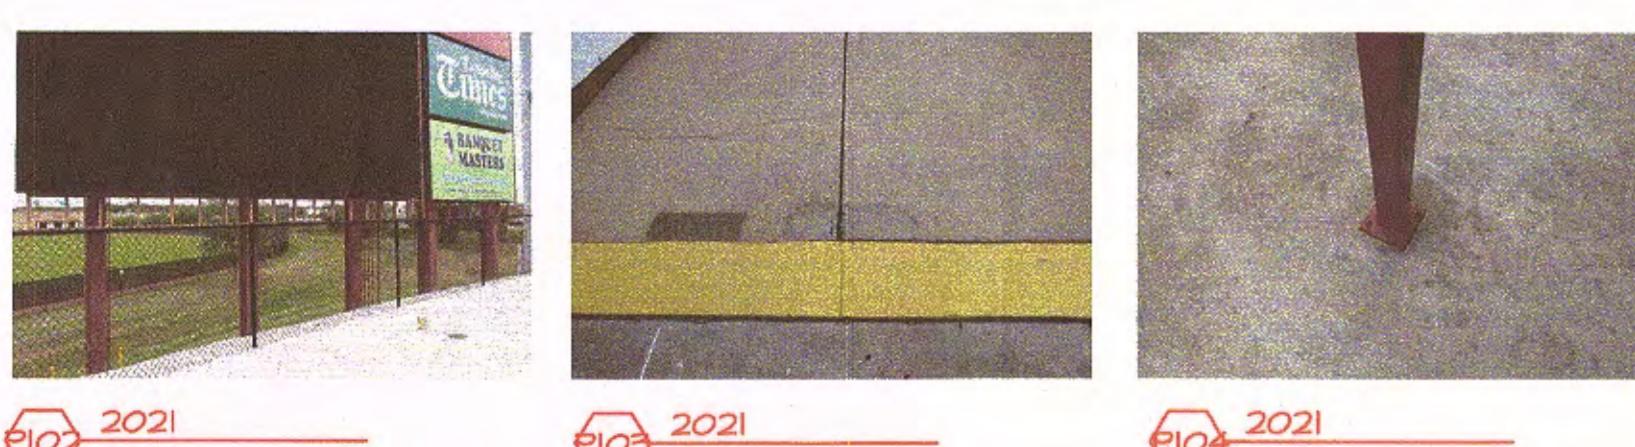
2021 SURVEY PHOTOS MAIN CONCOURSE PLAN

- Main Concourse level**
- P1: Rusted Post Pocket
 - P2: Rusted Post Pocket
 - P3: Rusted Post Pocket
 - P4: Rusted Post Pocket
 - P5: Rusted Post Pocket
 - P6: Rusted Post Pocket
 - P7: Damaged Light Cover
 - P8: Rusted Post Pocket
 - P9: Concrete Spall
 - P10: Rusted Post Pocket
 - P11: Rusted Post Pocket
 - P12: Rusted Post Pocket
 - P13: Concrete Crack
 - P14: Concrete Spall, Exposed Rebar

- P15: Concrete Spall, Rusted Steel
- P16: Speaker Damage
- P17: Rusted Steel
- P18: Damaged Sealant Joint
- P19: Concrete Crack
- P20: Concrete Crack, Concrete Spall

- P21: Rusted Post Pocket, Concrete Crack
- P22: Deck Cover Damage
- P23: Rusted Post Pocket
- P24: Rusted Railing
- P25: Rusted Railing
- P26: Bent Steel
- P27: Concrete Spall

- P28: Rusted Steel
- P29: Concrete Spall
- P30: Rusted Post Pocket
- P31: Rusted Post Pocket
- P32: Rusted Steel
- P33: Concrete Spall
- P34: Bad Fence
- P35: Damaged Sealant Joint

- P36: Rusted Steel
- P37: Concrete Crack
- P38: Concrete Spall
- P39: Concrete Spall
- P40: Rusted Post Pocket
- P41: Rusted Post Pocket
- P42: Rusted Post Pocket

- P43: Concrete Spall
- P44: Concrete Spall
- P45: Rusted Post Pocket
- P46: Rusted Post Pocket
- P47: Rusted Post Pocket
- P48: Concrete Spall
- P49: Concrete Spall

- P50: Concrete Spall
- P51: Concrete Spall
- P52: Failed Coating
- P53: Failed Sealant Joint
- P54: Rusted Post Pocket
- P55: Concrete Spall
- P56: Rusted Post Pocket

- P57: Rusted Post Pocket
- P58: Failed Sealant Joint
- P59: Rusted Steel
- P60: Concrete Crack

- P62: Failed Sealant Joint
- P63: Concrete Spall
- P64: Failed Sealant Joint
- P65: Rusted Post Pocket
- P66: Concrete Spall
- P67: Exposed Rebar
- P68: Rusted Post Pocket

- P69: Failed Sealant Joint
- P70: Failed Sealant Joint
- P71: Concrete Crack
- P72: Concrete Crack
- P73: Rusted Post Pocket
- P74: Rusted Post Pocket
- P75: Cracked Cold Joint

- P76: Cracked Cold Joint
- P77: Cracked Cold Joint
- P78: Failed Sealant Joint
- P79: Rusted Post Pocket
- P80: Concrete Crack, Failed Sealant Joint
- P81: Rusted Post Pocket

- P82: Rusted Post Pocket
- P83: Rusted Post Pocket
- P84: Rusted Steel
- P85: Exposed Rebar
- P86: Failed Sealant Joint
- P87: Damaged Expansion Joint
- P88: Standing Water

- P89: Rusted Post Pocket
- P90: Rusted Post Pocket
- P91: Rusted Post Pocket
- P92: Stair Damage
- P93: Stair Damage
- P94: Rusted Steel
- P95: Rusted Baseplate

- P96: Bad Fence
- P97: Repaint Baseplate
- P98: Rusted Steel
- P99: Rusted Steel
- P100: Rusted Steel
- P101: Repaint Frame
- P102: Repaint Frame
- P103: Concrete Spall

- P104: Repaint Baseplate
