**Subject: Limited Condition Assessment
115 S MLK Jr. Ave.
Clearwater, FL 33756**

*Limited Condition Assessment
115 S MLK Jr. Ave.
Clearwater, Florida
BillerReinhart Project No. 18-325*

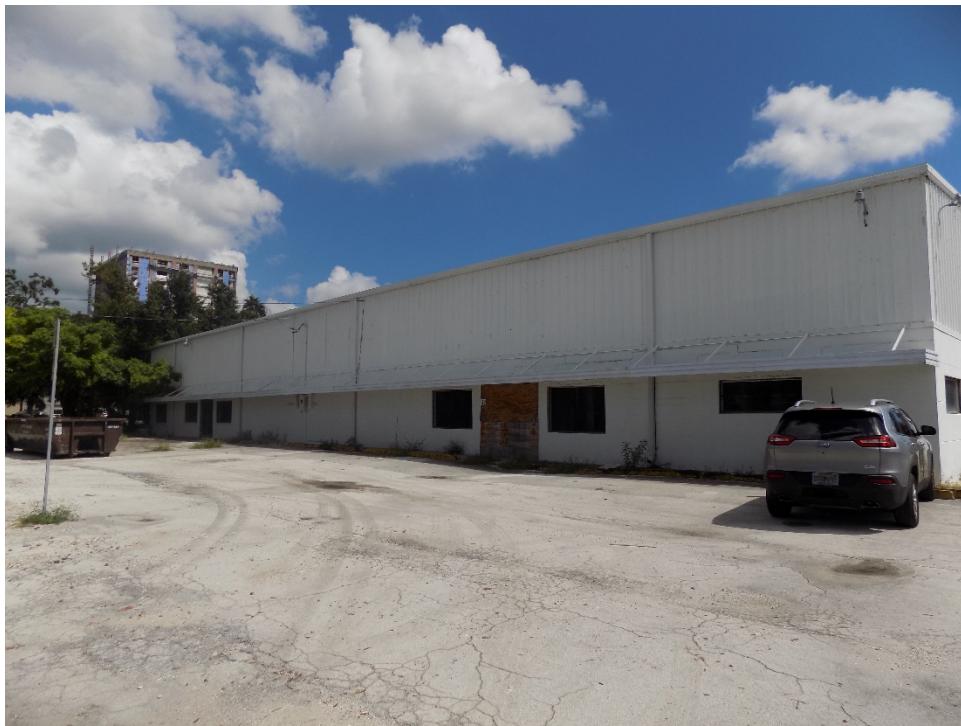
Figure A-1

Table A – Structure Exterior Observations	
Conditions Observed	Reference Photos (Figures in Appendix A)
West Elevation	A-1
Horizontal, Vertical, and stair-step cracking at the concrete masonry block (highest concentration at original structure; south end)	A-2 thru A-4
Cracking at concrete lintels overlying window units	A-5 and A-6
Cracking at the concrete window sills (addition)	A-7 and A-8
Paint delamination at lower concrete masonry block wall section (central portion of structure)	A-9
Indentations at metal wall panels	A-10
Paint delamination at metal wall panels	A-11
Deformation at canopy tension member	A-12
Tree branches bearing on canopy (north side)	A-13
Deformation and tearing at the canopy fascia (central portion)	A-14
Corrosion at fasteners underlying canopy	A-15
Run-off rust staining at concrete masonry block wall (central portion)	A-16
Minor wood decay at window framing	A-17
Separation cracking at the window frame and wall interface	A-18

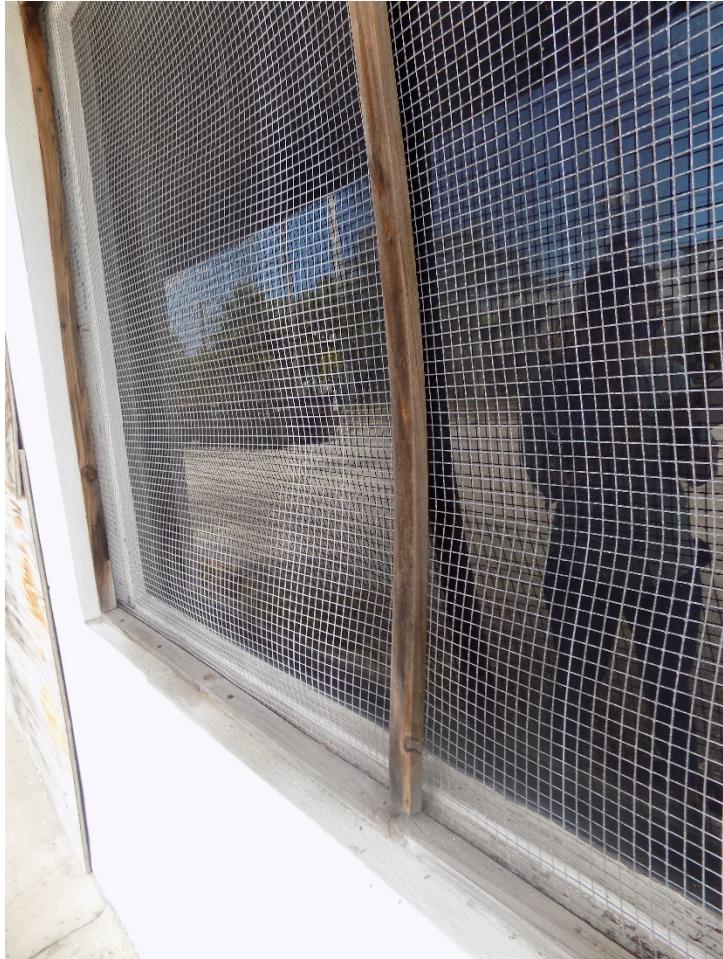
Figure A-19

Deformation at window screen framing	A-19
North Elevation	A-20
Hairline stair-step cracking at the east side of the north elevation	A-21
Partially displaced fascia	A-22
Paint delamination	A-23
Gap at wall and roof interface	A-24
South Elevation	A-25
Horizontal, Vertical, and stair-step cracking at the concrete masonry block	A-26 thru A-28
Cracking and spalling at concrete lintel overlying window units	A-29
Corrosion at fasteners located at abandoned canopy framing	A-30
Corrosion at overhead door rollers	A-31
Deformation at the gutter downspouts	A-32
Deformation at the overhead doors	A-33

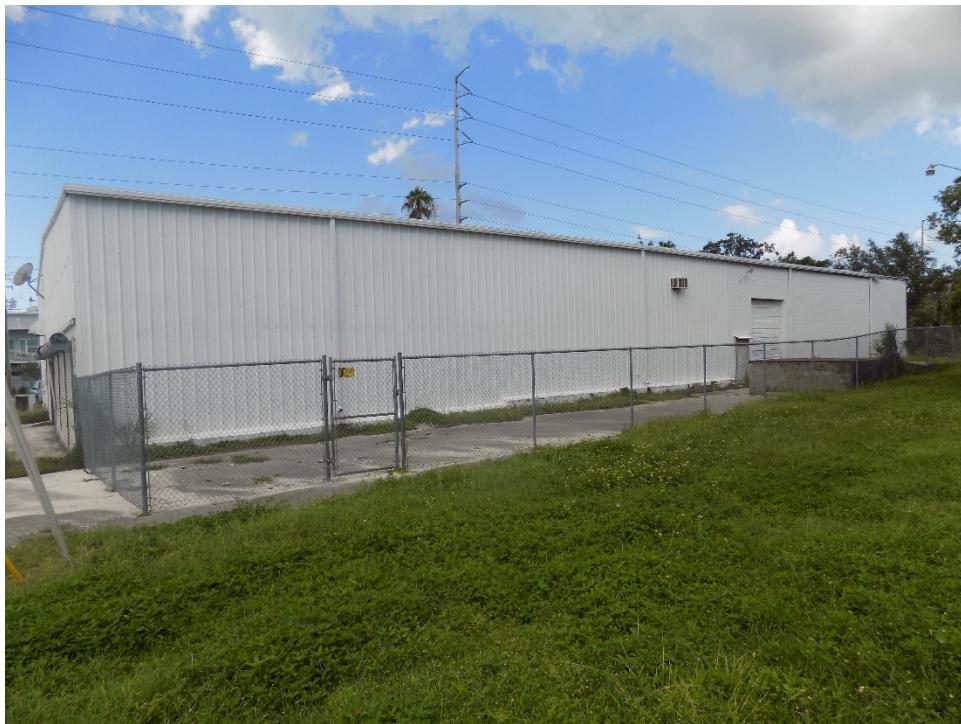
Figure A-34

East Elevation	A-34
Penetration at the corrugated metal wall panel (central portion)	A-35
Cracking, staining, and vegetation growth at concrete masonry stem wall	A-36
Corrosion at metal door	A-37
Deformation, paint delamination, and corrosion at loading dock overhead door	A-38
Separation cracking, paint delamination, and corrosion at metal accessory overlying the top concrete masonry unit course	A-39 and A-40
Run-off rust staining at concrete masonry block wall (north portion)	A-41
Displaced gutter system section (north section)	A-42

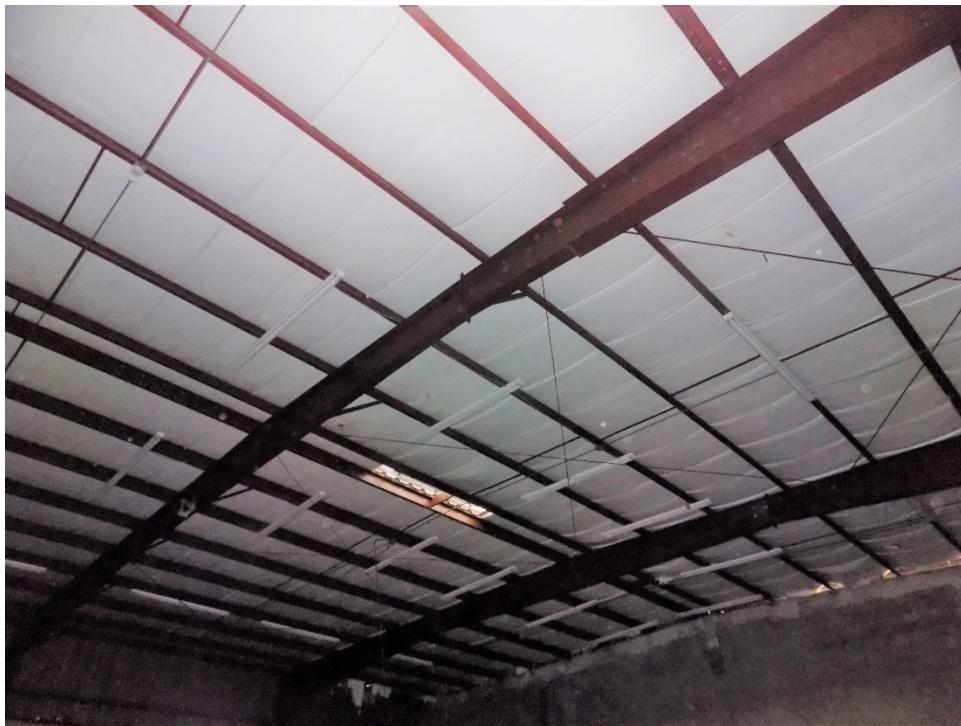
Figure B-1

Table B – Structure Interior Observations	
Conditions Observed	Reference Photos (Figures in Appendix B)
View of roof structure	B-1
View of bracing at wall girts, and roof purlins	B-2
Steel cable cross-bracing at moment frame	B-3
Steel cable cross-bracing at roof purlins	B-4
Moment frame connections	B-5 thru B-7
Steel wall girts	Reference B-2
Transition between metal wall panel and concrete masonry unit wall	B-8
Concrete columns and beams with concrete masonry block infills	B-9
Framing at the underside of the 2 nd floor mezzanine	B-10
Wood floor joists and cross-bracing at underside of 2 nd floor mezzanine	B-11
Elevation differentials at concrete slab joints (up to 2-inch differential)	B-12 and B-13
Cracking at concrete slab (isolated areas)	B-14 thru B-16

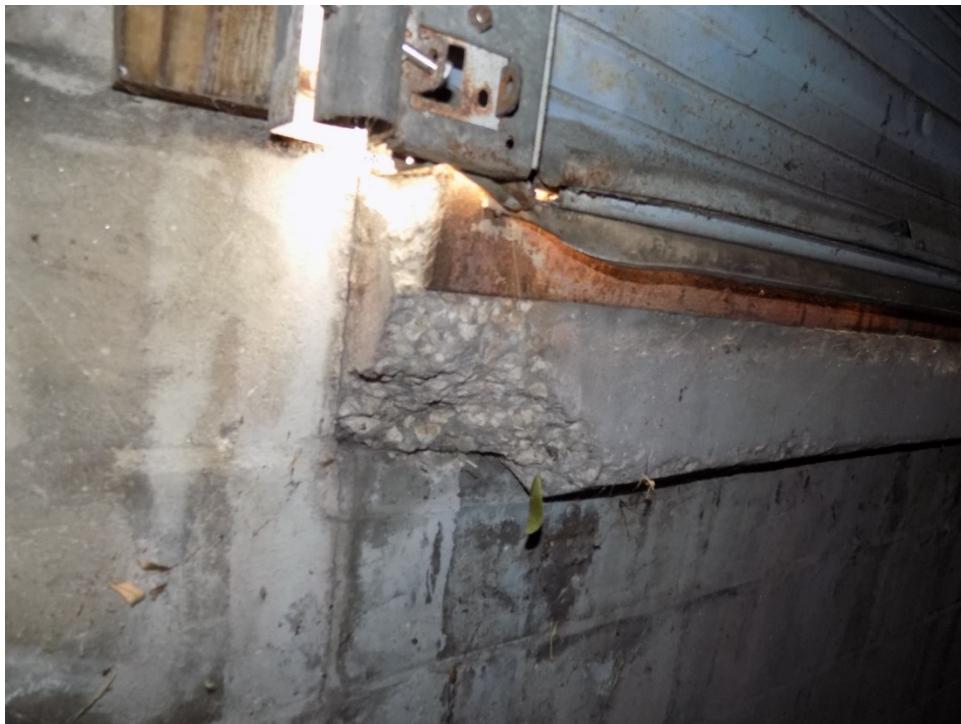
Figure B-17

Missing concrete section at north side of the loading dock along the east elevation	B-17
Isolated areas of torn roof insulation	B-18
Runoff rust staining down the concrete masonry unit wall and corrosion at the roof purlin located at the upper northwest corner of the structure	B-19
Corrosion at the bases of the steel columns located along the south elevation	B-20
Corrosion at steel framing located adjacent to the overhead doors along the south elevation	B-21
Corrosion at lower wall panel sections along the east elevation	B-22
Corrosion at lower metal angle along the east elevation	B-23
Wood decay at wall-mounted wood member (non-load bearing)	B-24
Splitting at wood beams underlying the 2 nd floor mezzanine	B-25
Tearing at metal wall panel located along the east elevation	B-26
Displaced railing at mezzanine stairway	B-27
Wood decay at the top of the mezzanine stairway landing and stair railing at the 2 nd story of the mezzanine	B-28 and B-29

- 1) Install elastomeric joint sealant at cracks within concrete slab
- 2) Repair concrete section at loading dock along east wall
- 3) Cleaning and coating of corroded metal members at the upper northwest corner of the structure
- 4) Cleaning and coating of steel columns and framing along the south wall
- 5) Cleaning and coating of corroded metal angle and wall panel along the east wall
- 6) Installation of new mezzanine railing system, including mezzanine stair railing
- 7) Removal and replacement of decayed mezzanine stairway landing members

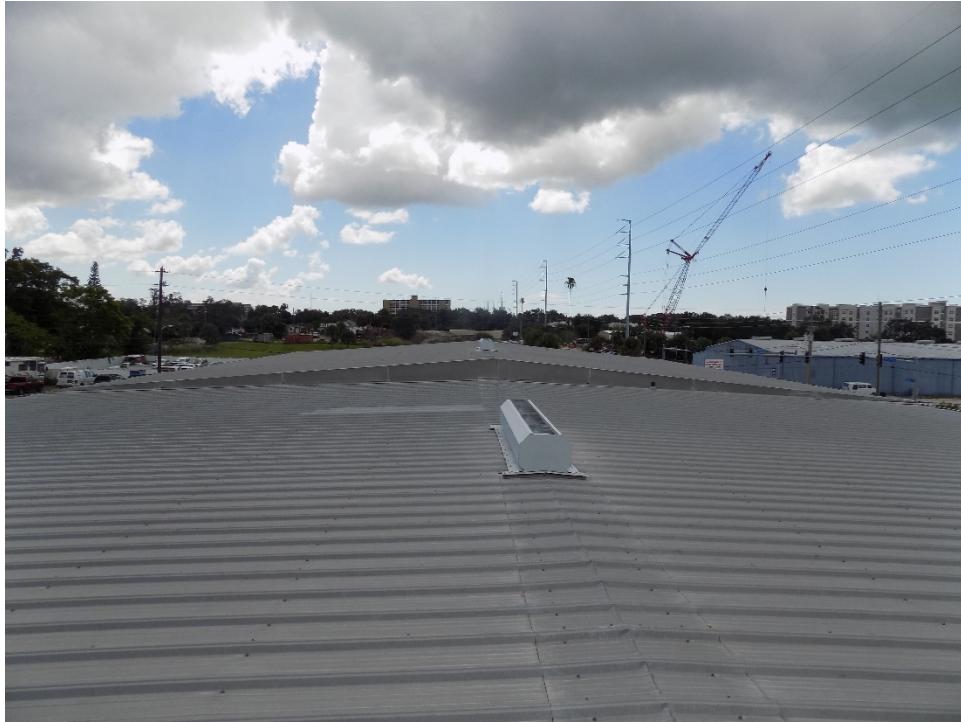
Figure C-1

Table C – Roof System Observations	
Conditions Observed	Reference Photos (Figures in Appendix C)
Roof System	C-1
Corrosion at the metal flashing installed along the northern roof rake	C-2
Intermittent isolated corrosion at the metal roof panels	C-3 and C-4
Protruding metal fastener at the east side of the roof transition between the original structure and the addition	C-5
Indentation at metal roof panel located at the southwest portion of the roof covering system	C-6
Corrosion at metal accessories attaching gutter system to roof system	C-7

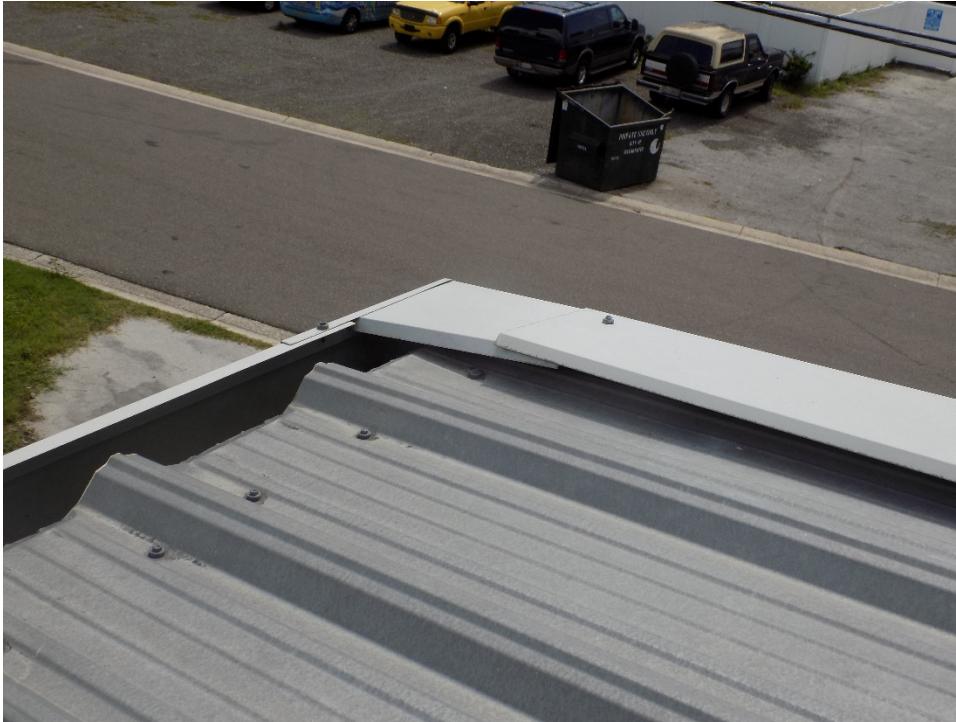
Figure C-9

Significant vegetation growth and debris accumulation within gutter system section located at the north side of the west elevation	C-8
Loosely attached roof flashing member at the east side of the southern roof rake	C-9

- 13) Removal and replacement of protruding metal fastener(s) along the roof transition
- 14) Re-attachment of the loose roof flashing at the east side of the south roof rake

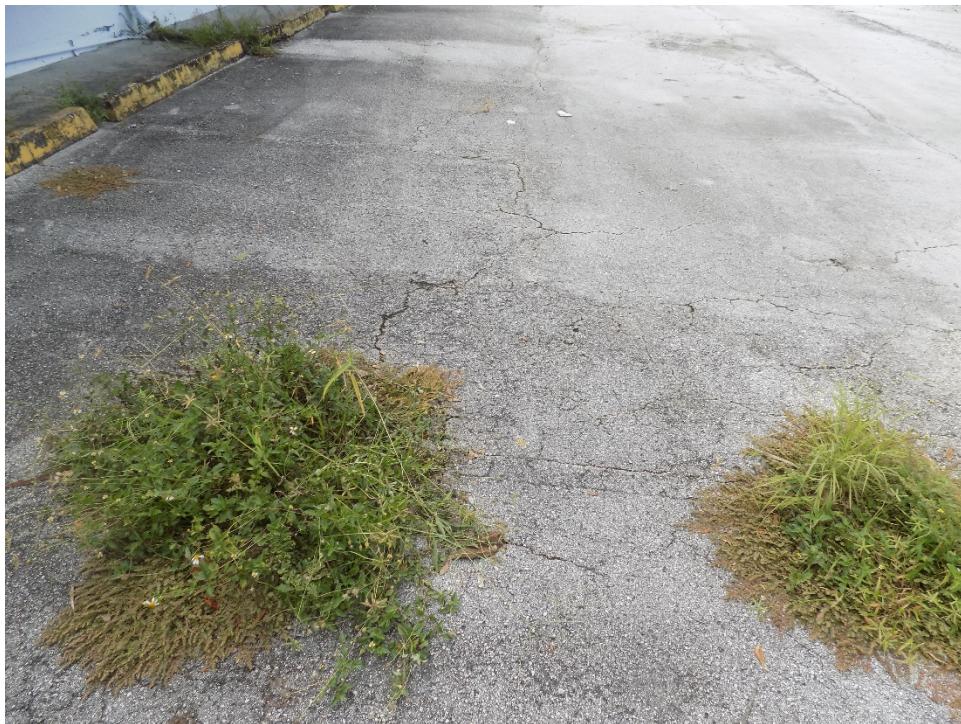
Figure D-1

Table D – Other Site Features Observations	
Conditions Observed	Reference Photos (Figures in Appendix D)
Cracking, vegetation growth, and depressions in the parking lot area	<i>D-1 and D-2</i>
Cracking at the concrete masonry units, concrete decking, and stairs at the loading dock along the east elevation	<i>D-3 and D-4</i>

- Cracking and depressions within the parking lot - consultation with a licensed Civil Engineer
- Painting – for specific paint coating requirements, we recommend consultation with painting specialists
- Elevation differential at interior concrete slabs – we recommend further evaluation, including consultation with a licensed Geotechnical Engineer
- A water test/flood test of the existing roof system to test water-tightness.
