Subject: Limited Condition Assessment
North Ward Elementary School
900 N. Fort Harrison Avenue
Clearwater, FL 33755

*Limited Condition Assessment
North Ward Elementary School
Clearwater, Florida
BillerReinhart Project No. 19-075*

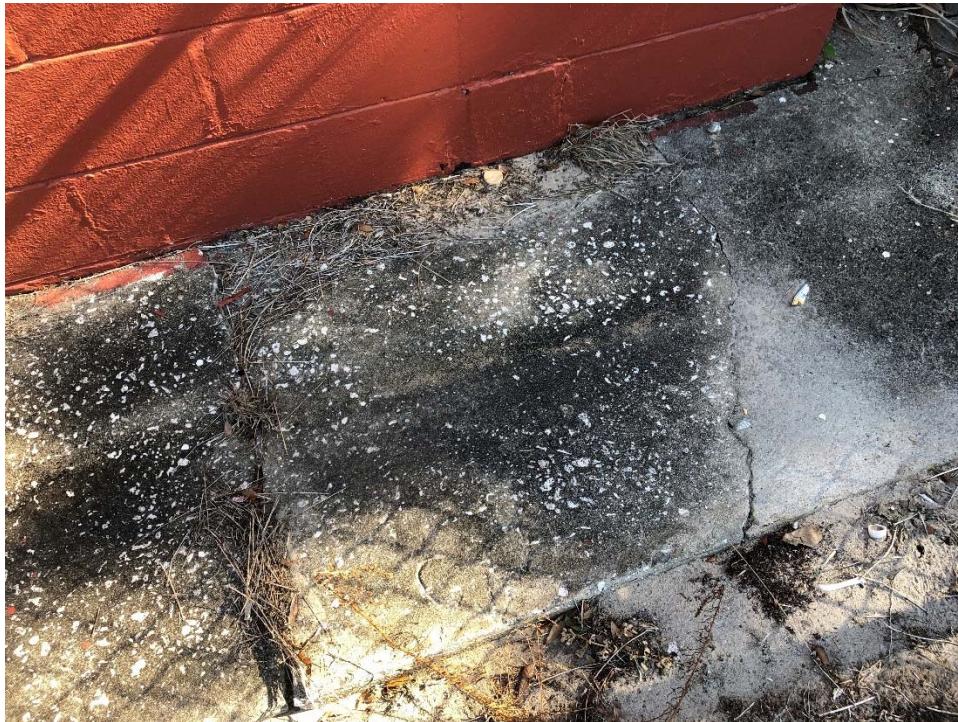
Figure A-1

Table A – Structure Exterior Observations	
Conditions Observed	Reference Photos (Figures in Appendix A)
Northeast Education Building	
General Conditions	
Cracking in concrete slab	A-1
Cracking in CMU walls	A-2 and A-3
Deteriorating paint at wood soffits and facias	A-4
Delaminating paint at CMU walls	A-5
Corroding metal window vents	A-6
Deteriorating window sealants	A-7
South Elevation	A-9
Paint separation on CMU wall surface	A-10
Moisture damage at soffit joint	A-11
Cracking/separation at CMU wall joint	A-12 and A-13
Corroding metal door framing and accessories	A-14 and A-15
Failed previous joint repair	A-16
Cracking and damaged concrete with vertical displacement in concrete sidewalk slab	A-17 and A-18
Cracking at concrete sidewalk exposing top of pipe	A-19 and A-20
West Elevation	A-21
Tree growth causing spalling in concrete slab	A-22
North Elevation	A-23 and A-24
Cracking in concrete windowsill	A-25 and A-26

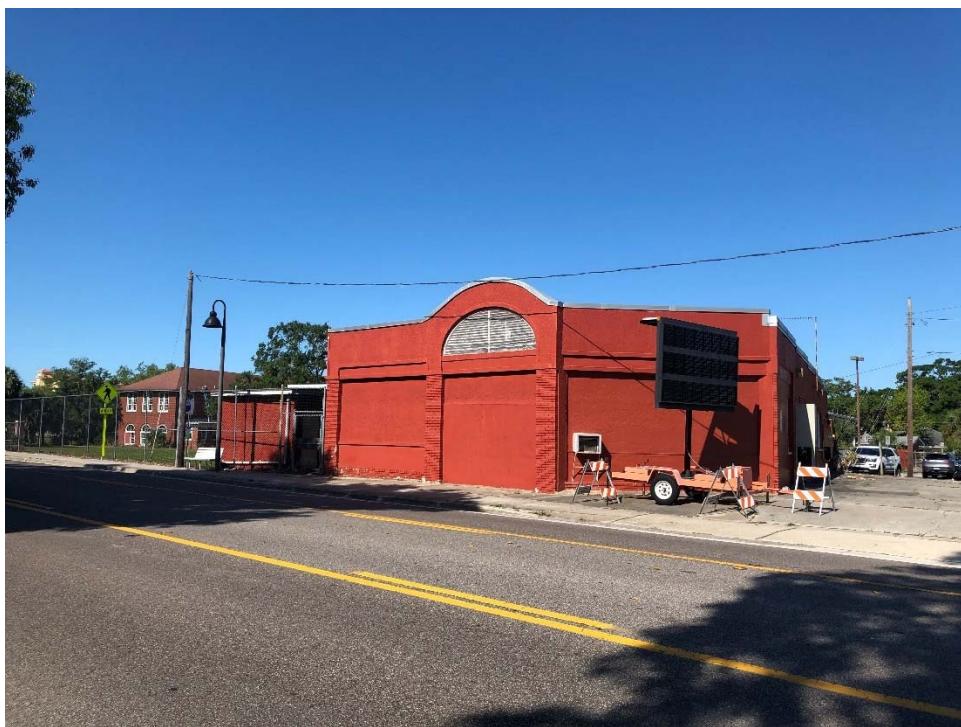
Figure A-27

East Elevation	A-27
Cracking and delaminating paint at wooden arch	A-28 and A-29

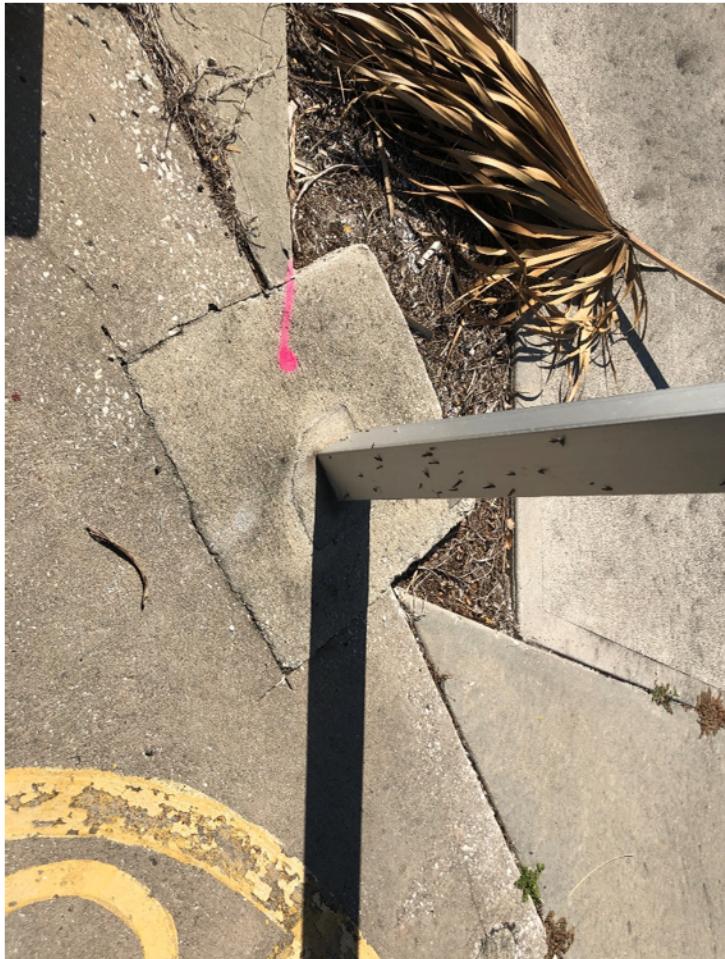
Figure A-33

Covered Sidewalk and Canopy	A-30 thru A-32
View of metal tube column foundation	A-33
Surface staining at overhead metal paneling	A-34
Corrosion at interface of metal support framing	A-35
Vegetation growth at column bases at the west end of overhang	A-36
Main Education Building	
North Building	
General Conditions	
Cracking in brick walls	A-37 and A-38
Corrosion at metal window framing and headers/lintels	A-39 and A-40
Deteriorated sealants	A-41
Deteriorating paint	A-40 and A-42
North Elevation	A-43
Previous crack repair	A-44
View of wood soffit; corroding electrical piping	A-40
View of stairway; corrosion at metal stringers, lateral bracing, treads and post bases with section loss, surface staining, exposed concrete foundations, and cracking at concrete landing	A-45 thru A-52
View of visitor's entrance; delaminating paint, cracking at concrete wall caps, and corroding at electrical conduits,	A-53 thru A-55

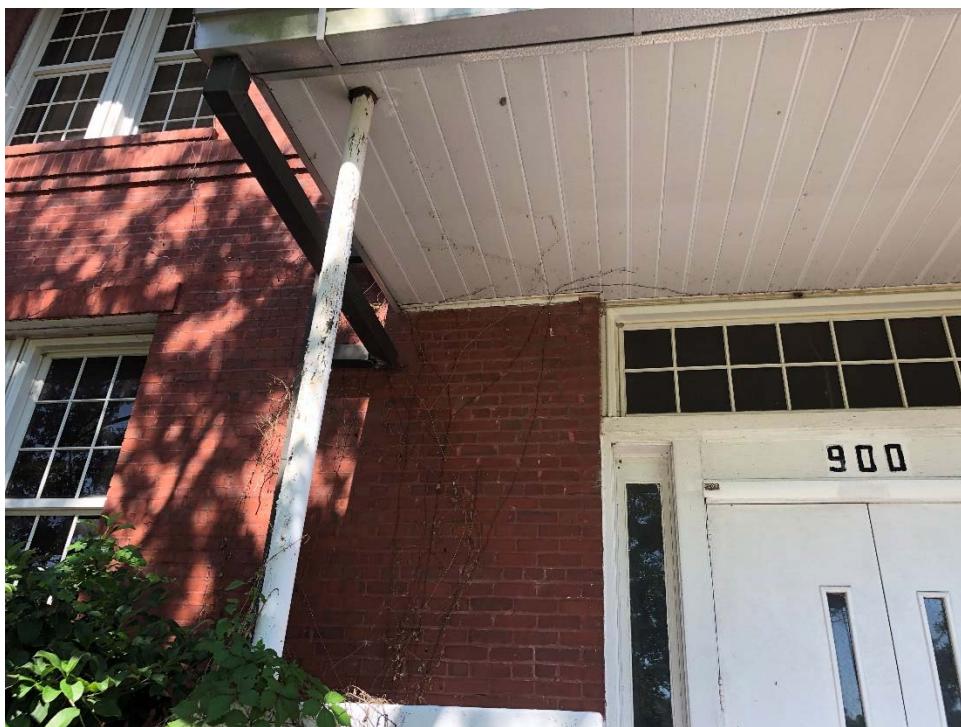
Figure A-59

East Elevation	A-56
View of roof overhang; surface rust at gutter system	A-57
View of north entrance; delaminating paint, corrosion at metal columns and handrail, cracking and vegetation growth in concrete landing	A-58 thru A-61
View of anchors above metal roof overhang	A-62
South Elevation	A-63
View of updated windows	A-63
West Elevation	A-64
View of retaining wall; cracking in concrete wall, spalling at top of concrete wall, and surface staining	A-65 thru A-68

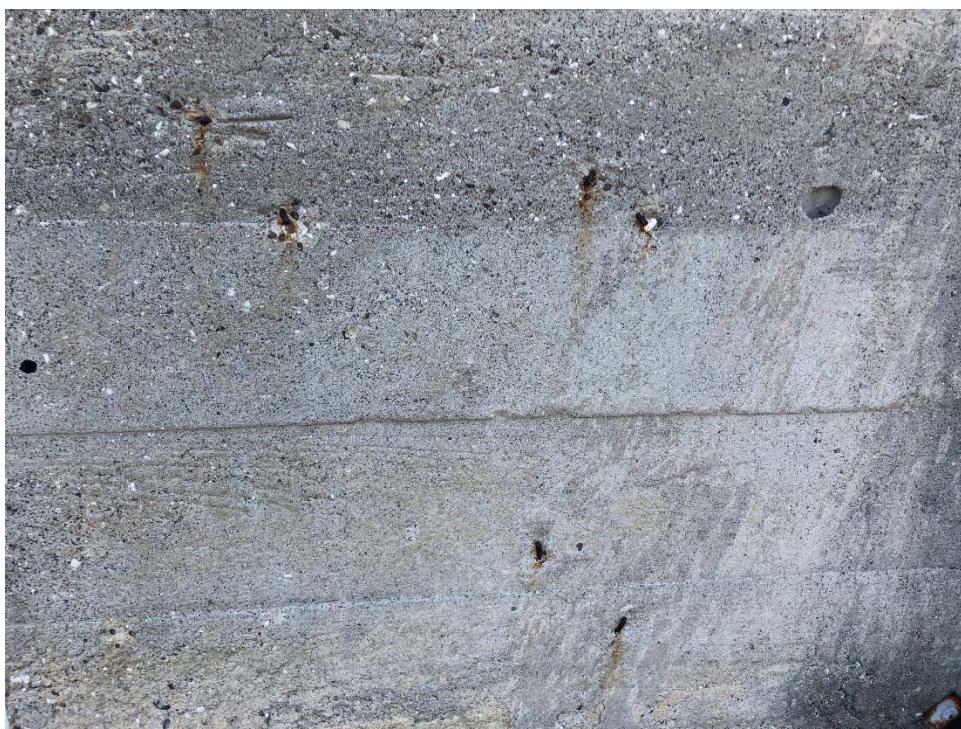
Figure A-100

View of entrance; broken window, corroding metal door and framing	A-88 and A-89
Broken windows	A-90
South Elevation	
View of stairway entrance; delaminating paint, corroding metal hand railing, window framing and post bases, broken windows, and cracking at concrete landing	A-93 and A-94
Cracking at concrete foundation wall	A-96
West Elevation	
South end of elevation; dented down spout, corroding steel pipe, and vegetation growth in asphalt	A-98
Corroding window vent framing	A-99
Corroding metal ties at concrete foundation walls	A-100
Previous repairs at brick interfaces	A-101

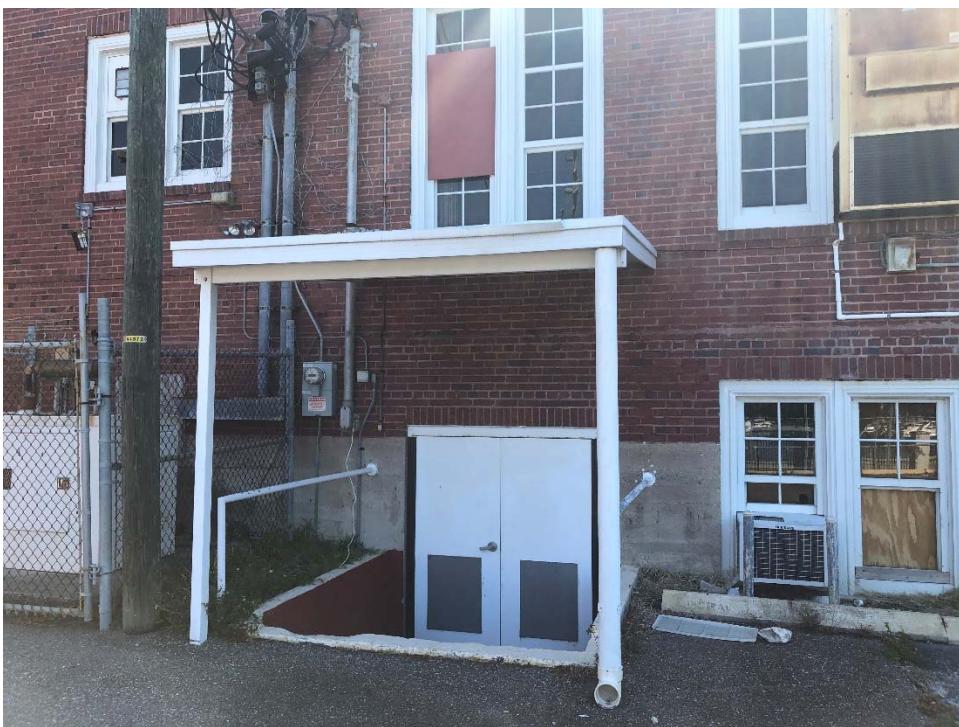
Figure A-103

Corroding at fasteners	A-102
View of basement entrance; corrosion at metal door, delaminating paint at metal railing, concrete retaining walls and concrete stairs	A-103 and A-104
West Building	
General Conditions	
Cracking in concrete walls	A-105 and A-106
Deteriorated sealants	
Staining on metal gutters	
South and East Elevation	
View of east staircase; corroding metal railing and post base, cracking in concrete stairs, and deteriorating paint	A-107 and A-109
View of crawl space exterior entry and retaining wall; cracking in concrete retaining wall, delaminating paint, and corroding metal door framing	A-110 thru A-112
View of crawl space interior; cracking in CMU wall, concrete overhead slab and concrete slab foundation, spalling in overhead concrete slab at pipe penetration, surface corrosion at steel beam that sisters concrete beam, and rust staining at reinforcing concrete beams	A-113 thru A-119

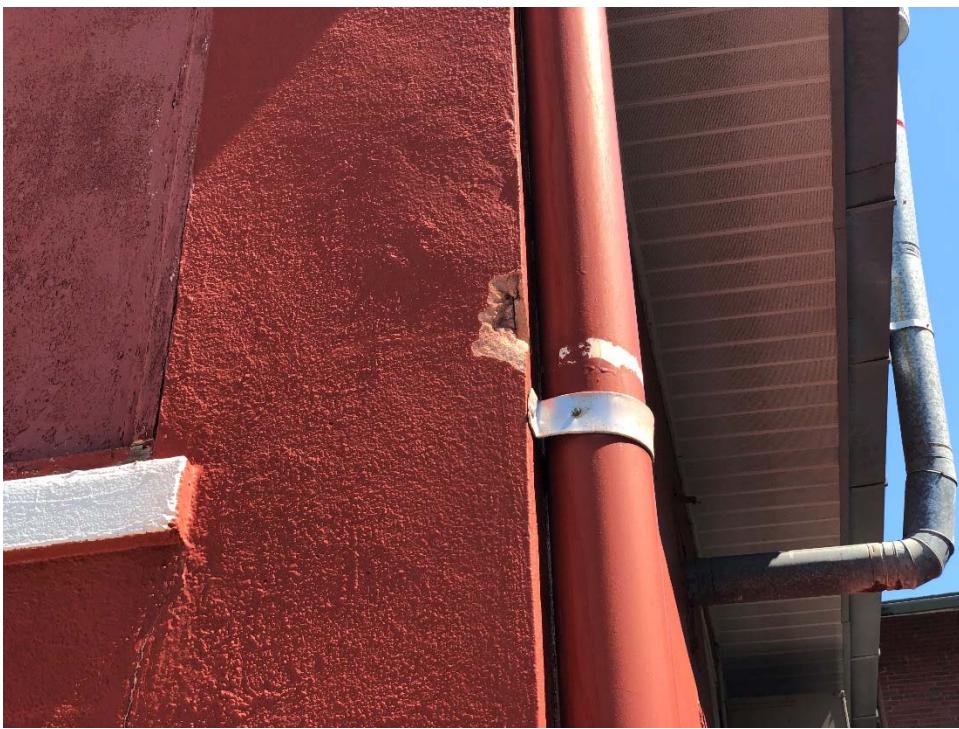
Figure A-120

Spalling at concrete wall	A-120
Corrosion at pipe stack	A-121
View of west concrete stairway; cracking in concrete wall, landing, slab and stairs, corroding metal railing, corroding metal posts, and delaminating metal railing	A-122 thru A-126
West Elevation	
Corroding metal strap	A-128
Staining at metal soffits	
Staining at concrete steps	A-129
Significant concrete wall cracking at cafeteria wall	A-130 thru A-133
Steel Pavilion	
Surface corrosion at steel members throughout pavilion	A-135 thru A-138
Section loss at metal gutter system, base of columns, base plates and girder/beam flanges,	A-139 thru A-142

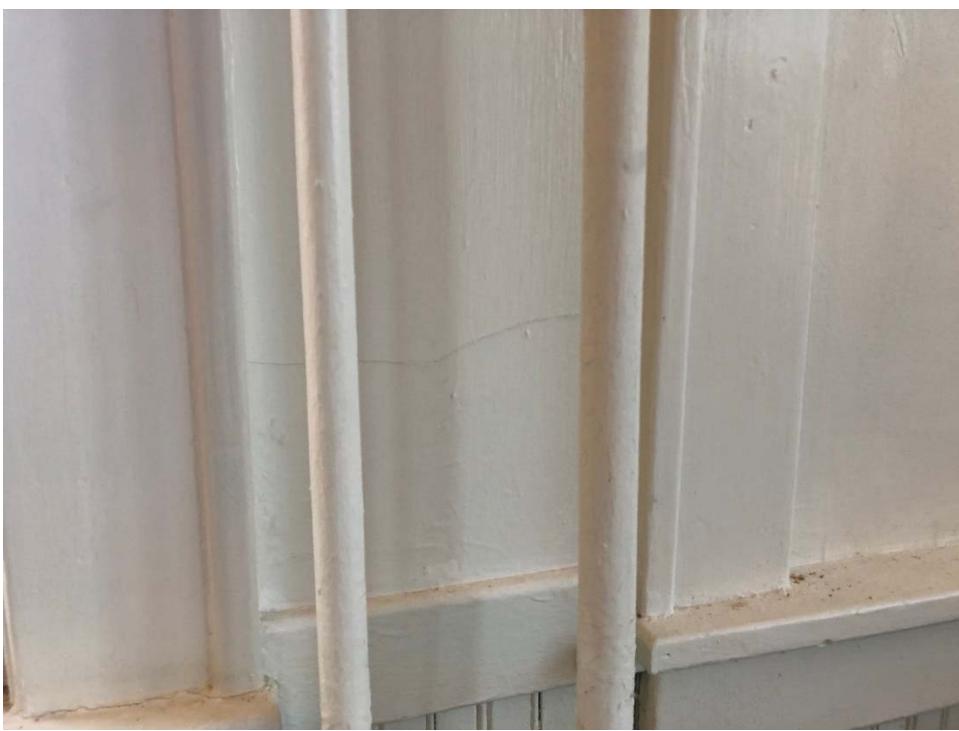
Figure B-2

Table B – Structure Interior Observations	
Conditions Observed	Reference Photos (Figures in Appendix B)
Main Education Building	
Typical Conditions	
Wall cracking	<i>B-1 thru B-3</i>
Delaminating paint	<i>B-4 and B-5</i>
Moisture damage at wall surfaces	<i>B-6 and B-7</i>
Moisture staining at ceiling surfaces	<i>B-8 and B-9</i>
Broken windows	<i>B-10</i>
Termite damage and evidence of termite activity	<i>B-11 and B-12</i>
North Classroom (1st Level)	<i>B-13 thru B-15</i>
Moisture staining at hard wood floors	<i>B-16 and B-17</i>
West Classroom (1st Level)	<i>B-18</i>
Ceiling plaster damage	<i>B-19</i>
Door handle indentation at south wall	<i>B-20</i>
Theater Classroom (2nd Level)	<i>B-21 thru B-23</i>
Moisture damage and staining at hard wood floors	<i>B-24</i>
View of attached side room	<i>B-25 thru B-27</i>
Southwest Classroom (2nd Level)	<i>B-29</i>
Vegetation growth through broken window	<i>B-30</i>

- 12) Restore and seal all brick facades via brick repointing and application of 100% silane sealer
- 13) Clean and coat all exposed corroding steel angle lintel surfaces at brick buildings
- 14) Repair all wall cracking at all buildings. Repairs may require rebuilding of blocks/bricks
- 15) Repair damaged stucco systems, where applicable
- 16) Seal non-structural cracks in non-brick buildings with an elastomeric joint sealant
- 17) Paint and seal all existing painted facade and overhead soffit surfaces
- 18) Remove and replace (2) metal stair systems

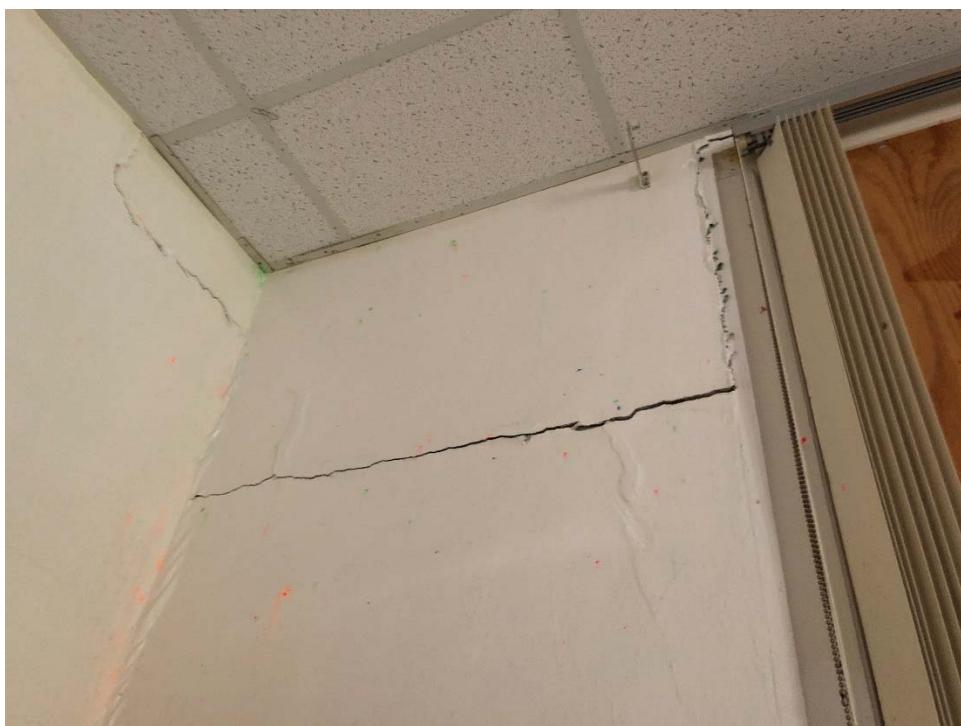
Figure B-38

Main Central Hallway	B-31
Cafeteria and Kitchen (2nd Level)	B-32 thru B-36
Significant wall cracking and separation at wall surfaces	B-37 thru B-42
Ceiling cracking in kitchen	B-43 and B-44
Evidence of termite activity	B-45
Southwest Basement	B-46 and B-47
Spalling at ceiling	B-48
Surface staining at brick surfaces	B-49
Northeast Education Building	
East Classroom	B-52
Moisture Damage	B-53 and B-54
Cracking in walls	
Delaminating paint at wall surfaces	
Northwest Classroom	
Cracking at walls	B-55

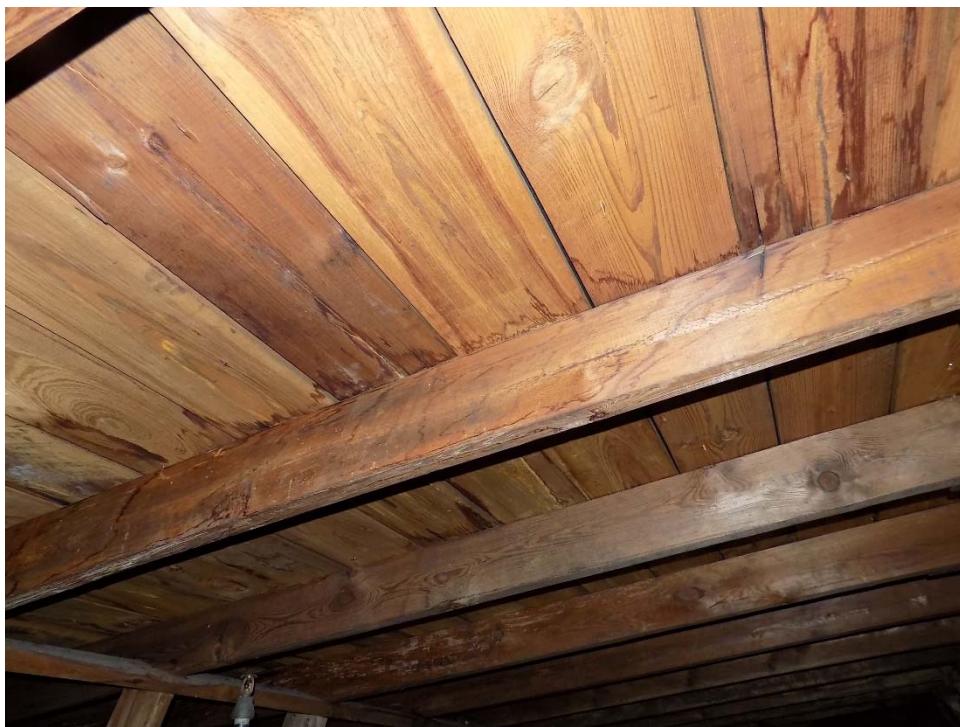
Figure D-2

Table D – Attic Space Observations	
Conditions Observed	Reference Photos (Figures in Appendix D)
Sporadic moisture staining throughout the north and south attic spaces	<i>D-1 through D-4</i>
Minor section loss at wood framing within the east side of the south attic space	<i>D-5</i>
Supplemental wood members at the diagonal bracing and columns within the north attic space area	<i>D-6 and D-7</i>
Apparent post construction vertical framing at north side of north attic space	<i>D-8</i>
