Cross-Belt Site Assessment (CBSA) PCW1 (Rossford, OH)

Project No. M-19-00072 January 26, 2022

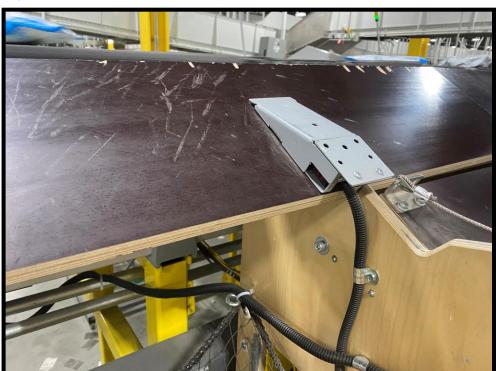
Figure 5-1 (2 to 1) Chutes Jam Photoeye

In the image below, you can see the flipper door bracket is extending above the through-going wood. This is a catch-point for items discharging into the chute.

The Jam photo-eye is within the trajectory path. If the item doesn't catch the top edge of the Jam photo-eye, it can deflect off the side and end up in the net. Relocate the Jam PEC further upstream to the Sorter flow or build a deflector bracket that helps the item glide over the Jam photo-eye bracket.

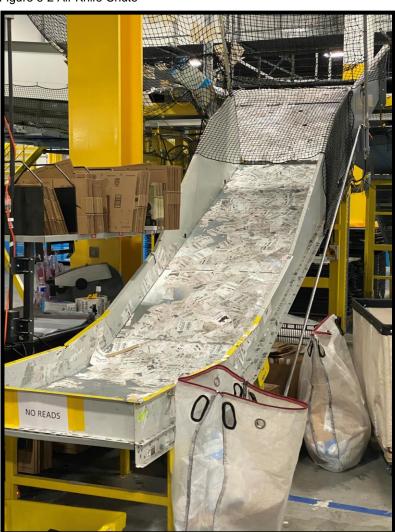
Figure 6-2 Air Knife Chute

The Air Knife Chute illustrates the inefficiencies in the air purge process. During the discharge process, some items won't discharge properly and move on the sorter in a non-preferred manner. Some items relocate to an unoccupied carrier, which later in the induction process, will receive an item. Now the carrier has [2] items on it. Or the item is relocated to an occupied carrier and the carrier has [2] items on it. This process is adding to the number of items landing in the safety nets. Take notice to the number of shipping labels removed from items by the Air Knife illustrated in **Figure 6-2**. This will increase the number of No Reads at the Scanner Tunnels.

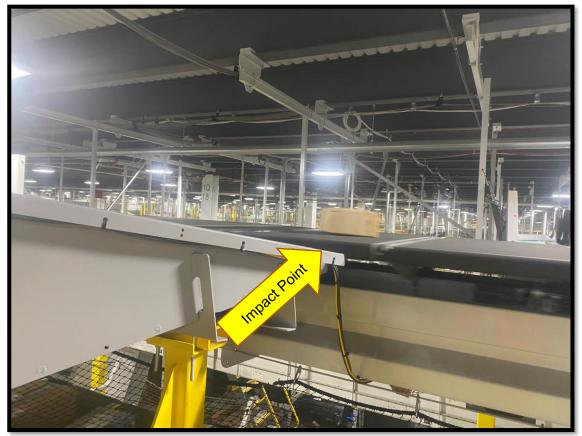
The chute hoods are working well, but isn't tolerent for inapropreately placed items. The chute hood design has an incline on the inlet side of the chute. The incline reduces tractory speed and has the capibilites of deflecting an item with inifecient item placement. This will increase the potential for poorly inducted items to land in the nets.
