PROPERTY TITLE

11112 Street Address, City, State

REPORT #123457

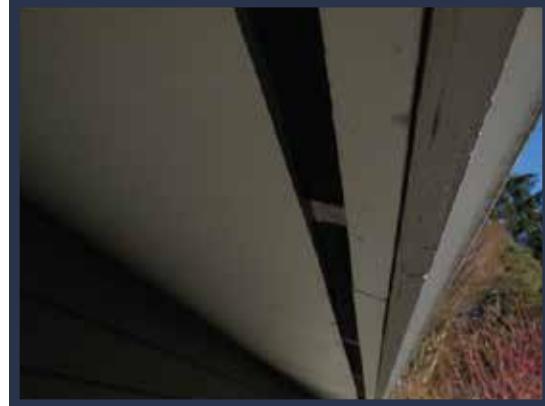
- Marginal
- Peeling paint
- Inadequate coverage
- Fungal Rot/probed
- Re-evaluate

Typical views of exterior soffit, wall cladding & trim condition

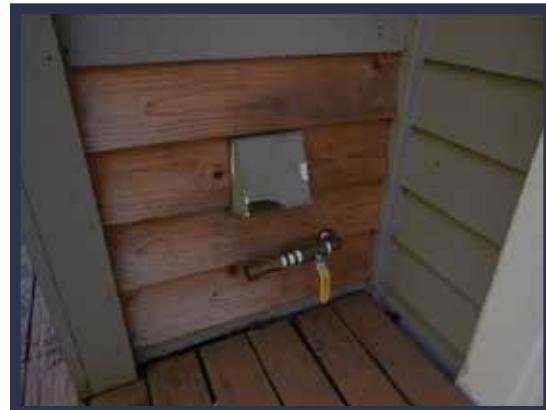
- Wood
- Screened Ventilation
- Foliage contact
- Enclosed soffit
- Poor protection/coverage
- Potential hidden damage
- Recommend re-evaluation

Unprotected exterior cladding

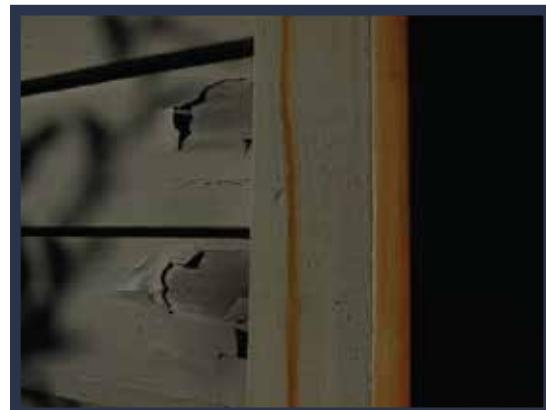
Peeling paint & rust-stained trim
