# A Serious Challenge to a New Building Technology

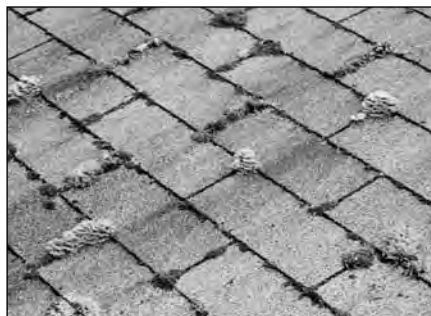
(top) Fungus growing on a SIPs roof is a sure sign of trouble. (middle) The author is exposing a failed joint. (bottom) This failed joint had an apparently good sealant installation.

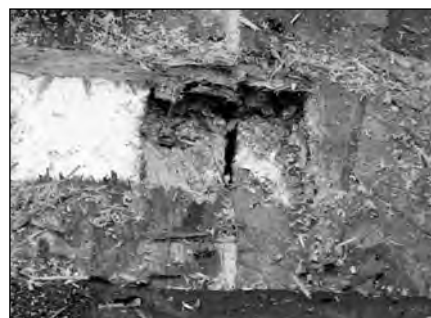
splines that are significantly larger than the spline material, making it impossible to achieve an effective seal. The seal is contained inside the panel skins, which are connected with splines that completely hide the sealant. Once the panels are in place, visual inspection would reveal only gross defects in the seal. When the sealant is compressed against the foam core rather than being bonded to the OSB on both sides of the joint, water vapor can pass through microscopic voids. Thus, failure is not detected until it reaches catastrophic proportions, as happened in Juneau.
