# After the Flood—There's Hope

*Homes that are damaged by flooding can be repaired and made more durable.*

by **Robert Wendt**  
and **Heshmat Aglan**

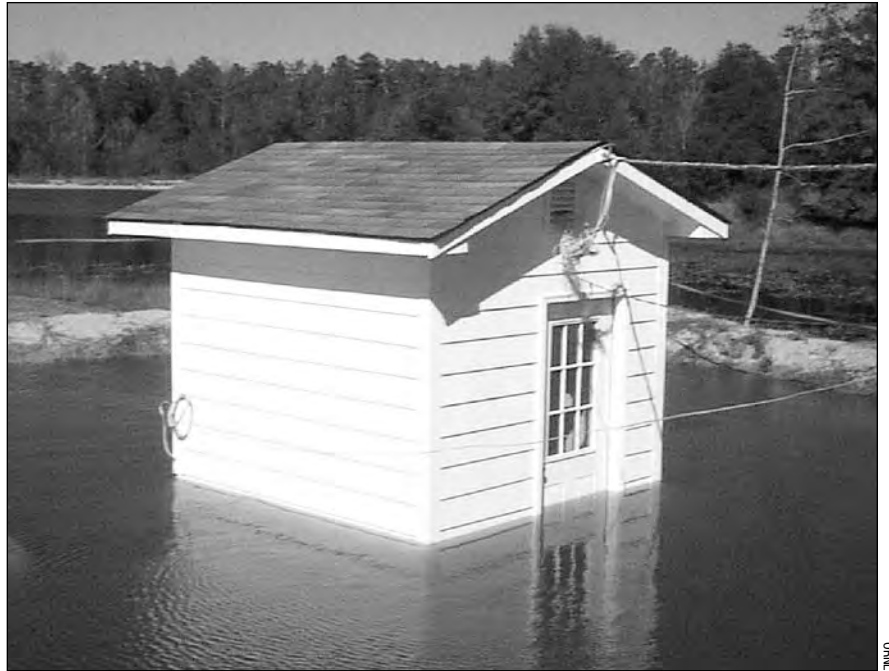
The first crawlspace test module tested hardboard lap siding, plywood sheathing, standard wood framing, fiberglass batt insulation, gypsum drywall, plywood subflooring, and a variety of interior finishes.

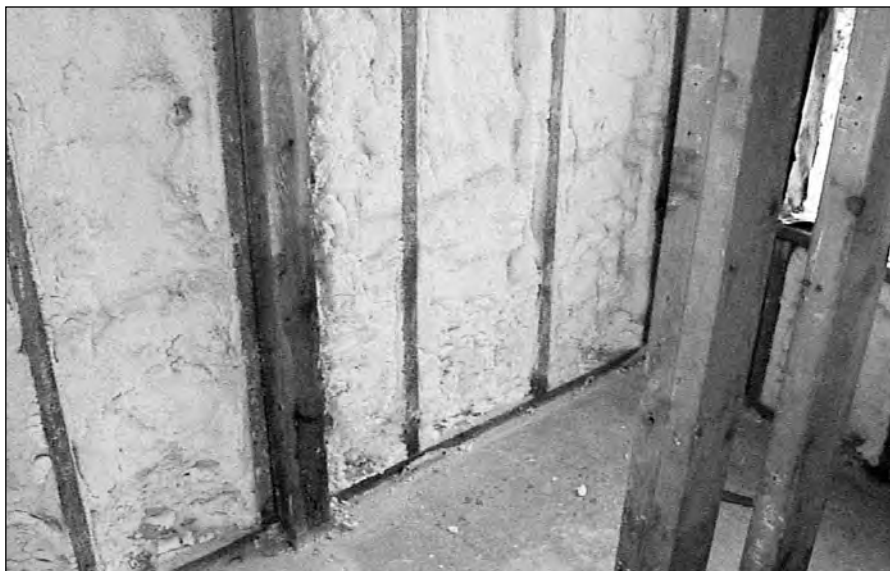
Spray polyurethane foam (SPUF) insulation was tested several times. It was unaffected by exposure to water and permitted adjacent materials to dry to pre-flood levels within the test period. The picture was taken during the autopsy of the module.

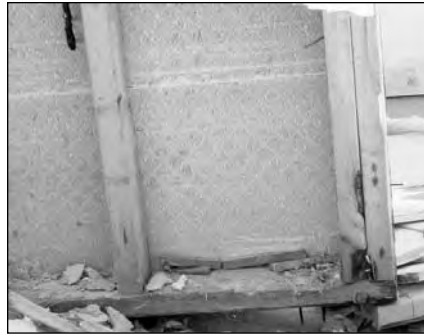
This is an inside view (taken at autopsy) of an open-cavity wall showing the back of a Fiberock gypsum panel after exposure to flooding. Note that there is no visible evidence of mold growth. The dark spots on the second stud from the right are knots or pitch pockets.

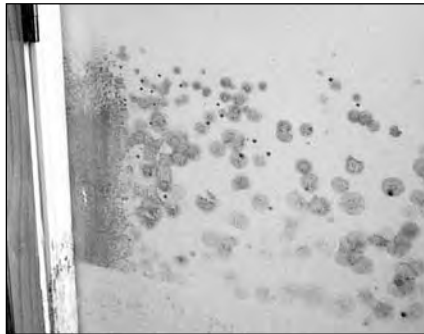
When we reentered the test module eight days after flooding, we found mold growth above the waterline and staining below it. Mold growth increased and the staining remained after we washed the test module ten days after flooding.

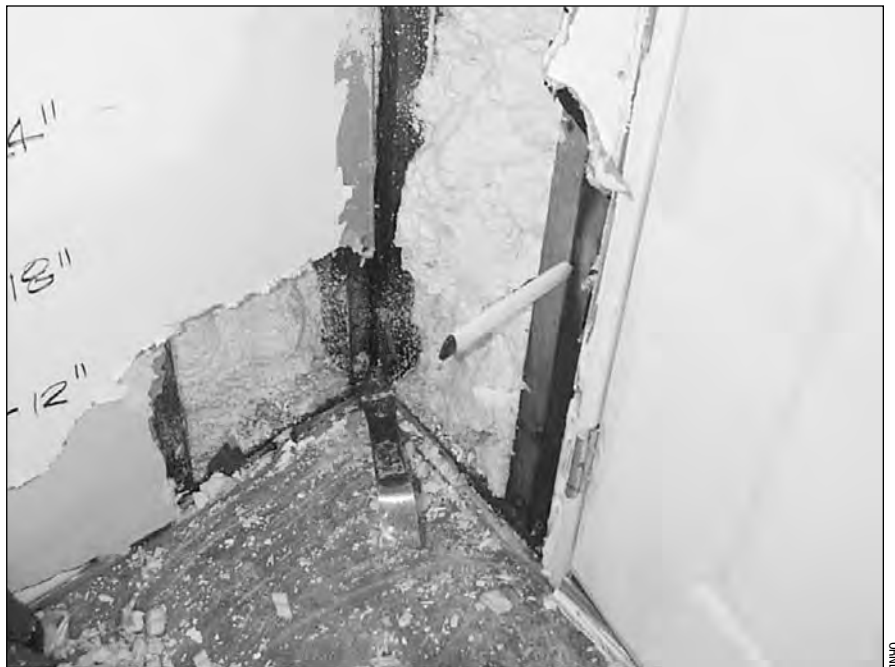
After the floodwater had penetrated the outer barriers, it entered the interior through the joint between the sill plate and the studs, as well as between the studs where they had been doubled (see tools stuck in these joints). The SPUF insulation was effective at preventing water from entering through the cavity of the wall.

We did not achieve dry floodproofing in two attempts (see photo). While the door and window dams that were designed and built were effective in preventing the entry of water through doors and windows, water entered the units through other paths, such as the joint between the interior partition and the exterior walls at floor level. Although the joint between the sill plate and the con-

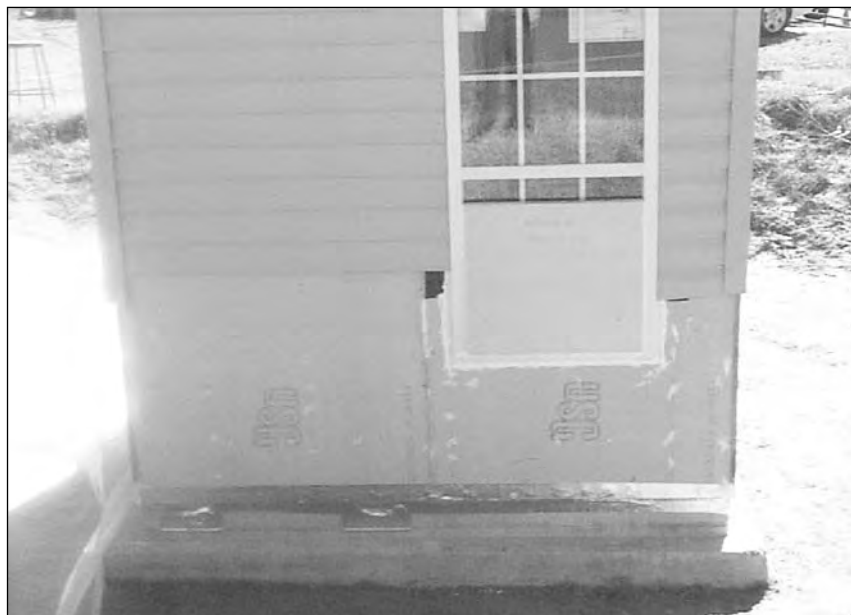
Our second try at dry floodproofing involved removing the vinyl siding below flood level, caulking all visible cracks or holes in the sheathing and around the window, caulking the sill plate joint with the slab, and covering that joint with butyl rubber tape. A window dam made from 2-inch-thick polystyrene insulation was fabricated and installed in the window frame. The dam was held in place with silicon caulk. Despite all these efforts, the envelope leaked when subjected to flooding, albeit at a slower rate than an unprotected structure.

crete slab had been caulked, water entered there as well. Additional steps were taken in the second attempt; the external joint between the sill and the slab and other potential leak pathways on the exterior were sealed. Despite these efforts, floodwater entered the modules. Based on these failures, dry floodproofing is not considered an appropriate approach to flood damage resistance.
