# ANATOMY OF A HOME PERFORMANCE RETROFIT

**After years of helping others make their homes more comfortable, a home performance professional turns his attention to his own home.**

by STEVE SOKOLSKY

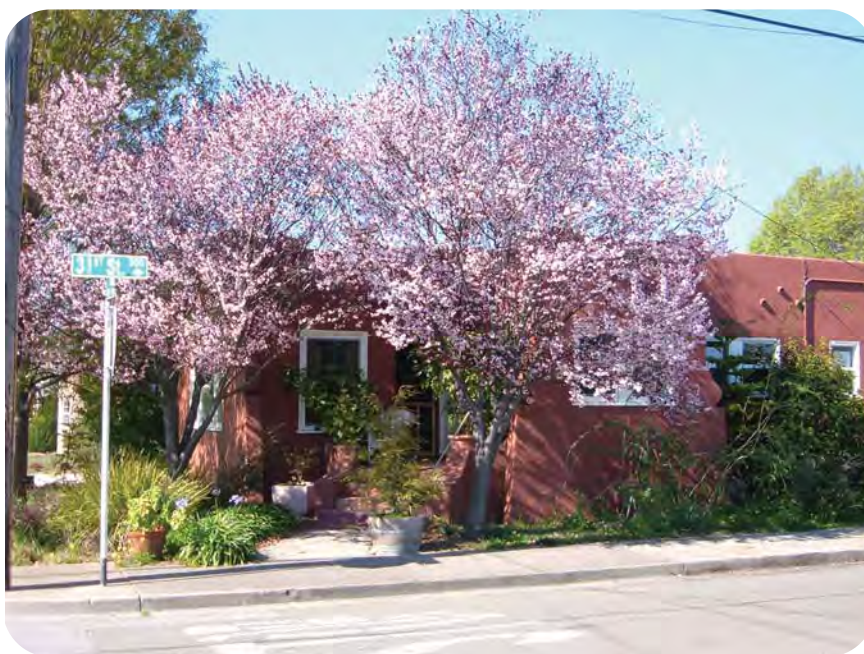
The Sokolskys' home hadn't performed well in the past winter, so they brought in some professional help.

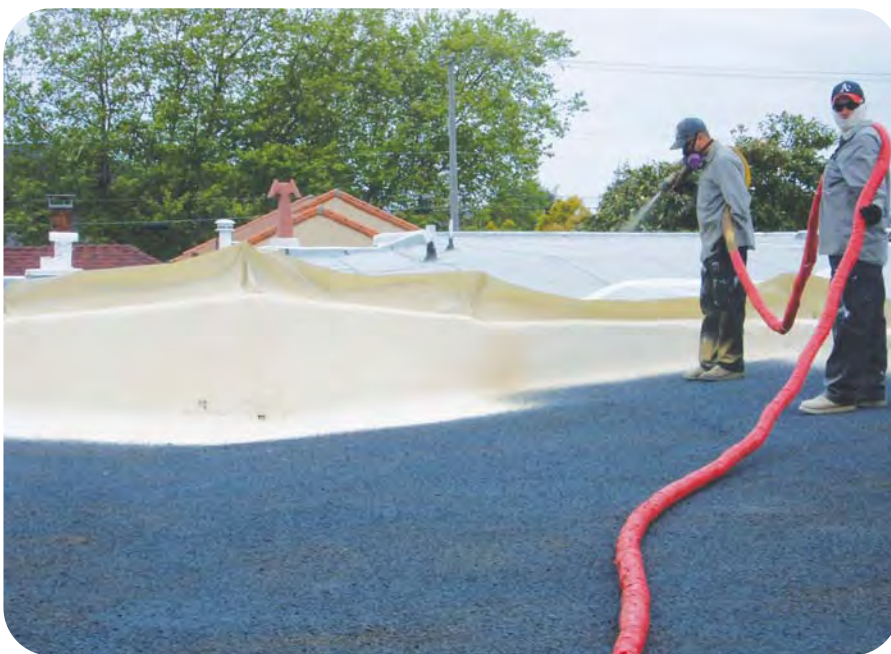
Sprayed polyurethane foam (SPF) roofs can last 50 years or longer, but most require a UV coating every 12–15 years.

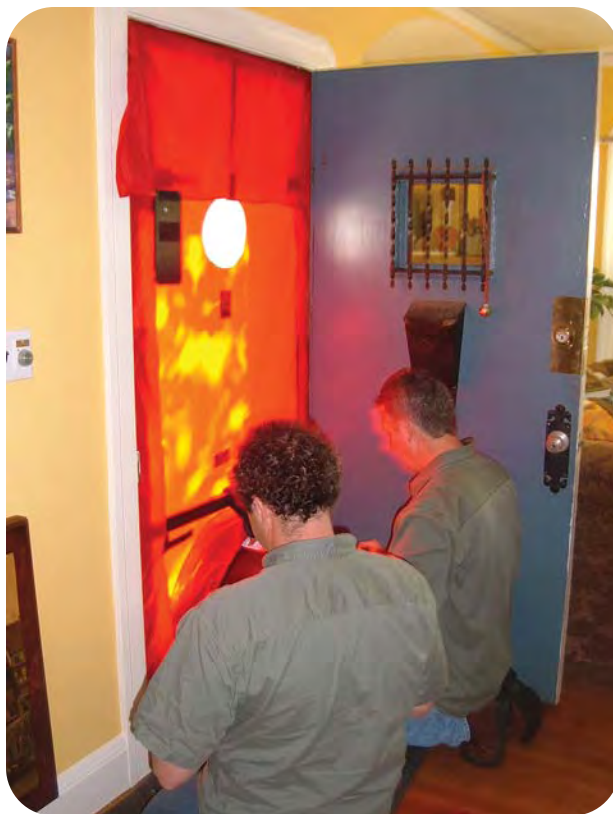
Robert Mitchell and Kevin Beck set up the blower door at the Sokolskys' house.

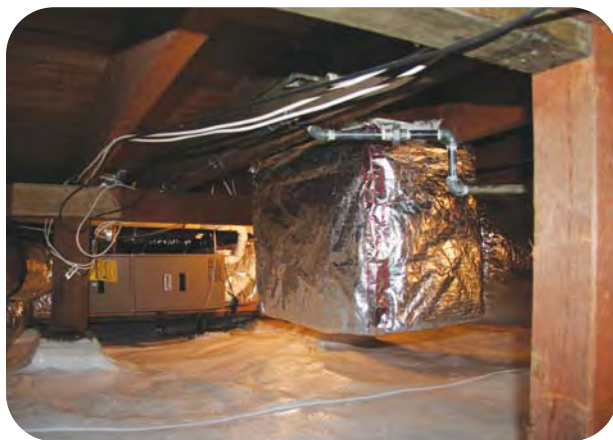
The installation of the insulation, furnace, and ducts has made the house much cozier on cold nights.

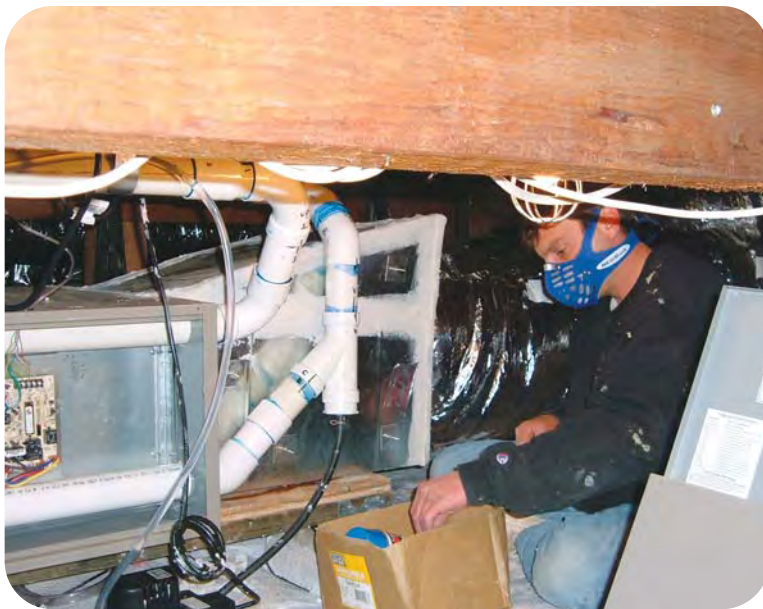
Matthew Dawson of AHP completes the installation of the furnace in the crawlspace.
